<b>HELICOPTER ACCIDENT REPORT AND EXECUTIVE SUMMARY</b>
---

Reference:	CA18/2/3/9809		
<b>Aircraft Registration</b>	<b>ZS-HGY</b>	<b>Date of Accident</b>	30 July 2019	<b>Time of Accident</b>	0915Z	
<b>Type of Aircraft</b>	Bell 47G-3B-1		<b>Type of Operation</b>	Game Culling (Part 137)		
<b>Pilot-in-command Licence Type</b>	Private Pilot Licence (H)		<b>Age</b>	69	<b>Licence Valid</b>	Yes
<b>Pilot-in-command Flying Experience</b>	Total Flying Hours		12685.7	<b>Hours on Type</b>	316.9	
<b>Last Point of Departure</b>	Tshwarelano Game Lodge: Limpopo Province					
<b>Next Point of Intended Landing</b>	Tshwarelano Game Lodge: Limpopo Province					
<b>Location of the accident site with reference to easily defined geographical points (GPS readings if possible)</b>						
Tshwarelano game farm at GPS co-ordinates determined to be 22°41'52"S, 029°22'44"E and at an elevation of 2516ft						
<b>Meteorological Information</b>	Wind direction: 330°; Wind speed: 04kts; CAVOK; Temperature: 22°C; Q940hPA

**Reference Number** : CA18/2/3/9809  
**Name of Owner/Operator** : Gauteng 45 Business Management (PTY) LTD  
**Manufacturer** : Westland Aviation LTD  
**Model** : Bell 47G-3B-1  
**Nationality**

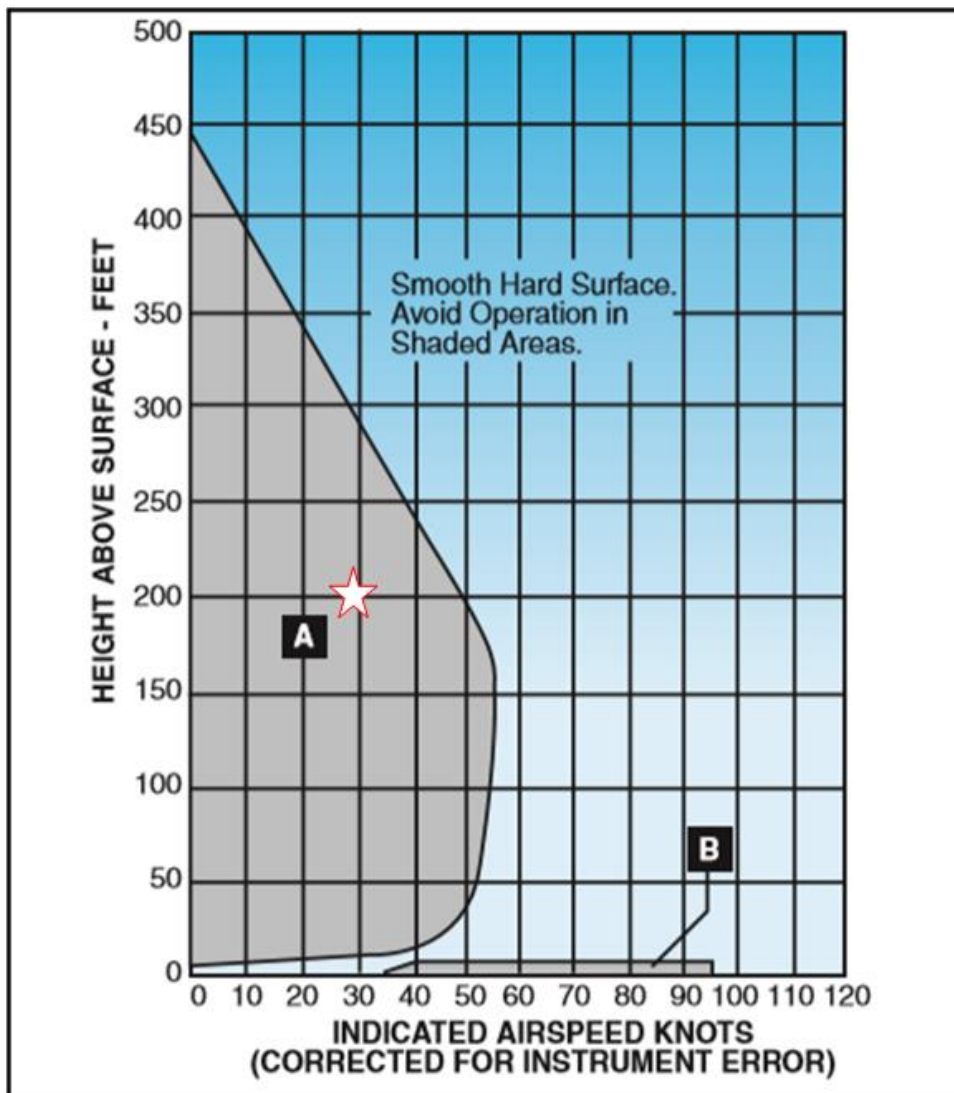
*Operating at the altitudes and airspeeds shown within the crosshatched or shaded areas of the height/velocity (H/V) diagram below may not allow enough time for the critical transition from powered flight to autorotation. According to the witness, the helicopter was flying at indicated airspeed of 20-30kts and was approximately 200ft AGL.*

**Figure 17:** By carefully studying the height/velocity diagram, one would be able to avoid the combination of altitude and airspeed that may not allow one sufficient time or altitude to enter a stabilised autorotative descent.

- 2.1.5 The witness stated that the helicopter was flying at an indicated airspeed of 20-30kts and that it was approximately 200ft AGL. This configuration made the helicopter susceptible to high vertical impact forces as it was operating inside the grey shaded area A (see Figure 17) without any room to fully recover in case of an emergency.
