AIRCRAFT ACCIDENT REPORT AND EXECUTIVE SUMMARY

Reference:	CA18/2/3/9815	
Aircraft Registration	ZS-LMI	Date of Accident	16 August 2019		Time of Accident	1700Z	
Type of Aircraft	Cessna 172		Type of Operation	Training (Part 141)			
Pilot-in-command Licence Type	Commercial Pilot Licence		Age	34	Licence Valid	Yes	
Pilot-in-command Flying Experience	Total Flying Hours		1514.7	Hours on Type	436.7		
Last Point of Departure	Grand Central Aerodrome (FAGC), Gauteng Province						
Next Point of Intended Landing	Grand Central Aerodrome (FAGC), Gauteng Province						
Location of the accident site with reference to easily defined geographical points (GPS readings if possible)							
On Plot 63 next to the N4 highway at Hartebeesfontein Road at GPS 25°32'59" South 027°55'58" East, at an field elevation of 3862 feet							
Meteorological Information	Wind: 150° at 06kt, Temperature: 20°C, Dew point: 0°C, Visibility: 10km and Query nautical height (QNH): 1020hPa

Reference Number : CA18/2/3/9748
Name of Owner/Operator : Lanseria Flight Centre (Pty) Ltd
Manufacturer : Cessna Aircraft Company
Model : Cessna 172M
Nationality : South African
Registration Marks : ZS-LMI
Place : Hartebeesfontein Road, Gau

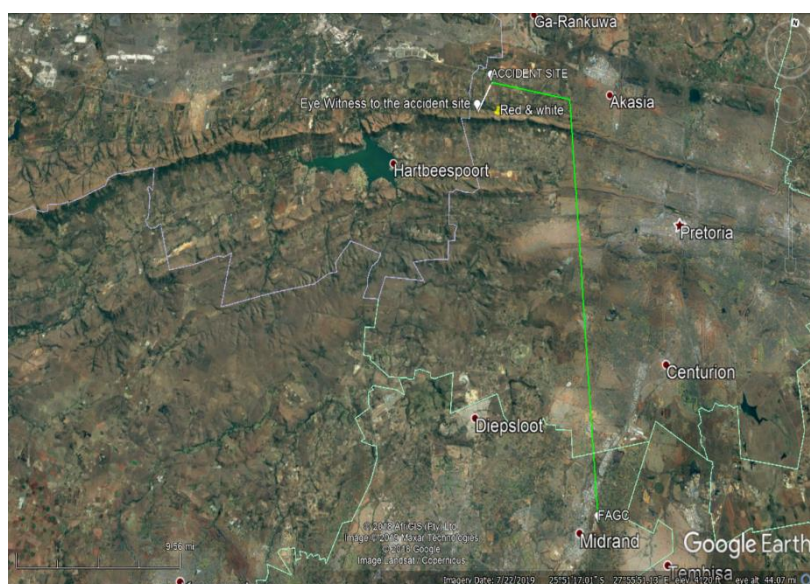
- 1.1.12 The accident occurred at Plot 63 next to the N4 Highway at dusk at a geographical position determined to be 25°32'59" South 27°55'58" East, at a field elevation of 3 862 feet (ft) above mean sea level (AMSL).

Figure 1: Overlay of the accident site. (Source: Google Earth Maps)

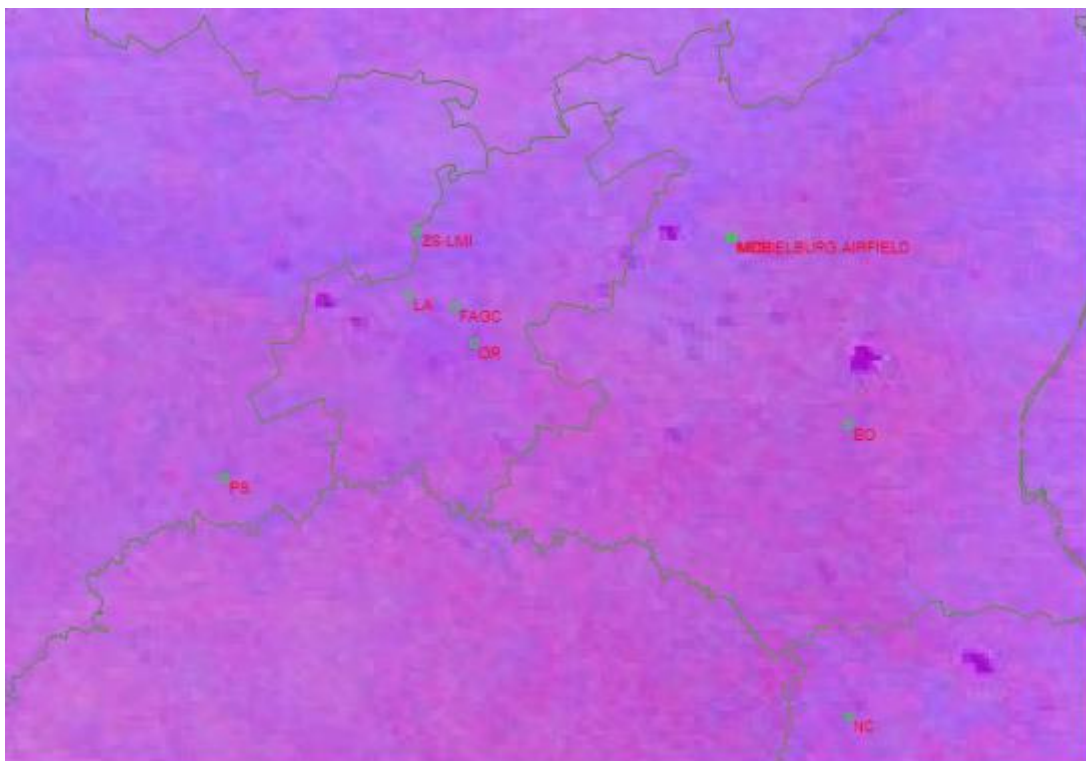
1.7.2 All observational data referred to in this report showed that the weather was not a factor.

Figure 3: The weather and the position of the wreckage from the departure aerodrome.

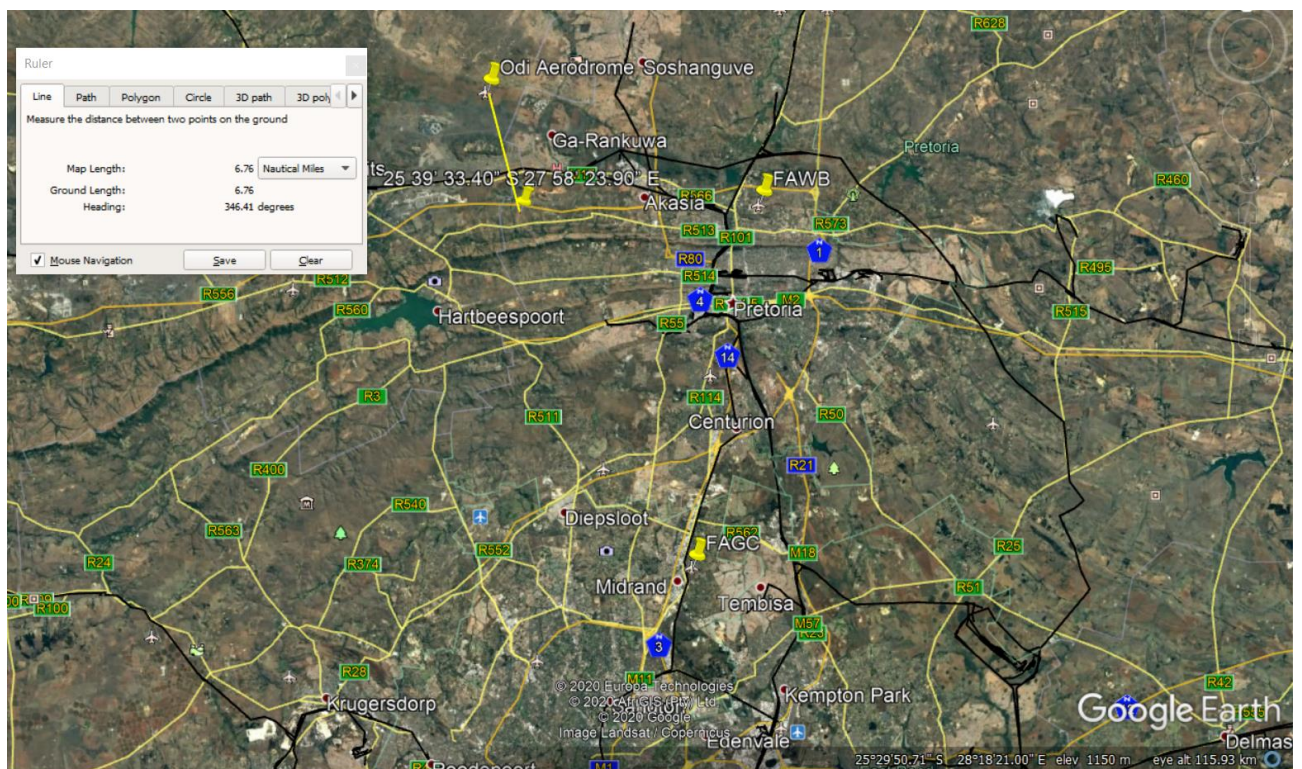
1.10.1 The accident did not occur at the aerodrome. It occurred north of Pretoria at night at a geographical position determined to be 25°39'33.40" South 27°58'23.90" East at an elevation of 4 271ft AMSL.

1.10.2 The accident occurred during night-time approximately 6.75 nautical miles (nm) north of Odi Aerodrome (FAIO) main entrance, North West province, at Global Positioning System (GPS) co-ordinates determined to be: S25°32'53" E027°56'19" East and at an elevation of 3 862ft.
