HELICOPTER ACCIDENT REPORT AND EXECUTIVE SUMMARY

Reference:		CA18/2/3/9832	
Aircraft Registration	ZT-RAL	Date of Accident	25 October 2019	Time of Accident	1030Z
Type of Aircraft	Robinson R44		Type of Operation	Training (Part 141)	
Pilot-in-command Licence Type	Commercial Pilot Licence		Age	70	Licence Valid Yes
Pilot-in-command Flying Experience	Total Flying Hours	7700.6	Hours on Type	134.1	
Last Point of Departure	Wonderboom Aerodrome (FAWB), Gauteng Province				
Next Point of Intended Landing	Wonderboom Aerodrome (FAWB), Gauteng Province				
Location of the accident site with reference to easily defined geographical points (GPS readings if possible)					
At position S 25° 40' 18.67" E 028° 12' 54.12" on Marjoram Ave position 0.6nm south of Runway 06 threshold					
Meteorological Information	Wind: 270°/14kts, Temperature: 36°C, Dew Point: 14°C, Visibility: CAVOK, QNH: 1018hPa and Clouds: Nil				
Number of People On-board	3 + 0	No. of People Injured	2 (minor) 1 (serious)	No. of People Killed	0

Reference Number : CA18/2/3/9832
Name of Owner/Operator : Delmart (Pty) Ltd t/a Powered Flight Training Centre
Manufacturer : Robinson Helicopter Company
Model : R44
Nationality : South Afri

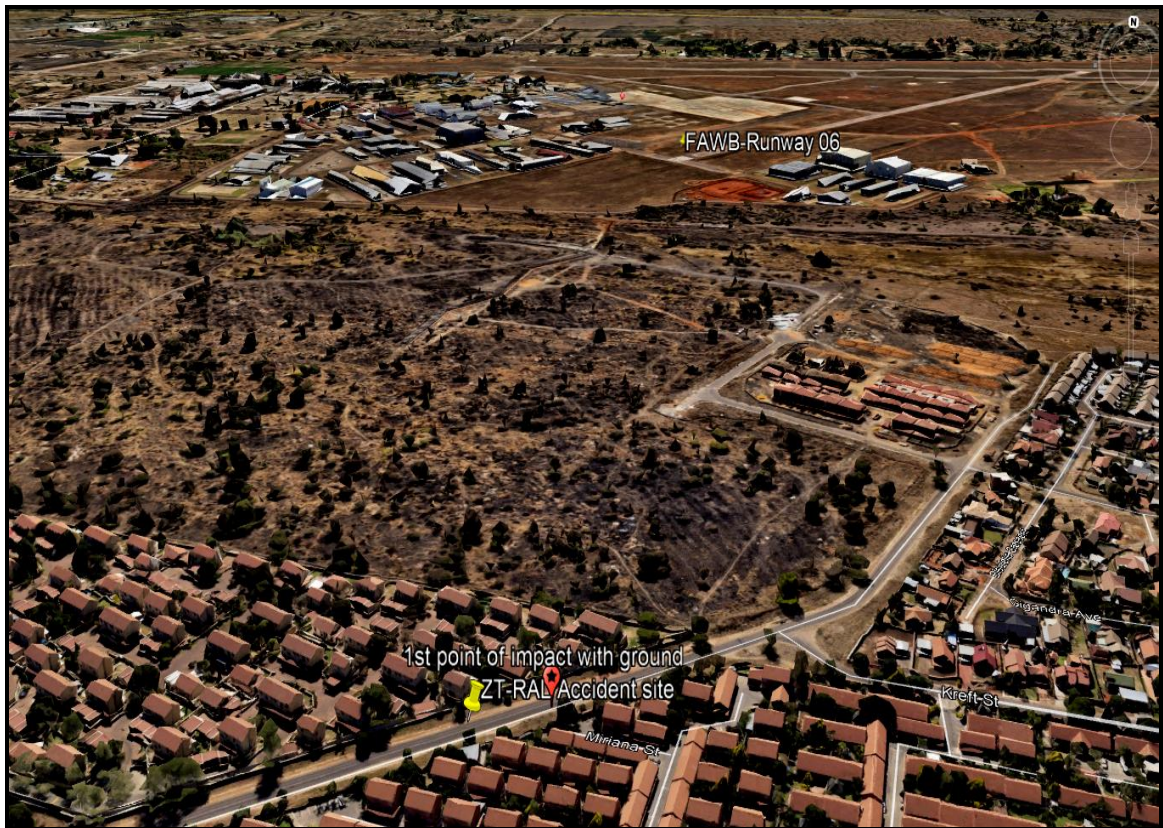
1.12.1 The helicopter accident occurred in a built-up area on Marjoram Avenue, which is approximately 0.6nm (1km) south of the threshold of Runway 06 with the following GPS co-ordinates: S 25° 40' 18.67" E 028° 12' 54.12" at a field elevation of 4092ft AMSL. The accident site was secured by both police as well as airport fire and rescue services with the street almost completely closed off to secure evidence. The helicopter was found lying on its left-hand side facing an easterly direction, approximately 20m from the initial point of impact with the ground. The helicopter's tail boom, which was severed and damaged, was lying close to the main wreckage.

Figure 6: Aerial view of the accident site. (Source: Google Maps)
