AIRCRAFT ACCIDENT REPORT AND EXECUTIVE SUMMARY

Reference:	CA18/2/3/9841	
Aircraft registration	ZS-UUA	Date of accident	2 December 2019		Time of accident	1555Z
Type of aircraft	Scheibe SF25D Falke		Type of operation	Commercial (Part 96)		
Pilot-in-command licence type	Commercial Pilot Licence	Age	67	Licence valid	Yes	
Pilot-in-command flying experience	Total flying hours	24 961.1		Hours on type	280.6	
Last point of departure	Plettenberg Bay Aerodrome (FAPG), Western Cape Province					
Next point of intended landing	Plettenberg Bay Aerodrome (FAPG), Western Cape Province					
Damage to the Glider	Destroyed					
Location of the accident site with reference to easily defined geographical points (GPS readings if possible)						
Plettenberg Bay Botanical Estate (GPS position: 34°05'22.31" South; 023°20'18.45" East), elevation 443 feet						
Meteorological information	Surface wind; 248°/17kts gusting 24kts, temperature; 21.9°C					
Number of people on-board	1 + 1	No. of people injured	0	No. of people killed	2

Probable Cause/s and/or Contributory Factors						
The pilot failed to maintain flying speed and, most probably, the glider entered an inadvertent stall due to the wind gradient, w

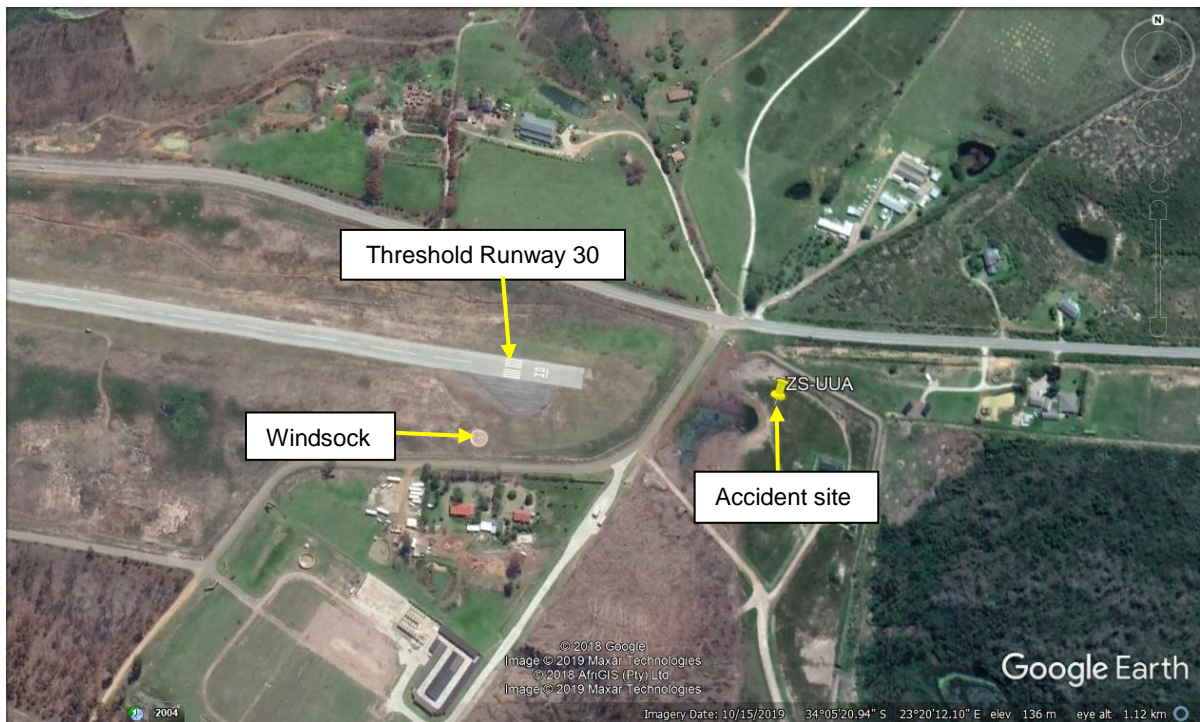
1.1.5 The accident occurred during daylight at a geographical position determined to be 34°05'22.31" South 023°20'18.45" East, at an elevation of 443 feet, which was within the Plettenberg Bay Botanical Estate.

Figure 1: Google Earth overlay of the accident site in relation to the threshold of Runway 30.

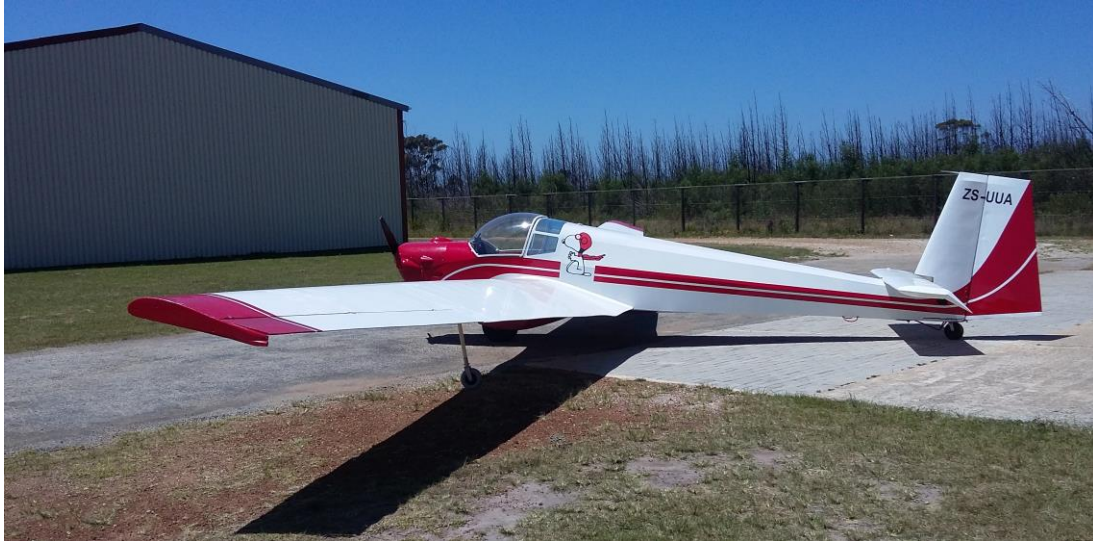
Figure 3: A photograph of the glider ZS-UUA.

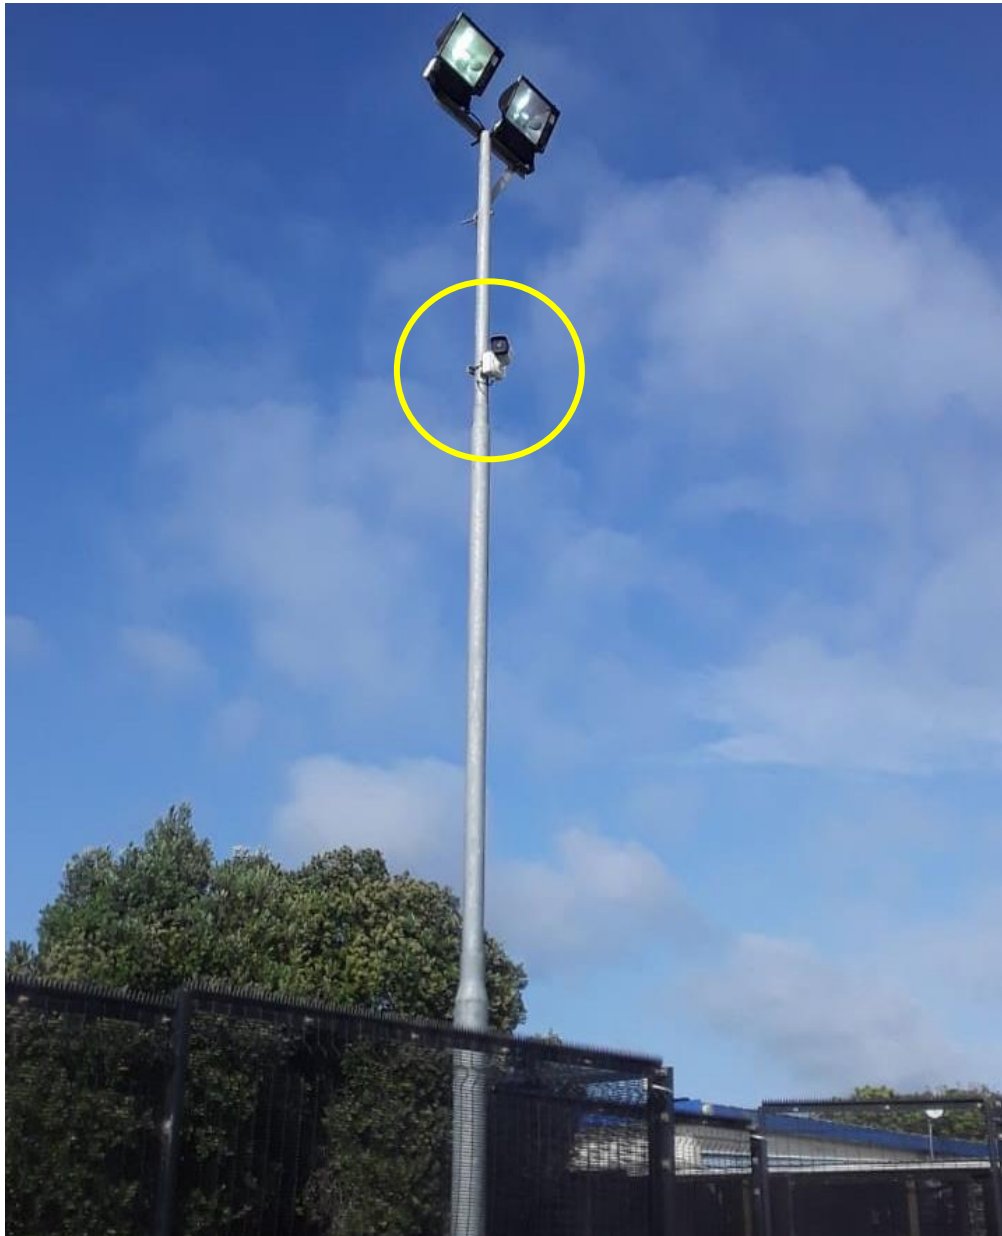
One of these cameras was positioned facing the direction of the final approach path for Runway 30. The camera was located on an apron flood light pole (Figure 13)

This camera footage was obtained from the aerodrome licence holder. The distance of the camera to the accident site was approximately 1 100m.

Figure 13: The flood light next to the apron at FAPG with the CCTV camera attached.
