The South African Civil Aviation Authority
Aircraft Accident Investigation
Final Report

Cessna S550 (ZS-CAR)
George Aerodrome (FAGG) January 23, 2020

AIID Ref No: CA18/2/3/9855
November, 2021

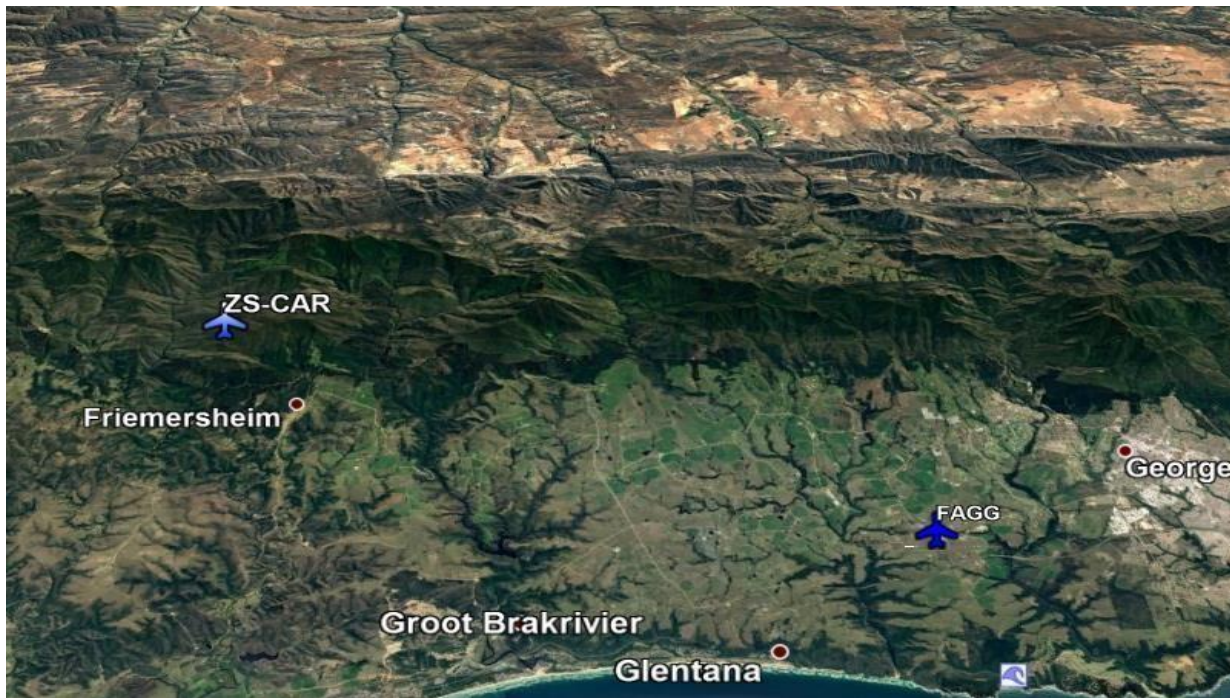
The crash site found at the top of the Outeniqua mountains, near the town of Friemersheim, at Global Positioning System (GPS) co-ordinates 33°55'24" South 022°06'30" East, at an elevation of 2192ft. The aircraft was found destroyed on impact and all occupants were fatally injury.

Figure 2: The wreckage was located north of Friemersheim in the Western Cape. (Source: Google Earth)

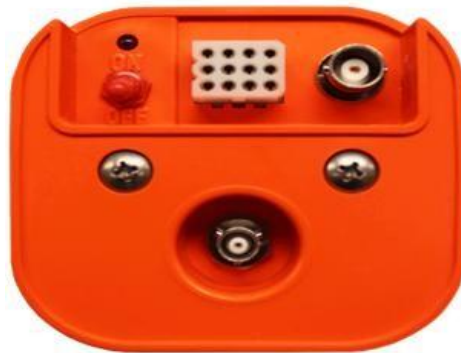
FIGURE 3: ELT ARTEX C406-2

The aircraft was fixed with an Emergency Locator Transmitter (ELT) with the description ARTEX ELT C406-2 with part number 453-5000 and serial number 170-07269. The ELT did not transmit a signal following the accident, and it was not found at the accident site. The ELT was last bench-checked on 28 May 2019 and its battery changed on 2 October 2019.

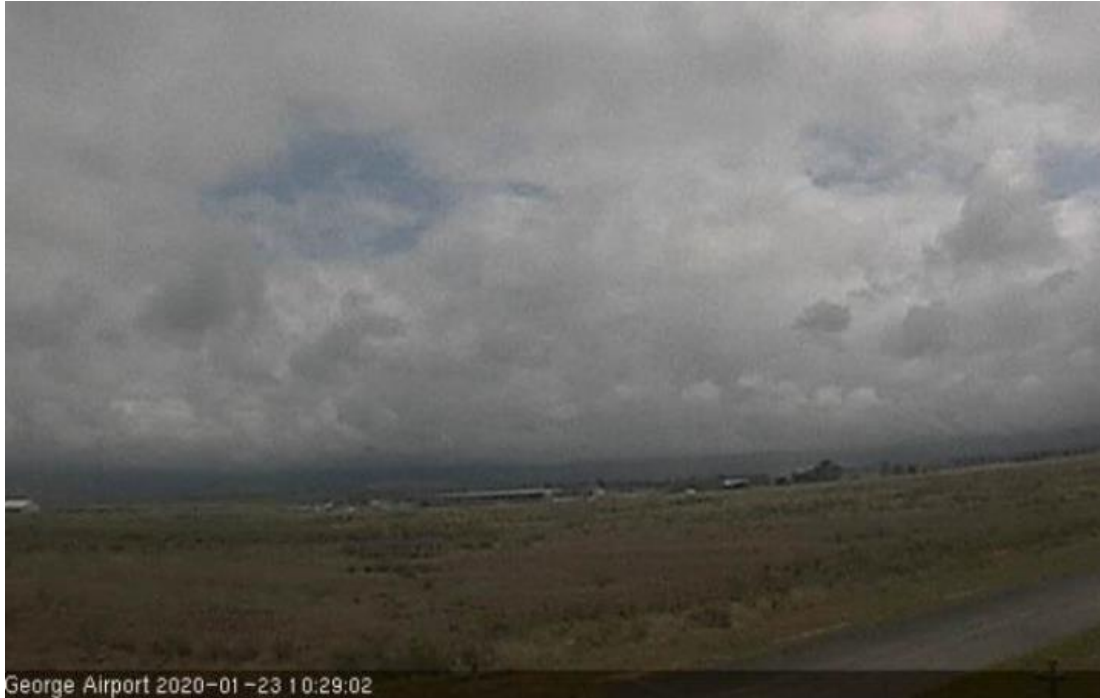
According to the SAWS report “Significant clouds below 1,500ft above ground level (AGL) were present at the time of the accident as observed in the METARs. There was no indication of drastic wind direction or speed changes as seen on the spot graph. Mountain tops were obscured as seen on the webcam.” Refer to Figure 5. Furthermore, no low-level turbulence was forecasted or observed in the area.

Figure 5: A Webcam Observation at 0829z in the morning of the accident at FAGG. (Source: SAWS)

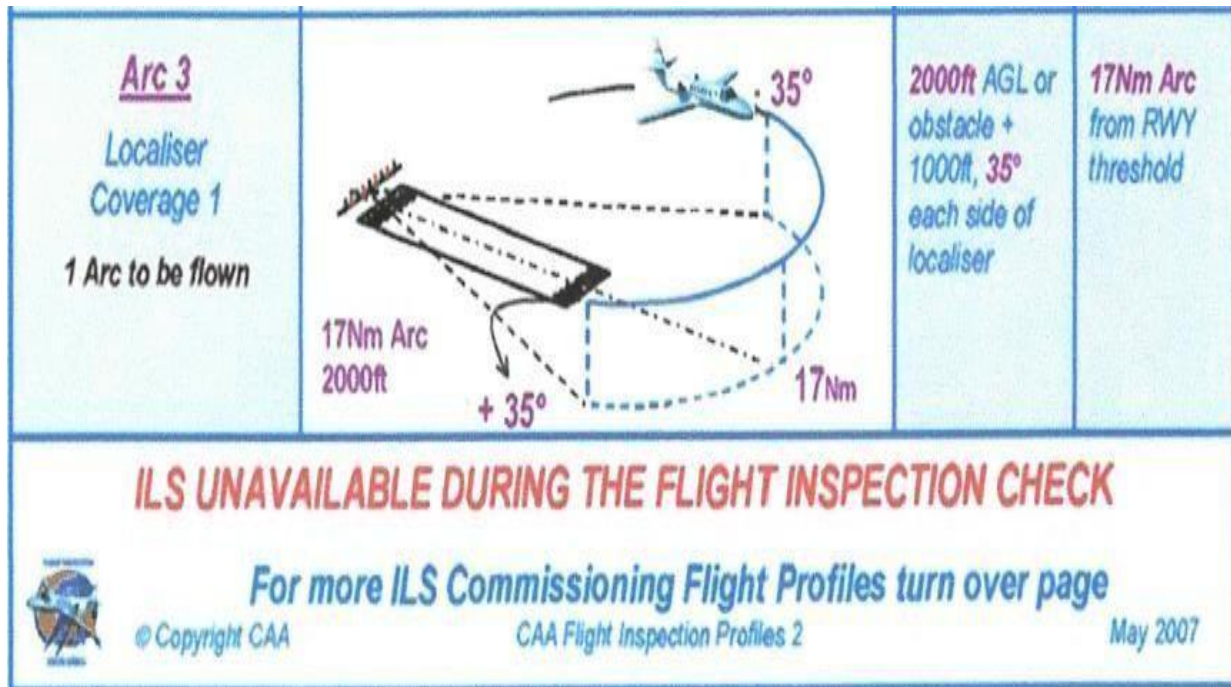
Figure19: The ILS procedure. (Source: FIU Operations Manual)

process requires the aircraft to fly 35° on either side of the runway centre line while maintaining a 17NM DME arc. The height for the operation is 2000ft AGL or obstacle plus 1000ft. Refer to Figure 17. The AMO that carried out the last maintenance inspection on this aircraft prior to the accident flight had been issued with an AMO approval certificate on 31 October 2019 with an expiry date of 31 October 2020.
