AIRCRAFT ACCIDENT REPORT AND EXECUTIVE SUMMARY

Reference:	CA18/2/3/9878	
Aircraft Registration	ZU-IPS	Date of Accident	15 March 2020		Time of Accident	0914Z
Type of Aircraft	Sling 4 TSi		Type of Operation	Private (Part 91)		
Pilot-in-command Licence Type	National Pilot Licence		Age	54	Licence Valid	Yes
Pilot-in-command Flying Experience	Total Flying Hours		406.8		Hours on Type	81.6
Last Point of Departure	Groutville (Ballito) Airfield, Kwa-Zulu Natal Province					
Next Point of Intended Landing	Groutville (Ballito) Airfield, Kwa-Zulu Natal Province					
Location of the accident site with reference to easily defined geographical points (GPS readings if possible)						
UMkhomazi River Valley, KwaZulu-Natal at GPS co-ordinates S 30° 00' 59.1", E 030° 18' 48.8" and at a field elevation of 1540ft						
Damage to aircraft	Destroyed					
Meteorological Information	Wind: 30° at 0-5kts; Temperature: 29°C; Visibility: 10km					
Number of People On-board	1+0	No. of People Injured	0	No. of People Killed	1

Reference Number : CA18/2/3/9878
Name of Owner/Operator : Interrex Dealer CC
Manufacturer : Airplane Factory Pty Ltd
Model : Sling 4 TSi
Nationality : South African
Registration Marks : ZU-

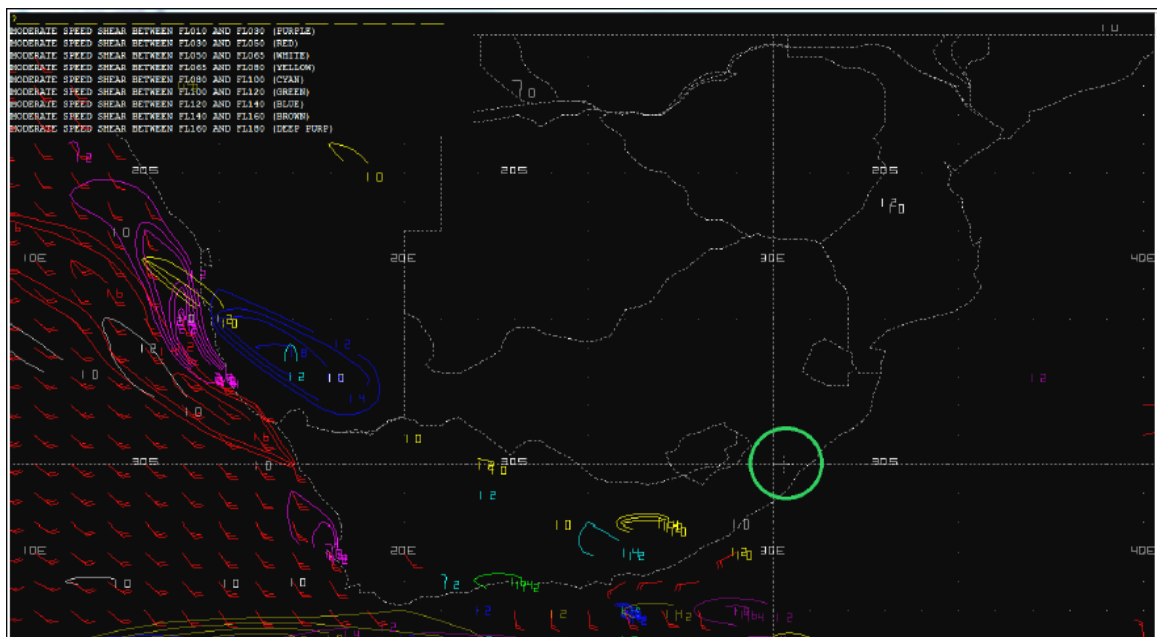
Figure 8: Moderate forecast area. (Source: SAWS)

Figure 8 shows possible forecasted low-level moderate turbulence areas at 0900Z over South Africa. No low-level turbulence was expected in and around the accident site. The accident point is indicated as a cross in the green circled area.
