AIRCRAFT ACCIDENT REPORT AND EXECUTIVE SUMMARY

Reference:		CA18/2/3/9891	
Aircraft Registration	ZS-EBC	Date of Accident	30 June 2020		Time of Accident	1048Z	
Type of Aircraft	Piper PA-28-180 Cherokee		Type of Operation		Training (Part 141)		
Pilot-in-command Licence Type	Student Pilot Licence		Age	16	Licence Valid	Yes	
Pilot-in-command Flying Experience	Total Flying Hours		24.14		Hours on Type	24.14	
Last Point of Departure	Wonderboom Aerodrome (FAWB), Gauteng Province						
Next Point of Intended Landing	Wonderboom Aerodrome (FAWB), Gauteng Province						
Damage to Aircraft	Destroyed						
Location of the accident site with reference to easily defined geographical points (GPS readings if possible)							
On a ploughed field behind Pretoria University Faculty of Veterinary Science Campus at GPS co-ordinates determined to be S25° 38' 55.5" E28° 10' 30.7" at an elevation of approximately 3991 feet above mean sea level (AMSL)							
Meteorological Information	Wind direction: 090°; Wind speed: 08 knots; Temperature: 19°C; Dew point: -02°C; Visibility: 9999m; QNH:1028hPa

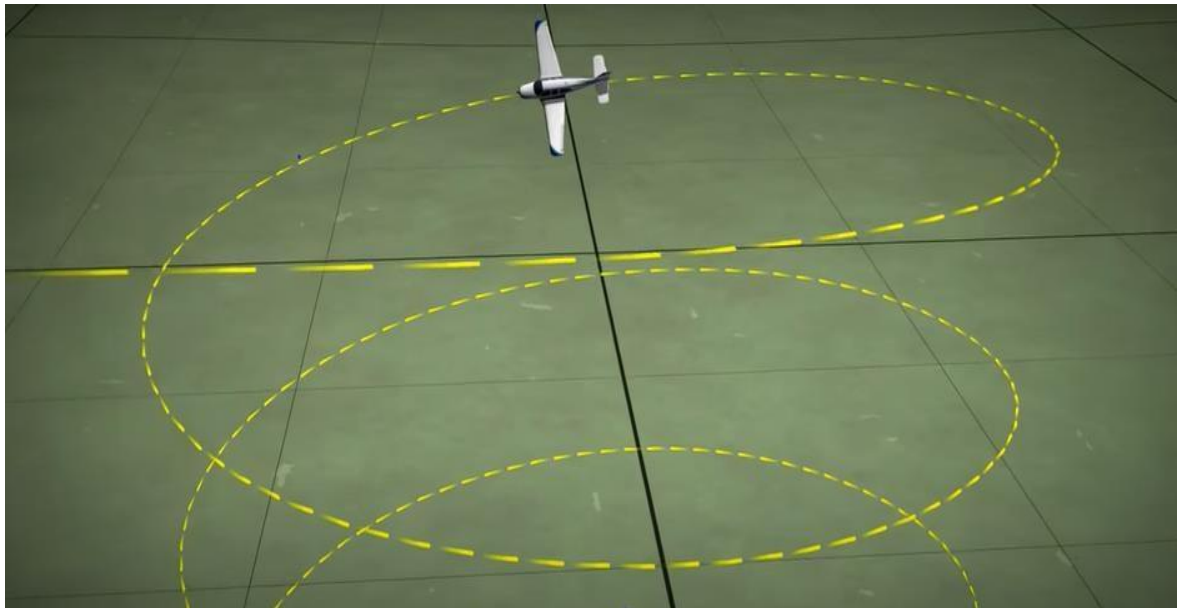
Figure 1: An illustration of a spiral. (Source: <https://protectza.mimecast.com/s/LaopCAnXyBiN497vUGSx8e>)

- 1.1.4 The first eyewitness who was driving in a car on the Onderstepoort Road near the accident site reported that he saw a small “red and white” single engine aircraft approaching from the west. The aircraft then executed a left turn at a height of about 100 feet AGL before the left wing suddenly dropped; the aircraft descended towards the ground in a spiral (illustrated in Figure 1). The witness brought his car to a stop on the side of the road and watched the aircraft until it disappeared from his view. The next thing he heard were the high engine revolutions, followed by the high-impact sound and black smoke emerging from behind the university buildings which he had just seen the aircraft fly over before disappearing from sight.

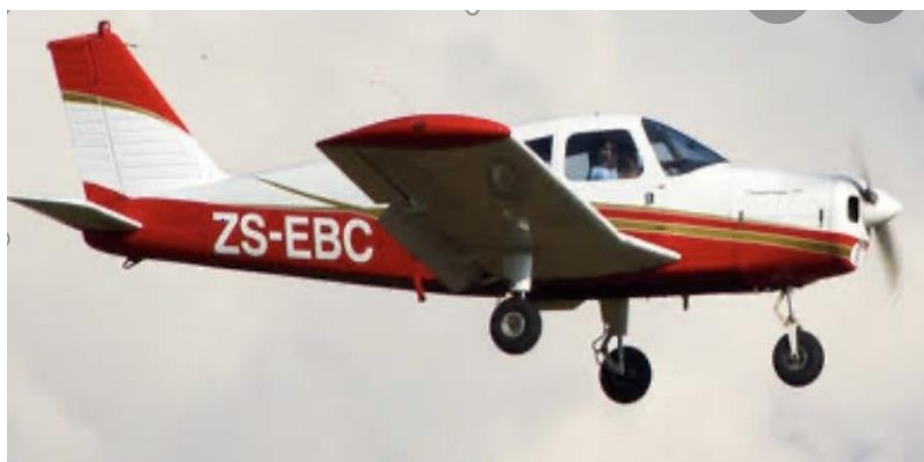
Figure 7: The ZS-EBC aircraft. (Source: <https://www.jetphotos.com>)

According to available records, on 16 March 1999, the ZS-EBC aircraft's nose landing gear collapsed during the landing phase at 5421.59 recorded total airframe hours. The propeller blades and the fire wall were damaged during the incident. The fire-wall was repaired, and the engine was subjected to a shock-load inspection and overhaul. A new propeller was fitted to the engine crankshaft flange. The task was carried out by a SACAA-approved maintenance organisation (AMO) 85; the aircraft was returned to service on 4 August 2008.

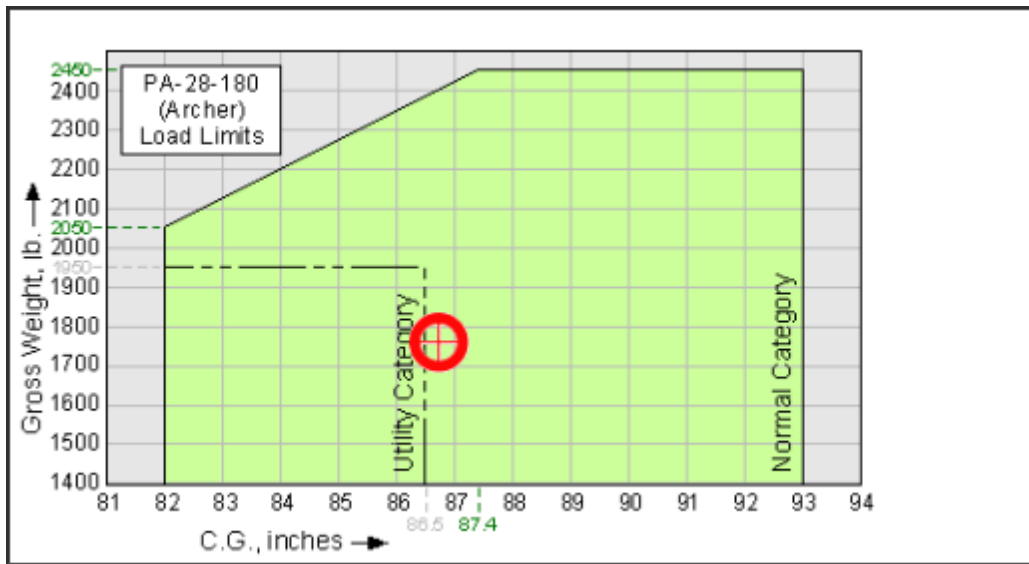
Piper PA-28-180	Weight (lbs)	Arm (inches)	Moment (lbs-inches)
Aircraft Empty Weight	1438.1	86.7	124683
7 Quarts of Oil	12	27.5	337
Pilot (Front Seat)	145	80.5	11673
Fuel (50 US Gallons Max)	162	95	15390
Rear Seat L & R	0	118.1	0
Baggage (200 lbs Max)	5	142.8	714
Operating Empty Weight	1762	86.7	152797

1.6.5 The maximum take-off weight of this aircraft, according to the Pilot Operating Handbook (POH), is 2 400 pounds (lbs). According to the last weight and balance calculation carried out on 23 August 2017, the aircraft’s empty weight was 1438.1 lbs. The total fuel capacity for this aircraft type is 50 US gallons (300 lbs/189 litres). The aircraft burns or consumes 10 US gallons of fuel per hour. Due to the severity of the accident impact, both fuel tanks were destroyed, and it was not possible to retrieve any fuel post-accident. However, during the one-on-one interview with the student pilot’s flight instructor at the flight school, he indicated that the aircraft burned 54 lbs (9 US gallons) of Avgas LL 100 fuel during the earlier check-flight (assuming normal fuel burn from taxi to take-off and subsequent three circuits that were flown) and 162 lbs (24.2 US gallons/92 litres) remained in the tanks prior to the student pilot’s undertaking of a solo consolidation flight. According to post-accident weight and balance calculations, the aircraft was within the allowable weight category and centre of gravity (C of G) for the intended flight.

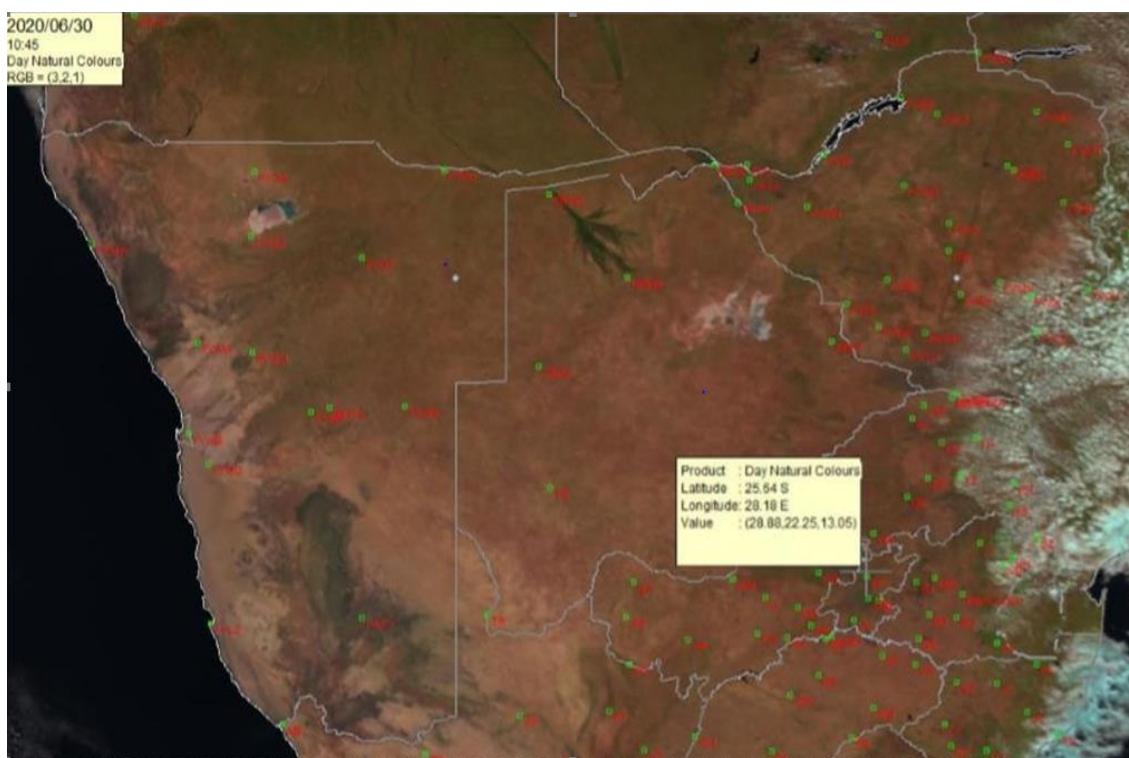
Figure 8: Satellite image indicated clear skies.

The Meteorological Aeronautical Report (Metar) recorded at FAWB for the day and time of the accident is included (see Figure 8) and contains the following weather variables:

Wind direction	090°	Wind speed	08kts	Visibility
Temperature	19°C	Cloud cover	Nil	Cloud base
Dew point	-02°C	QNH	1028hPa

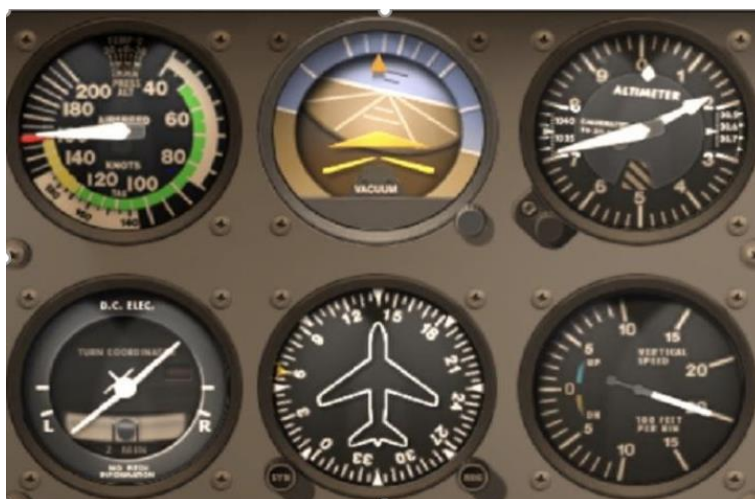
Figure 18: An example of the instrument panel of an aircraft in a spiral.

A spiral is a descending turn during which airspeed and G-load can increase rapidly and often results from a botched turn. In a spiral dive, the airplane is flying very tight circles, in a nearly vertical attitude, and will be accelerating because it is no longer stalled. Below are instrument indications of the aircraft in a spiral.

- *Increasing airspeed*
- *Attitude indicator showing nose below the horizon*
- *Loss of altitude*
- *Turn co-ordinator showing a full deflection in the direction of the dive*
- *Heading indicator changing*
- *Vertical speed indicator showing a rapid descent*

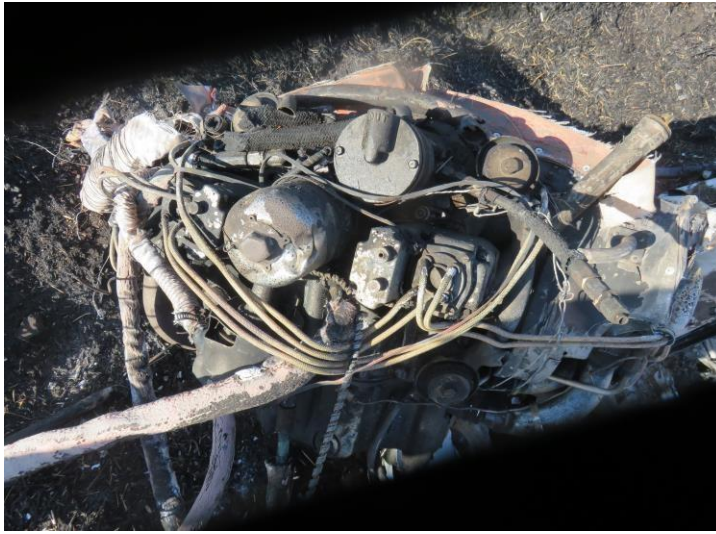
Appendix D - Engine teardown inspection

1.16.2 The accessory housing was removed and the internal bolt on oil pump assembly was examined. Oil was evident throughout the pump body. The oil cooler, bypass valve and oil pump together with its drive gears were serviceable, and all filter screens and oil galleries throughout the crankcase and crankshaft were found free from obstruction. The oil pressure relief valve was also examined and found to be correctly installed and serviceable. The engine oil filter was cut open and the filter mat inspected; no evidence of metal particles was observed. Piston rings were free and rotating in all piston ring channels and some cylinders still showed the machined barrel surface cross hatch marks from the original cylinder machining with minimum barrel wear. The pistons exhibited no signs of detonation and had normal combustion signatures on the piston heads. The intake and exhaust valve heads were good. Dimensions of the engine crankshaft, counterweights, counterweight bushings, and counterweight pins and plates were measured and checked and found to be within the engine manufacturer's new parts limits. This indicated a very high degree of engine balancing that was performed on the engine.

1.16.3 Hydraulic lifters, engine gears, camshaft and all internal engine bearings were in good condition. No pitting or corrosion was found on the engine camshaft or hydraulic lifter assemblies. No corrosion or pitting was observed on the engine gears. The valve rocker arms were in good condition with no wear indications and smooth rocker tip machined surfaces were found to be in good condition. Dimension of all internal engine parts were measured and found to be within the original manufacturer's new parts limits listed under the engine overhaul manual. Connecting rods were all in good condition with no signs of wear, fretting or misalignment. Examination and testing of the engine components and accessories did not identify any evidence of mechanical malfunction or significant defects that would have prevented normal engine operation.

1.16.4 The fractured engine crankshaft/driveshaft that was noted at the accident site was an indication that the engine was developing a large amount of power at impact and that the internal

The engine, a Lycoming O-360-A30 engine, Serial No. L-6678-36.
