AIRCRAFT ACCIDENT SHORT REPORT

CA18/2/3/9895: Dynamic roll-over during a training flight at FACT.

Aircraft registration : ZS-ROP

Aircraft manufacturer and model : Airbus Helicopters, H120

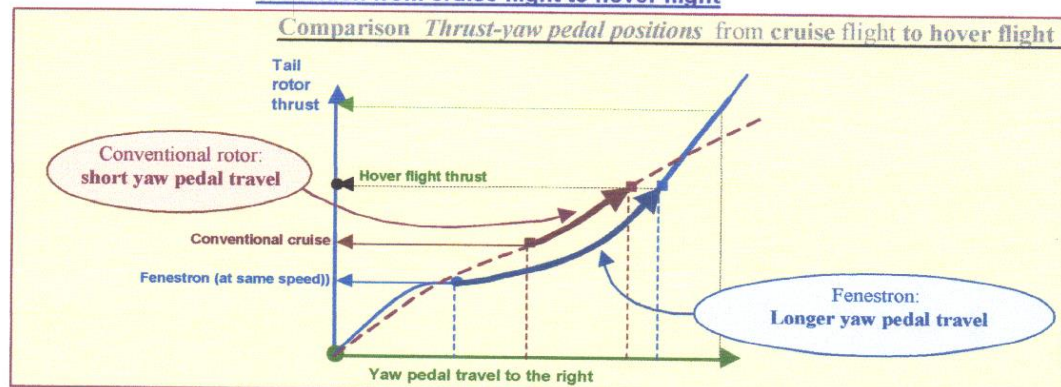
Transition from cruise flight to hover flight

With a Fenestron, when changing from **cruise flight to hover flight**, be prepared for a **significant movement of the foot to the right**.

Insufficient application of pedal would result in a leftward rotation of the aircraft during the transition to hover.

To stop rotation to the left, whether it is intentional or not, never hesitate to go up to the yaw pedal RH stop!

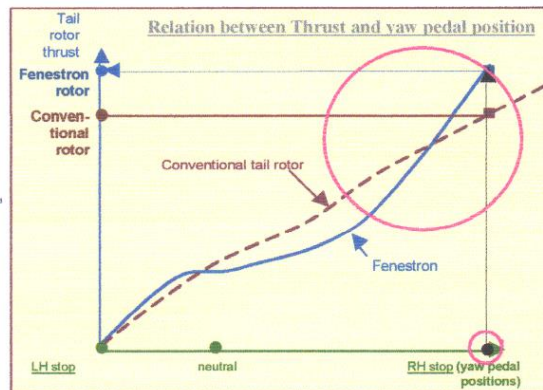
It can be noticed that near the RH stop, the Fenestron efficiency is very high (curve slope).

- 1 – In hover flight or at very low forward flight speed, stopping a quick rotation to the left must be performed by **immediately applying** the RH yaw pedal with a significant and maintained amplitude, regardless of the tail rotor type.
- 2 – In hover flight or at very low speed, intentional initiation of a turn to the left shall always be made by moderate action on the yaw pedals.
- 3 – Wind coming from the left or tail wind increases the aircraft rotation speed.
