AIRCRAFT ACCIDENT REPORT AND EXECUTIVE SUMMARY

Reference:	CA18/2/3/9907	
Aircraft registration	ZS-OET	Date of accident	26 August 2020		Time of accident	1630Z
Type of aircraft	Cessna 172F (Aeroplane)		Type of operation		Training (Part 141)	
Pilot-in-command licence type		Commercial Pilot	Age	26	Licence valid	Yes
Pilot-in-command flying experience		Total flying hours	1 220.0		Hours on type	150.3
Last point of departure		Springs Aerodrome (FASI), Gauteng Province				
Next point of intended landing		Springs Aerodrome (FASI), Gauteng Province				
Aircraft damage		Destroyed				
Location of the accident site with reference to easily defined geographical points (GPS readings if possible)						
Springs Aerodrome (GPS position: 26°15'15.68" South 028°23'42.58" East), elevation 5 363 feet						
Meteorological information		Surface wind: 320°/3kts, temperature; 22°C, dew point; -2°C, CAVOK				
Number of people on-board		2 + 0	No. of people injured	1	No. of people killed	1

Reference number : CA18/2/3/9907
Name of owner : Mach 1 Aviation Academy (Pty) Ltd
Name of the operator : Mach 1 Aviation Academy (Part 141)
Manufacturer : Cessna Aircraft Company
Model : 172F
Nationality : South African
Reg

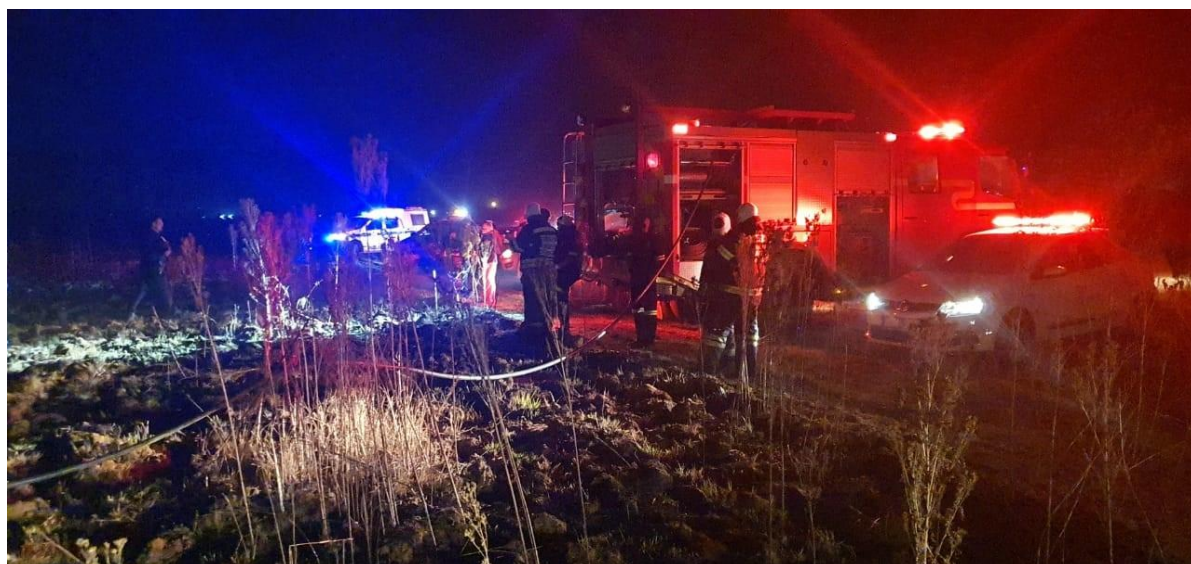
1.15.2 The accident occurred on a licensed aerodrome (unmanned), however, there was no aerodrome rescue and fire-fighting (ARFF) personnel stationed at the aerodrome. Emergency services from the local metro responded to the accident scene as well as the police service personnel.

Figure 12: Emergency personnel who responded to the accident scene.

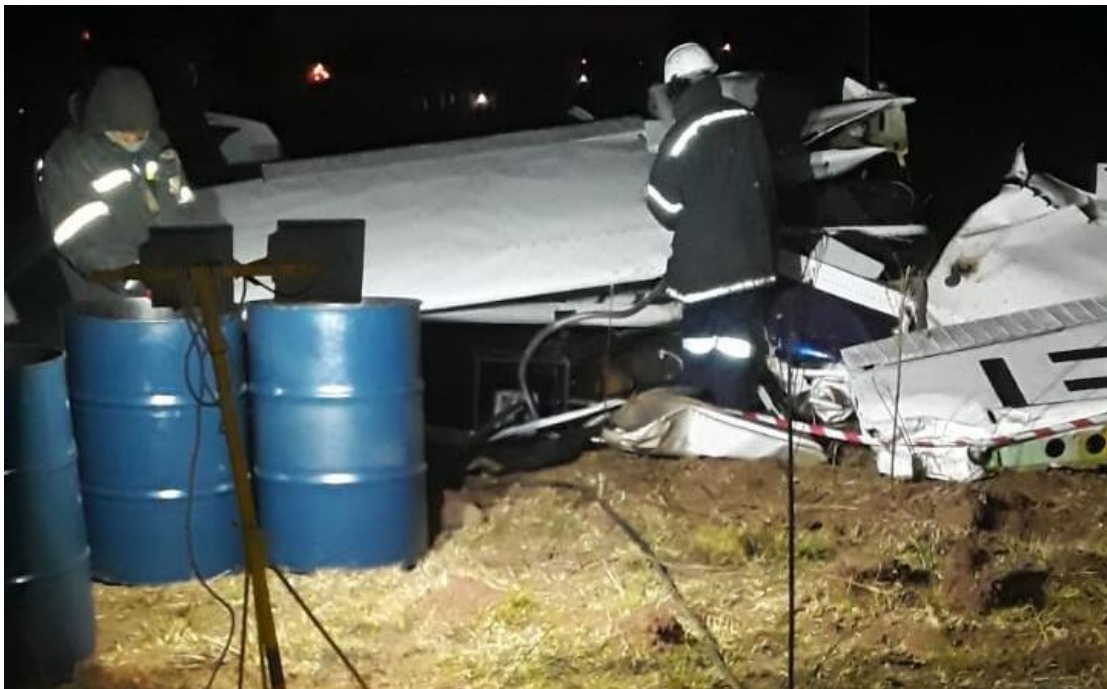
Following the accident, the ATO commissioned the services of an environmental spill recovery company. Four members of the service provider responded to the scene. A site assessment and site set-up were conducted, where after, plastic sheeting was placed on the ground beneath the wings of the aircraft to prevent ground contamination during the pumping process. The company personnel placed 2 x 210L close top drums on top of the plastic sheeting and pumped out fuel from the two fuel tanks of the aircraft into the 210L drums until the fuel tanks were empty.

Figure 14: Spill response company members draining fuel from the right-wing tank into a 210L drum.
