<b>AIRCRAFT ACCIDENT REPORT AND EXECUTIVE SUMMARY</b>
---

<b>Reference:</b>		<b>CA18/2/3/9942</b>	
<b>Aircraft Registration</b>	<b>ZS-JJJ</b>	<b>Date of Accident</b>	13 January 2021		<b>Time of Accident</b>	0515Z	
<b>Type of Aircraft</b>	Piper PA-46-350P Jetprop DLX		<b>Type of Operation</b>		Private (Part 91)		
<b>Pilot-in-command Licence Type</b>	Private Pilot Licence (PPL)		<b>Age</b>	69	<b>Licence Valid</b>	Yes	
<b>Pilot-in-command Flying Experience</b>	<b>Total Flying Hours</b>		6 654.0		<b>Hours on Type</b>	772.2	
<b>Last Point of Departure</b>		Koedoesberg Game Farm private airstrip, KwaZulu-Natal Province					
<b>Next Point of Intended Landing</b>		Pongola Aerodrome (FAPL), KwaZulu-Natal Province					
<b>Damage to Aircraft</b>		Substantial					
<b>Location of the accident site with reference to easily defined geographical points (GPS readings if possible)</b>							
On a gravel road 500m from the take-off runway; Global Positioning System co-ordinates: 27°26'34.69" South 031°41'2.91" East) at an elevation 913 feet (ft)

<b>Probable Cause</b>							
Engine power loss in-flight, resulting in an unsuccessful forced landing.							
<b>Contributing Factor/s:</b>							
Disregar

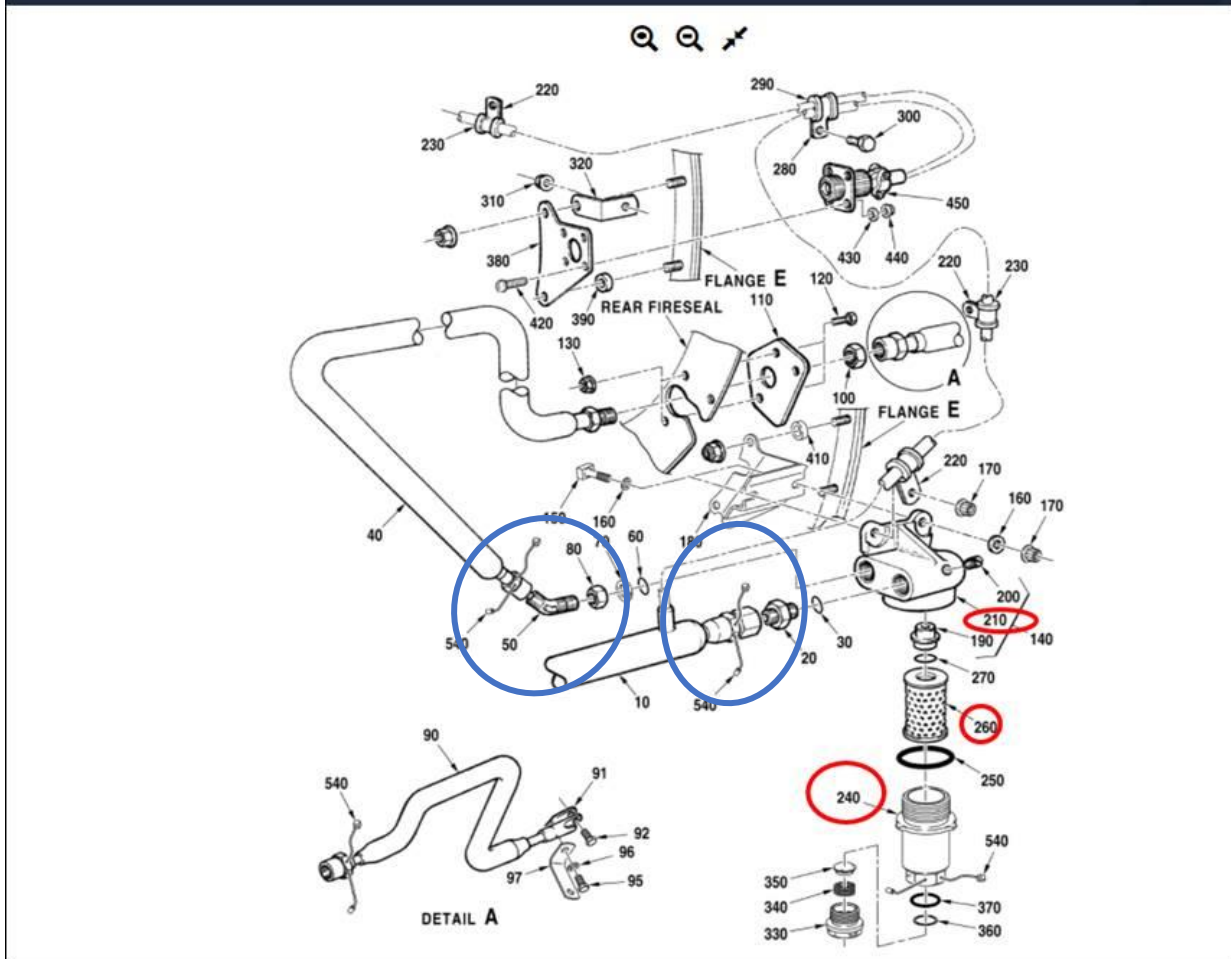
**Diagram 1:** Schematic diagram of a P3 air filter and the B-nuts.

Manipulation of the flexible portion of the P3 line influenced the leak rate at the B-NUT

1.16.6 *Power Turbine Control (PY):* Py line was continuous from the FCU to the constant sector unit (CSU) and the B-nuts were tight and secured. Examination of the engine displayed two loose B-Nuts at the P3 filter housing. A leak test revealed that both locations were leaking. The condition of the threads in both locations did not show any evidence that would have prevented proper assembly.
