<b>LIMITED ACCIDENT INVESTIGATION REPORT</b>
--

<b>Reference Number</b>		CA18/2/3/9952						
<b>Classification</b>	Accident	<b>Date</b>	4 September 2021	<b>Time</b>	1106Z			
<b>Type of Operation</b>		Private (Part 94)						
<b>Location</b>								
Place of Departure		Numbi Airstrip near Hazyview, Mpumalanga Province		Place of Intended Landing		Da Gama Dam near White River, Mpumalanga Province		
Place of Accident		5nm south of Numbi Airstrip						
GPS Co-ordinates		Latitude	25°05'50.68"S	Longitude	031°04'26.0" East	Elevation	2621ft	
<b>Aircraft Information</b>								
Registration		ZU-DVG						
Model/Make		Bantam B22J (Serial Number: 05268)						
Damage to Aircraft		Substantial		Total Aircraft Hours		3659.7		
<b>Pilot-in-command</b>								
Licence Valid		Yes	Gender		Male	Age	76	
Licence Type		National Pilot Licence (NPL)						
Total Hours on Type		±6890		Total Flying Hours		+7005.2		
People On-board		1+1	Injuries	1	Fatalities	0	Other (on ground)	0
<b>What Happened</b>

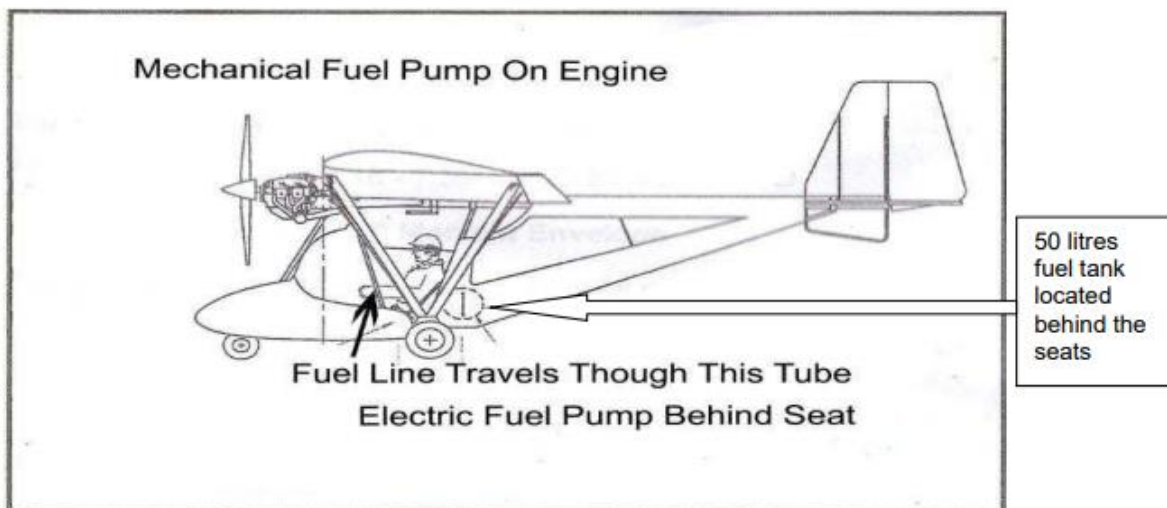
The aircraft has a 50-litre fuel tank located behind the seats. Fuel travels from the fuel tank to the secondary electric pump behind the seats at the same level as the tank output. It then goes to the fuel line and then to the gascolator. From there, it goes through the tap and into the primary fuel pump on the motor before it goes to the carburettor. The fuel specified for this engine is either Avgas 100/130 (preferred) or Mogas with an octane rating of 95 or above.
