<b>LIMITED ACCIDENT INVESTIGATION REPORT</b>
--

<b>Reference Number</b>		CA18/2/3/9963						
<b>Classification</b>	Accident	<b>Date</b>	4 March 2021	<b>Time</b>	0545Z			
Type of Operation		Private (Part 24)						
<b>Location</b>								
Place of Departure		The Coves Airfield	Place of Intended Landing		The Coves Airfield			
Place Accident		1 nm east of The Coves Airfield in Gauteng Province						
GPS Co-ordinates		Latitude	S25°46'27"	Longitude	E027°48'42.3"	Elevation	3885 ft	
<b>Aircraft Information</b>								
Registration		ZU-FOK						
Model/Make		Fokker E3						
Damage to Aircraft		Substantial		Total Aircraft Hours		3.8		
<b>Pilot-in-command</b>								
Licence Type		National Pilot Licence		Gender		Male Age 46		
Licence Valid		Yes						
Total Hours on Type		3.8		Total Flying Hours		1987.6		
<b>People On-board</b>		1+0	Injuries	1	Fatalities	0	Other (on ground)	0
<b>What Happened</b>								
<p>On Thursday afternoon 4 March 2021, the pilot flying solo on-board a Fokker E3 aircraft with registration mark ZU-FOK took off from The Coves Airfield to conduct a proving flight. The Coves Airfield is situated approximately 32 kilometres (km) north of Lanseria Airport. The aircraft was iss

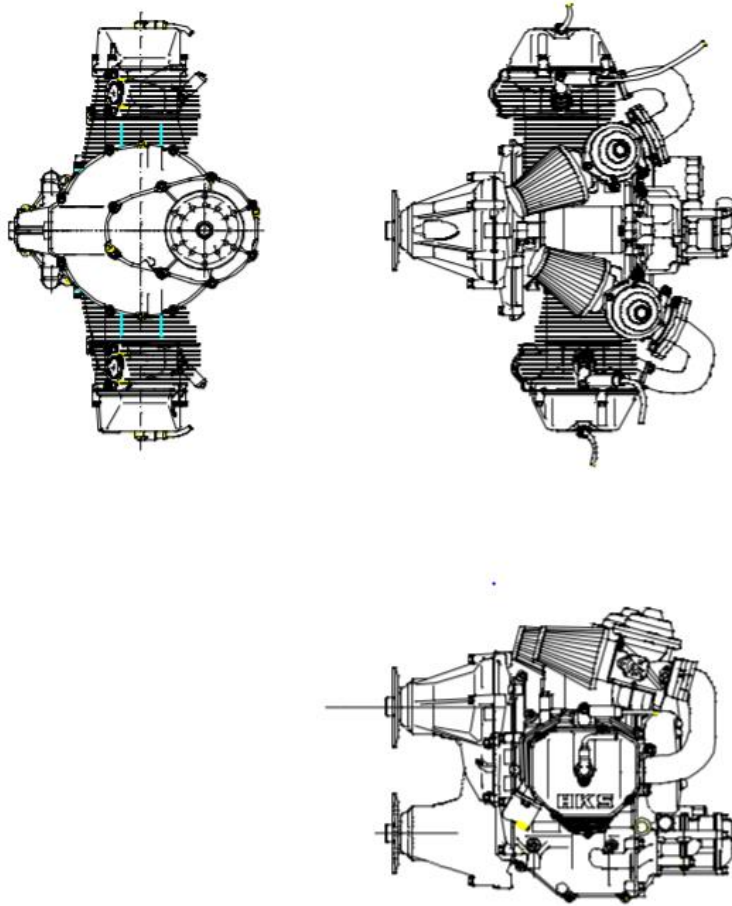
**Figure 2:** Engine schematics of HKS 700E. (Source: Engine manual)

Investigation found that there were no anomalies with the engine and/or any other systems; and there was enough fuel for the flight on-board the aircraft.

The cause of engine failure was undetermined. The manufacturer indicated that this engine type could fail without warning at any phase of flight.

(1) It is recommended that the Director of Civil Aviation reviews the use of this engine type which contains a disclaimer that the engine may fail without warning at any phase of flight in all non-type certified aircraft (NTCA) as this poses a challenge when there is an accident or incident as a result of none accountability on the product/part by the manufacturer.

(2) It is recommended that the Executive responsible for accidents and incident investigations reviews the investigation of aircraft fitted with engines such as the type fitted to the accident aircraft as there would be no value in investigating aircraft or engines which have a disclaimer on aircraft parts.
