**PRELIMINARY ACCIDENT REPORT**

**Accident and Incident Investigations Division**

Accident  
- Preliminary Report -  
AIID Ref No: CA18/2/3/10054

On Wednesday morning, 13 October 2021 at 0518Z, a Bombardier BD-700-1A10 aircraft with registration 9H-VJM was involved in an accident when the crew was taxiing through the Echo security gate at O.R. Tambo International Aerodrome (FAOR). As the aircraft approached the gate, the (motorised) gate had already started to close and it impacted the right-wing leading-edge slat of the aircraft, causing substantial damage to the number 2 slat. This was an international non-scheduled flight from FAOR to Dubai International Aerodrome (OMBD).

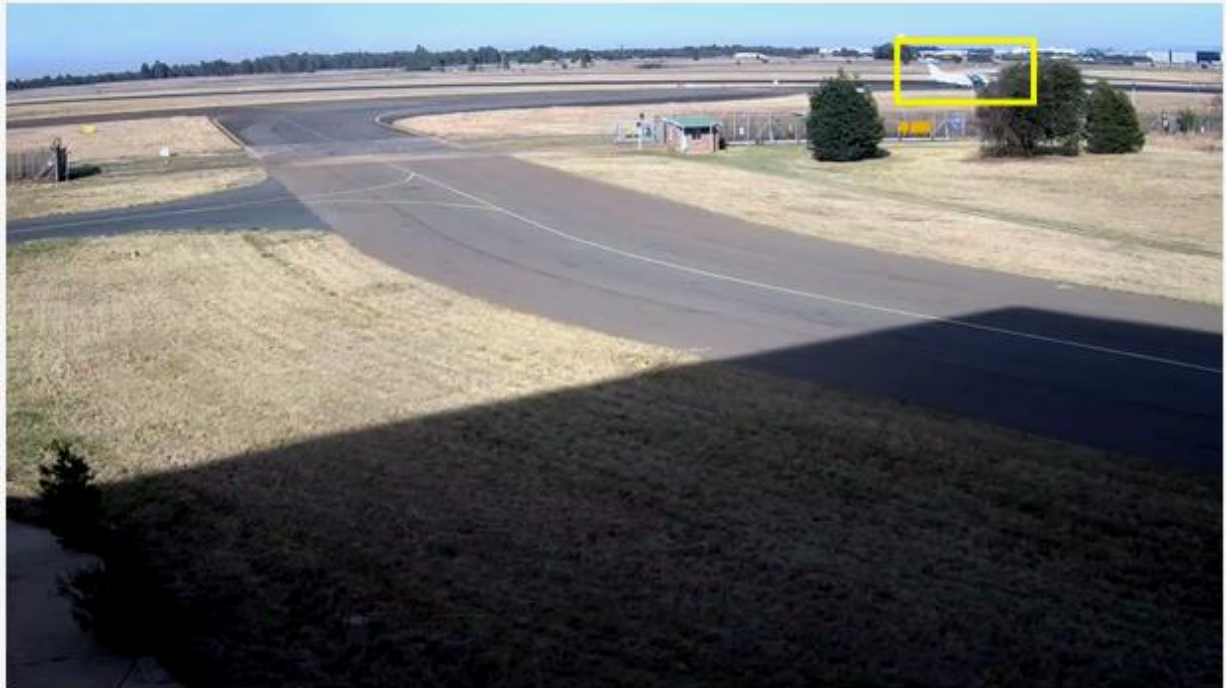
1.12.1 The aircraft was taxied from the FBO apron area (where it was parked) to the Echo gate. As the aircraft approached the motorised gate, the gate had already started to close. The last phase of taxi was captured on CCTV footage; four screenshots were taken (see Figures 5, 6, 7 and 8) which illustrate the sequence of events as the gate impacted the aircraft. Figure 9 (picture) was taken by the first responders to the accident scene; it illustrates the position of the gate relative to the damage on the leading edge slat, which was deployed to 20° as required for take-off.

**Figure 5:** In this screenshot, the aircraft ZS-AAK exits the gate as shown in the yellow window.

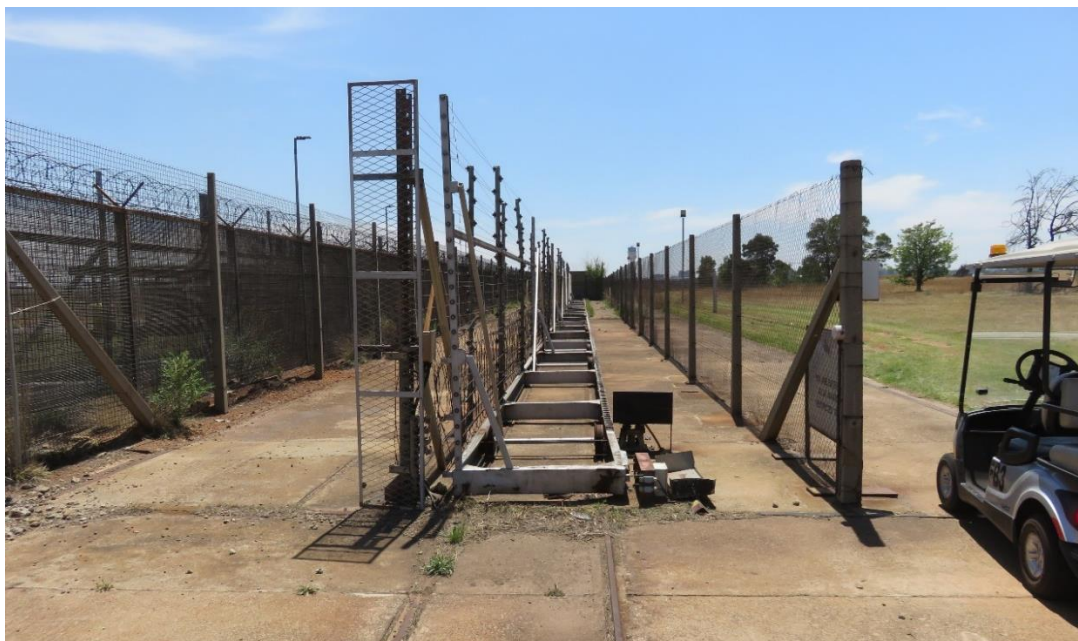
There are two gates at this location. The Denel Campus gate (see Figure 10) has been decommissioned several years ago and currently stands in the fully open position. There is a security guard at this gate, with a guard house. The other gate is on the Fireblade Aviation side.

**Figure 10:** The Denel Campus gate stationary in the fully open position.

A traffic light at this gate is located next to the guard house. This light was not working as there was power failure in the area at the time. The traffic light is not connected to an alternate power supply in case of power failures.

- 3.4 It is recommended that Denel Aviation consider installing an alternate power source for communication records at the Denel Campus Operations to prevent loss of communication should the main power source be unavailable.

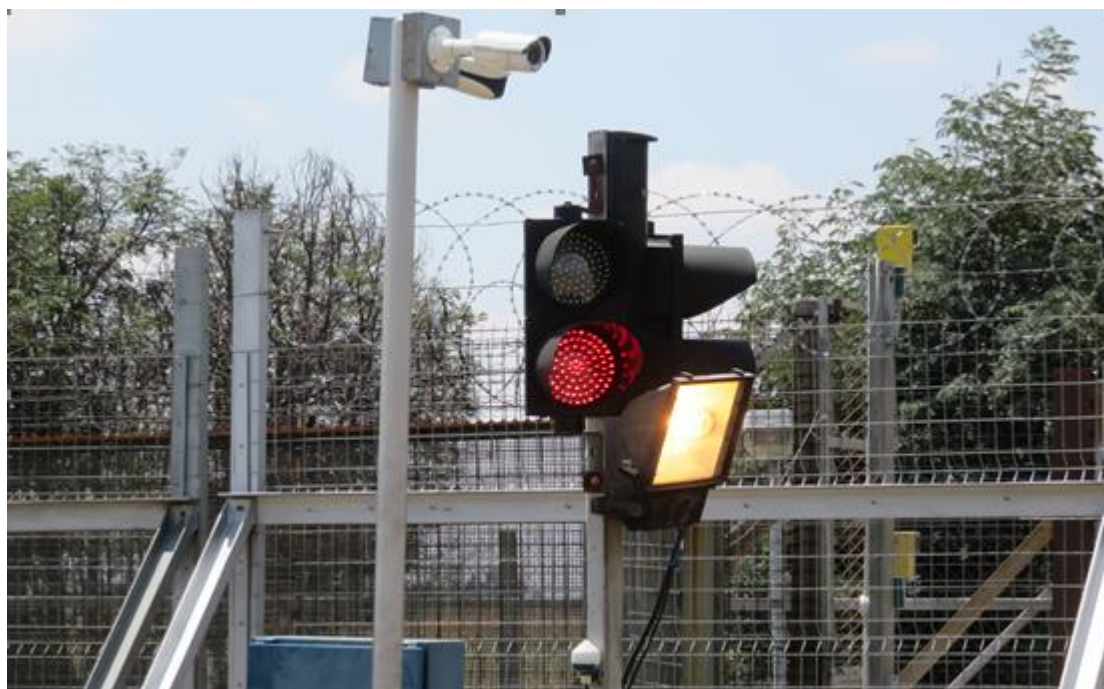
A traffic light is located on both sides of the Echo gate, one being near the guard house (gate open side), and the other light is on the 'gate close' side. These lights were working at the time as the traffic light on the 'gate close side' was visible on the CCTV footage. The light was green while the gate was in open position, as soon as the gate started to move to the close position, the green light switched off. The pictures in Figures 16 and 17 were taken on 19 October 2021 by the investigator. These traffic lights were not working on 13 October 2021 when the investigation team inspected the gate.

**Figure 16:** The traffic light at the gate open position.

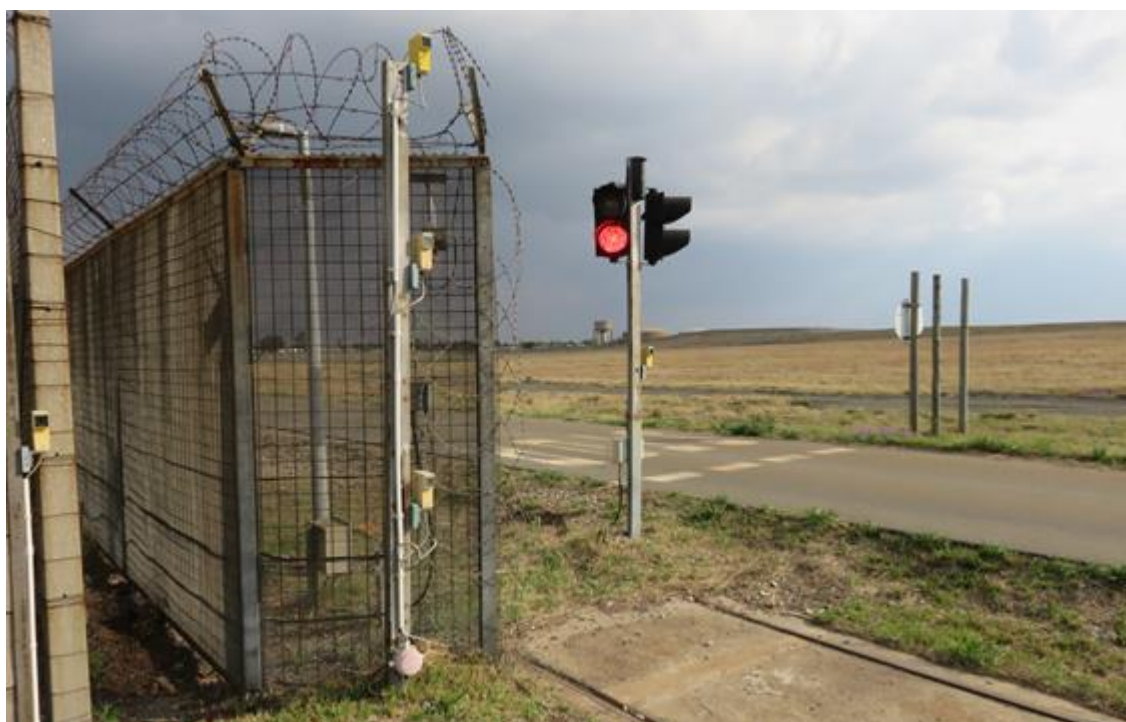
**Figure 17:** The traffic light at the gate close position.

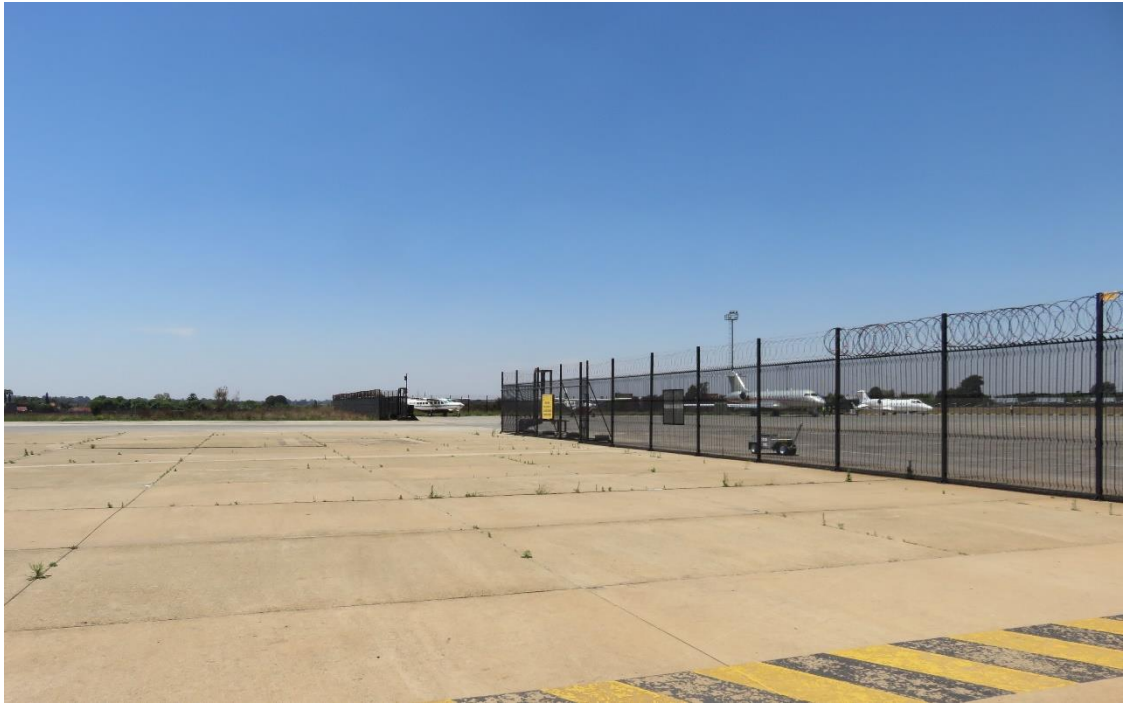
The FBO apron is fenced off, and aircraft had to taxi through the security gate into the Denel Campus area. This gate is controlled by FBO operations, located in the FBO building and looking out onto the apron area.

**Figure 18:** The FBO fenced off area and the view of the gate from the Denel Campus side.

- 3.1 It is recommended that Airports Company South Africa (ACSA) and Denel Aviation consider moving the control (operation) of Echo (V4) gate (opening and closing) from the control room to the AMC building.
- 3.2 It is recommended that ACSA and Denel Aviation consider the installation of a stop sign on both sides of Echo (V4) gate and a visible notice board which must include the following statement:  
"BEFORE PROCEEDING THROUGH THE GATE, PLEASE CONTACT ACSA GATE CONTROL ON THE VHF FREQUENCY 122.65 MHZ."
- 3.3 It is recommended that ACSA and Denel Aviation ensures that the safety beams fitted at the gate to keep the gate opened when the aircraft brakes the beam are kept in working

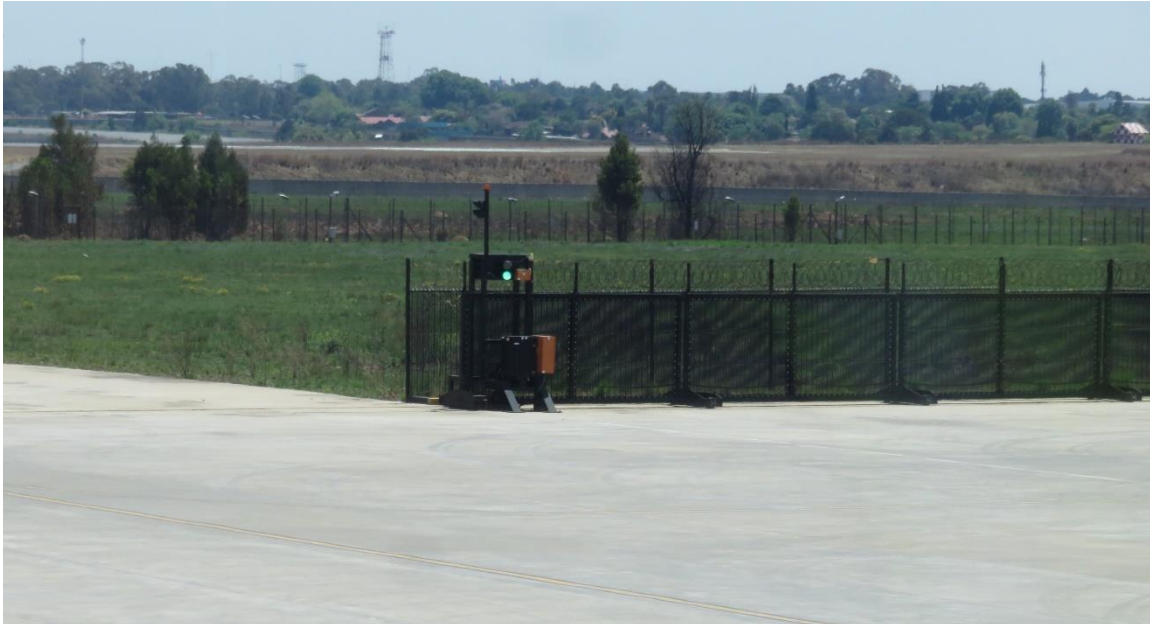
**Figure 20:** The FBO apron gate and the traffic light (on green) at the gate.
