INTERIM STATEMENT

Accident and Incident Investigations Division (AIID)

Serious Incident
Boeing 737-400, ZS-OAF
AIID Ref No: CA18/3/2/1325

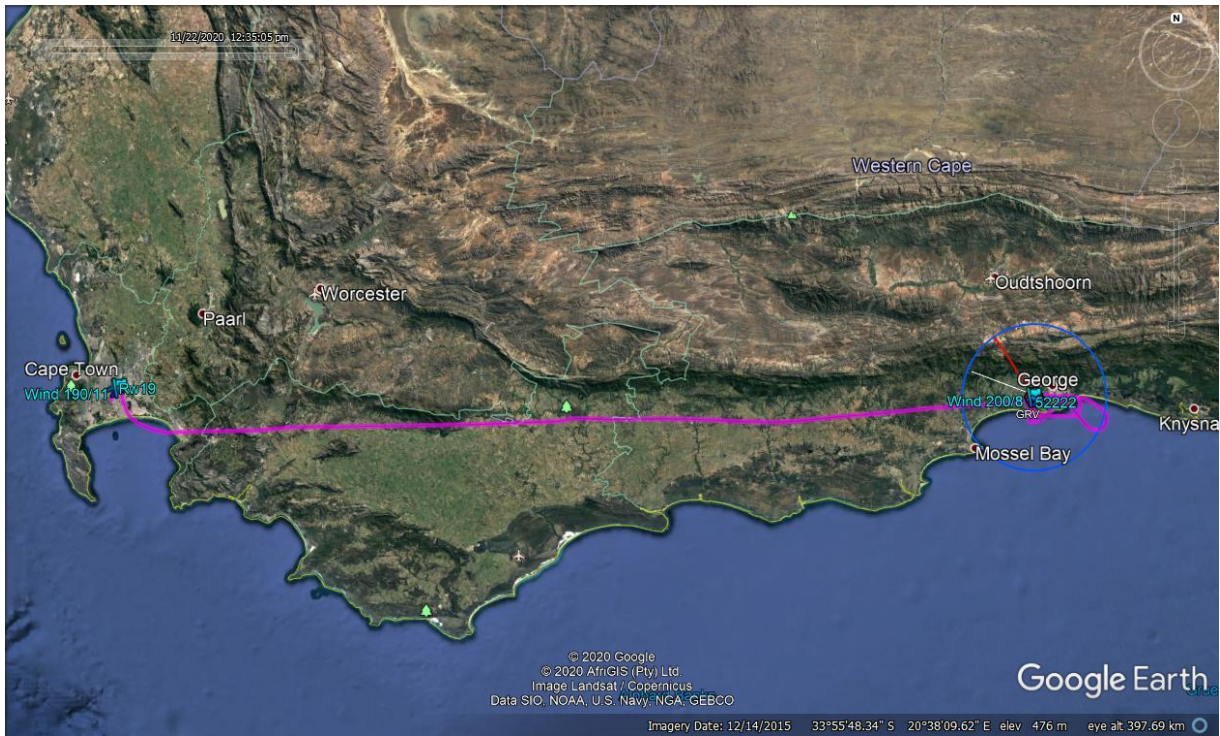
This aircraft was not interrogated by SSR due to the inoperative state of the transponder. The aircraft was visible on primary radar, which is effectively a signal reflected off the aircraft only. The flight was also conducted with traffic collision avoidance system (TCAS) inoperative. The aircraft was briefly detected on SSR for the first time when it was on the right-side hold over GRV, descending through 2 500ft on a left downwind for landing Runway 29 at FAGG.

Figure 4: Overlay of the flight path of the aircraft. (Source: Google Earth)
