INTERIM STATEMENT

1. The South African Civil Aviation Authority (SACAA) is conducting a safety investigation into a Bell 205 flight involving ZU-UHI which crashed into a game reserve on 22 April 2015 at Bainskloof area, Western Cape Province, at GPS coordinates 33°36'30.68"S, 19° 6'29.18"E.
2. The investigation is being conducted in accordance with the international protocol set out by the International Civil Aviation Organisation (ICAO). The investigation team includes Investigator In-Charge (IIC) from the South African Civil Aviation Authority and the operator.

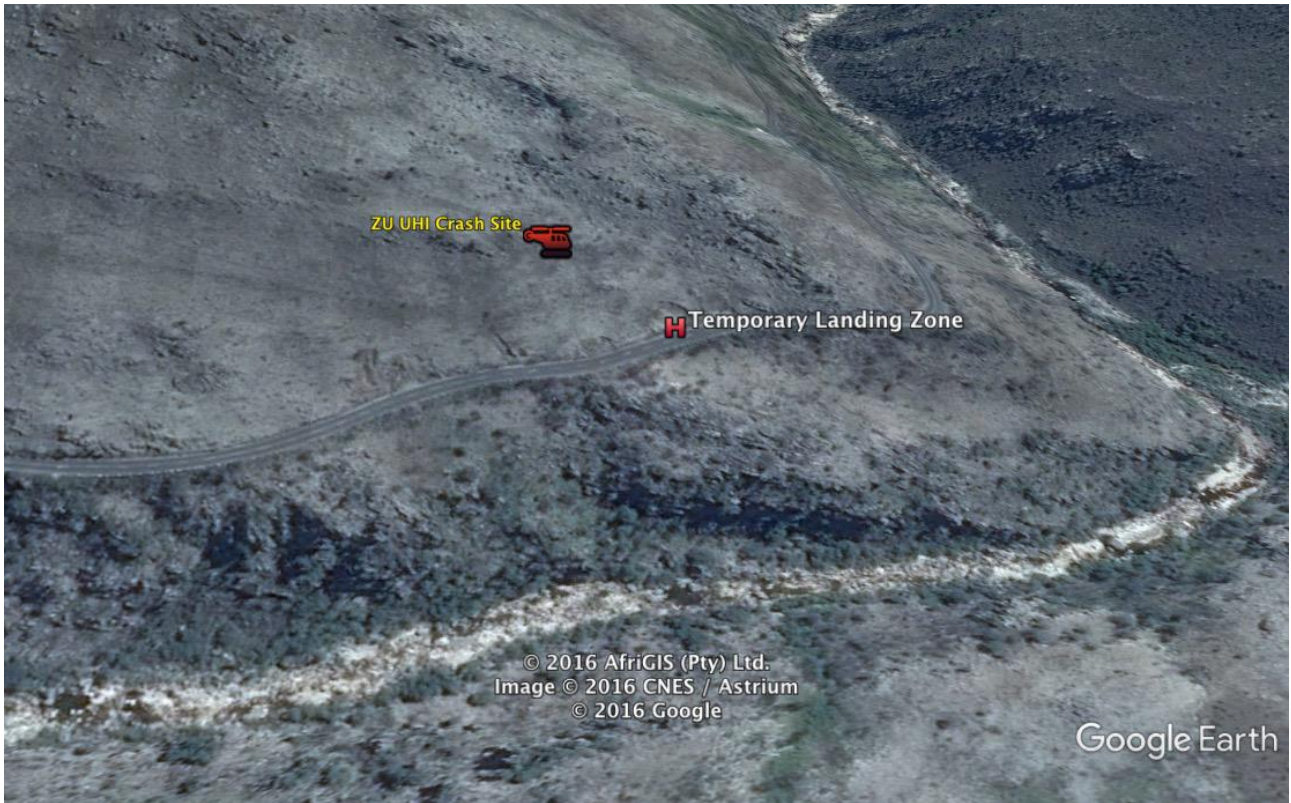
- 1.1.7 The accident occurred at the GPS coordinates 33°36'30.68"S, 19° 6'29.18"E at the Elevation 645m. The GPS coordinates for the landing zone was 33°36'39.09"S, 19°06'29.18"E. The distance from the road to the accident site was approximately 91meters.

Figure 1: Picture from Google earth indicating the accident site and the national road R301
