PRELIMINARY ACCIDENT REPORT

Accident
- Preliminary Report -
AIID Ref No: CA18/2/3/10030

Reference Number : CA18/2/3/10030
Name of Owner/Operator : Simon Bennett
Manufacturer : Piper Aircraft Company
Model : PA-18A-150 (Super Cub)
Nationality : South African
Registration Marks : ZS-CKP
Place : Port Alfred (FAPA), Eastern Cape province
Date : 23 August 2021
Time : 1035Z

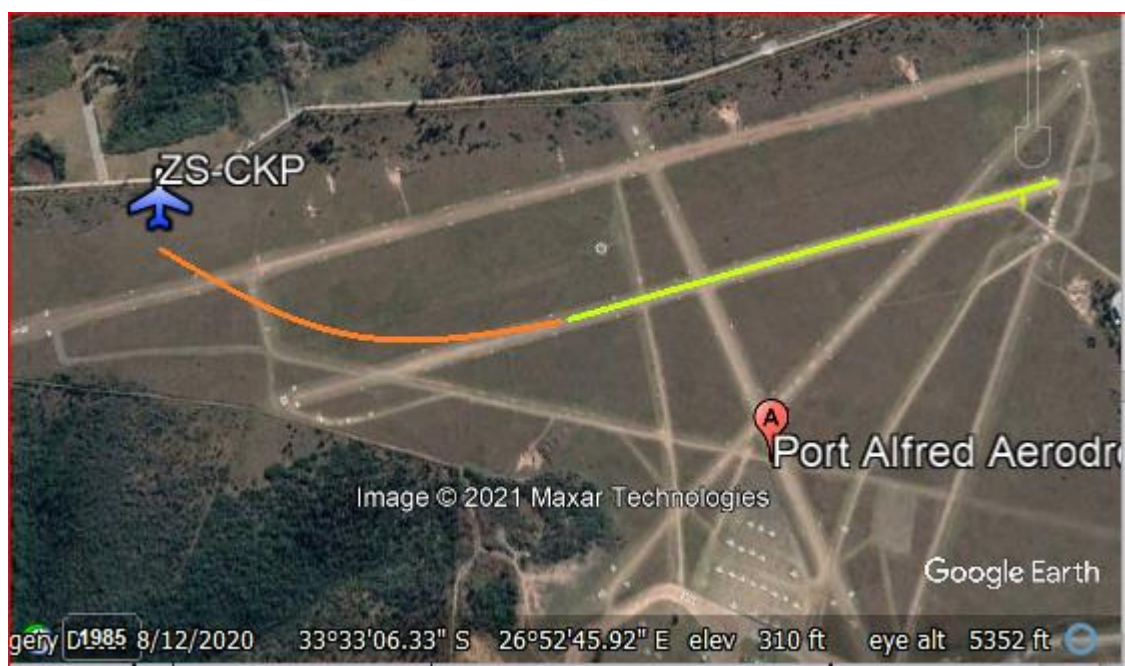
- 1.1.3 The pilot reported that he took off without incident; however, at approximately 600 feet (ft) above ground level (AGL), the aircraft engine stopped. The pilot then switched tanks and restarted the engine, which ran momentarily but stopped again. The pilot then elected to execute a teardrop manoeuvre to conduct a forced landing on RWY10L, but he overshot the runway.

Figure 2: The aircraft path after take-off. (Source: Google Earth)
