PRELIMINARY ACCIDENT REPORT

Accident
- Preliminary Report -
AIID Ref No: CA18/2/3/10165

Reference Number : CA18/2/3/10165
Occurrence Category : Category 2
Type of Operation : Private (Part 91)
Name of Operator : Private
Aircraft Registration : ZS-CSL
Aircraft Make and Model : Piper PA-24-250
Nationality : South African
Registration Marks : ZS-CSL
Place : Panorama Airfield
Date and Time : 26 May 2022 at 1520Z
Injuries : Serious
Damage : Substantial

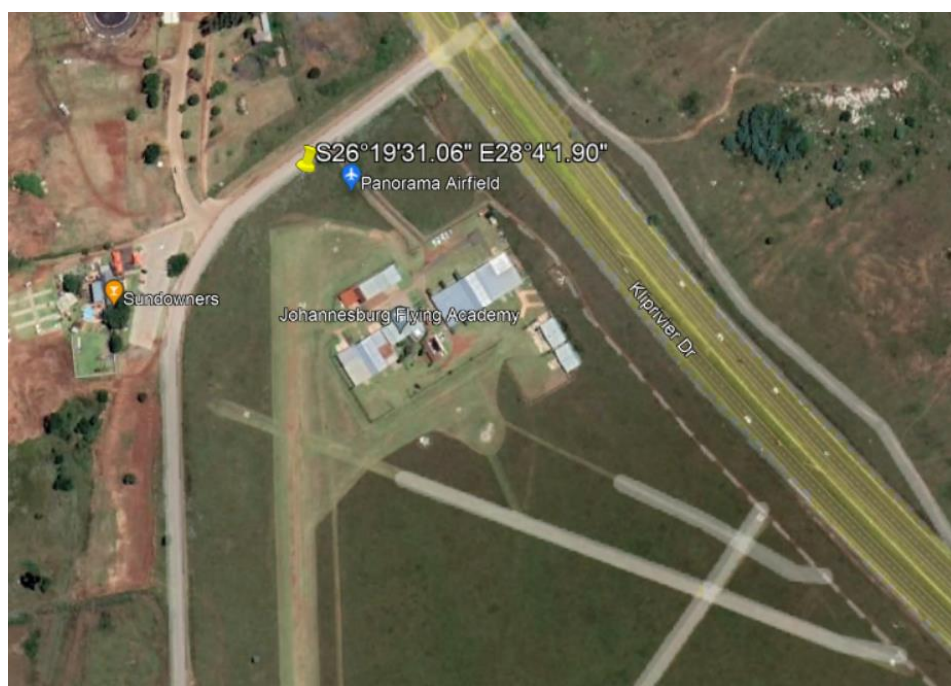
1.1.7 The accident occurred in daylight near Panorama Airfield's perimeter fence at Global Positioning System (GPS) co-ordinates determined to be: S26°19'31.06" E028°4'1.90", at an elevation of 5020 feet (ft).

Figure 2: An aerial view of Panorama Airfield and the accident site. (Source: Google Map)
