PRELIMINARY ACCIDENT REPORT

Accident
- Preliminary Report -
AIID Ref No: CA18/2/3/10087

Reference Number : CA18/2/3/10087
Type of Operation : Private
Manufacturer : Cessna Aircraft Company
Model : Cessna 177, Cardinal
Nationality : South African
Registration Mark : ZS-EZM
Place : 300m east of Baragwanath Aerodrome (FASY), Gauteng Province
Date : 7 December 2021
Time : 0635Z

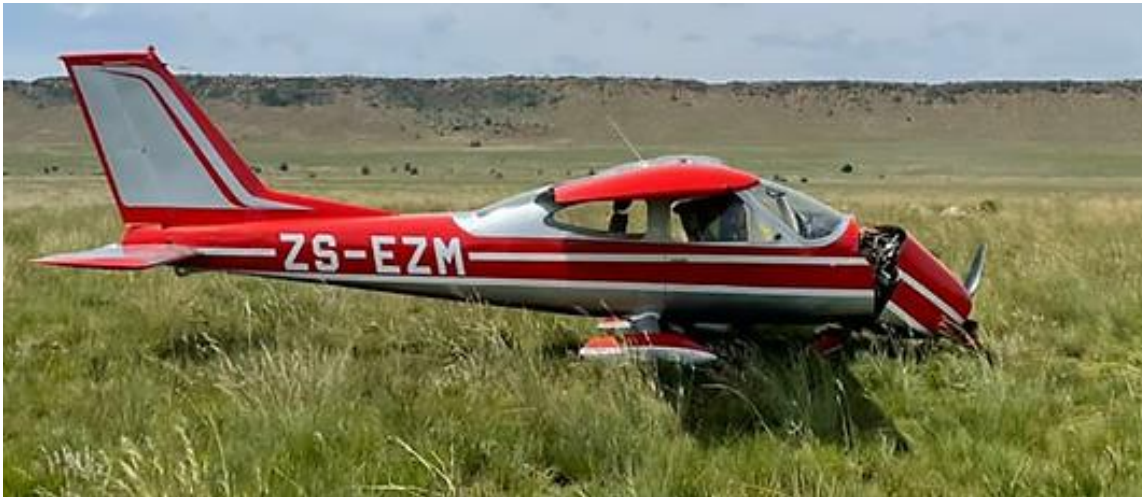
Figure 1: The Cessna 177 Cardinal aircraft, ZS-EZM. (Source: Pilot)

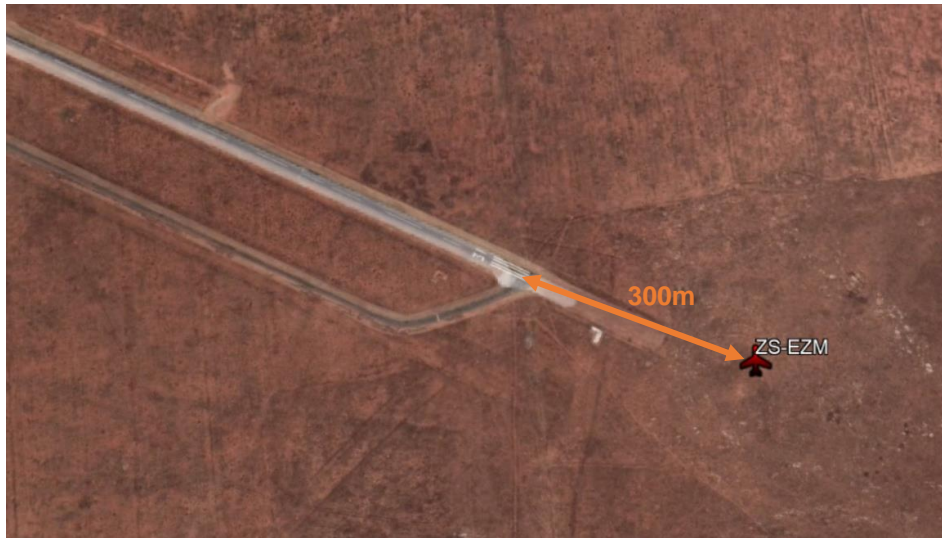
- 1.1.6. The aircraft landed on an open field 300m before the threshold of RWY 31 at FASY at Global Positioning System (GPS) co-ordinates determined to be 26°21'05.2" South 027°47'10.8" East, at 5439ft above mean sea level (AMSL).

Figure 3: Aerial view of the accident site's proximity to FASY RWY 31. (Source: Google Earth Pro)
