PRELIMINARY ACCIDENT REPORT

Accident
- Preliminary Report -
AIID Ref No: CA18/2/3/9944

The Bell 206B Jet Ranger II helicopter with registration ZS-HUC collided with high-tension electrical cables (the top earth conductor) during a fruit fly baiting operation. The helicopter crashed, and the pilot was fatally injured during the accident.

Reference Number : CA18/2/3/9944
Name of Operator : Heli X Charters (Pty) Ltd
Manufacturer : Bell Helicopter Textron
Model : Bell 206B Jet Ranger II
Nationality : South African
Registration Marks : ZS-HUC
Place : Silverstroom Farm, Wolseley, Western Cape
Date : 19 January 2021
Time : 0550Z

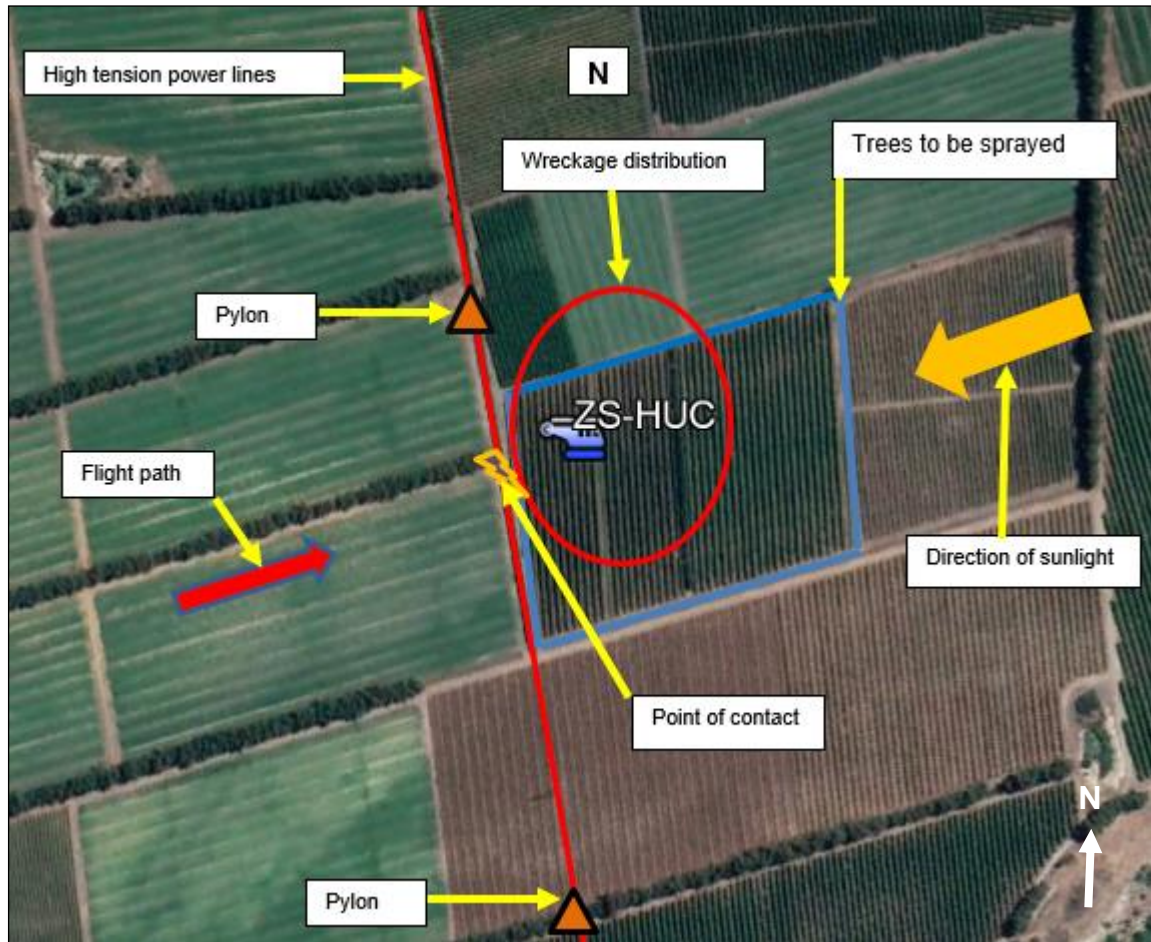
- 1.1.8. The flight was conducted under visual flight rules (VFR) by day. The helicopter crashed approximately 110m east of the power lines at the following Global Positioning System (GPS) co-ordinates: 33°25'32.80" South, 19°14'037.62" East at an elevation of 932 feet (ft) above mean sea level (AMSL).

Figure 2: An aerial view of the accident site. (Source: Google Earth)

1.12.3. The wreckage distribution consisted of numerous fragments of the helicopter that were found scattered at a radius of approximately 80m (around the main wreckage), which was indicative of an in-flight break-up of the helicopter after colliding with the earth cable.
