PRELIMINARY ACCIDENT REPORT

Accident
- Preliminary Report -
AIID Ref No: CA18/2/3/10080

Reference Number : CA18/2/3/10080
Name of Owner/Operator : George Chettle
Manufacturer : Cessna Aircraft Cooperation
Model : Cessna 421B Golden Eagle
Nationality : South African
Registration Marks : ZS-IGG
Place : On an open field, north of Middleburg Aerodrome (FAMB)
Date : 26 November 2021
Time : 1150Z

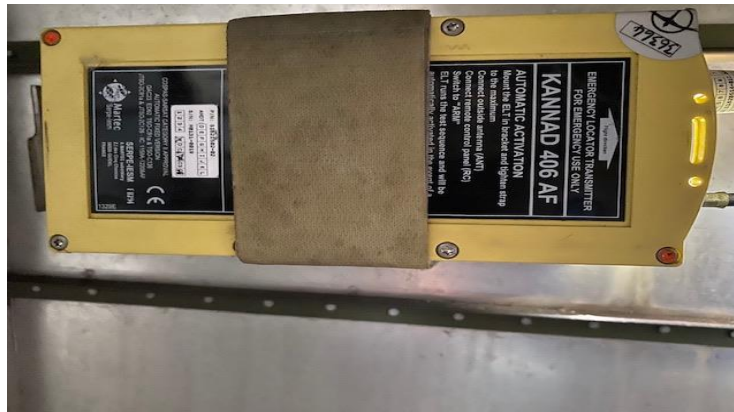
1.15.1 The accident was considered survivable as the occupants were properly restrained with the aircraft-equipped safety harnesses during the flight, as well as the low impact force associated with the accident. Work-order 13131 dated 5 March 2021 showed that a Kannad 406 AF ELT part number S1821502-02, serial number 40131-0019 was installed on the tail section and on the left-side of the aircraft in accordance with (IAW) the maintenance manual (MM) 25-63-05, Revision 4, dated 20 January 2019. The ELT activated and was detected by the Aeronautical Rescue and Coordination Centre (ARCC) in JHB. The ELT was switched off by the investigators during the on-site investigation.

Figure 15: The ELT as installed on the aircraft's tail-section.

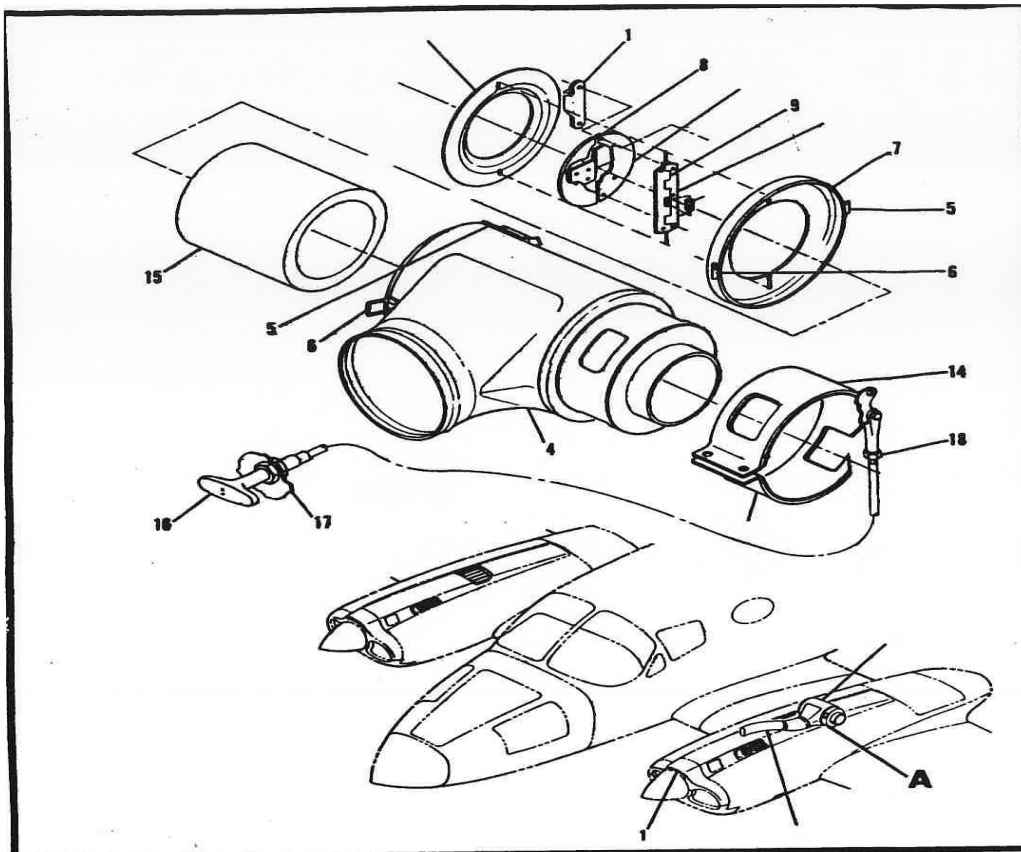
1.16.1 A preliminary finding revealed that the rough-running engines were caused by the induction icing (intake icing). The air filter's primary function on the engines is to remove dust and other foreign objects from the induction air. However, if they become obstructed or blocked by ice, the engines are starved for air, and would ultimately draw air from their respective engine intake manifolds with rapidly decreasing induction air pressure. There is no gauge in the cockpit to indicate induction icing except for the development of rough-running engines as the obstruction chokes the air flow. The alternate air (ALT AIR) T-handles on the left pilot side must be pulled out IAW the AFM to bypass the engine air filters, thus, allowing the unfiltered alternate air to be taken from inside of each engine nacelle into the combustion.

Induction air enters the system through a ram air duct located on the inboard duct of each nacelle and is directed through a filter mounted to the turbo-charger compressor air inlet. A magnetically controlled alternate air door incorporated in the airfilter permits compressor suction to open the door and admits alternate air if the air induction system becomes obstructed. A manually controlled alternate air door within the nacelle permits the pilot to open it to admit alternate (heated engine compartment air) if the air induction system should become obstructed. An exhaust driven turbocharger is automatically controlled by controllers to maintain a manifold pressure at 39.5 inches Hg, from sea level to a critical altitude (16,000ft) regardless of temperature. The turbocharger is completely automatic requiring no pilot action to critical altitudes.

Figure 17: Turbocharger induction air components. (Source: Engine Service Manual).
