PRELIMINARY ACCIDENT REPORT

Accident  
- Preliminary Report -  
AIID Ref No: CA18/2/3/9942

**Reference Number** : CA18/2/3/9942  
**Name of Owner** : Mbega Trust  
**Name of Operator** : Carel Jacobsz  
**Manufacturer** : Piper Aircraft Corporation  
**Model** : PA-46-350P  
**Nationality** : South African  
**Registration Marks** : ZS-JJJ  
**Place** : Koedoesberg Game Farm-Pongola, KwaZulu-Natal Province  
**Date** : 13 January 2021  
**Time** : 05:15Z

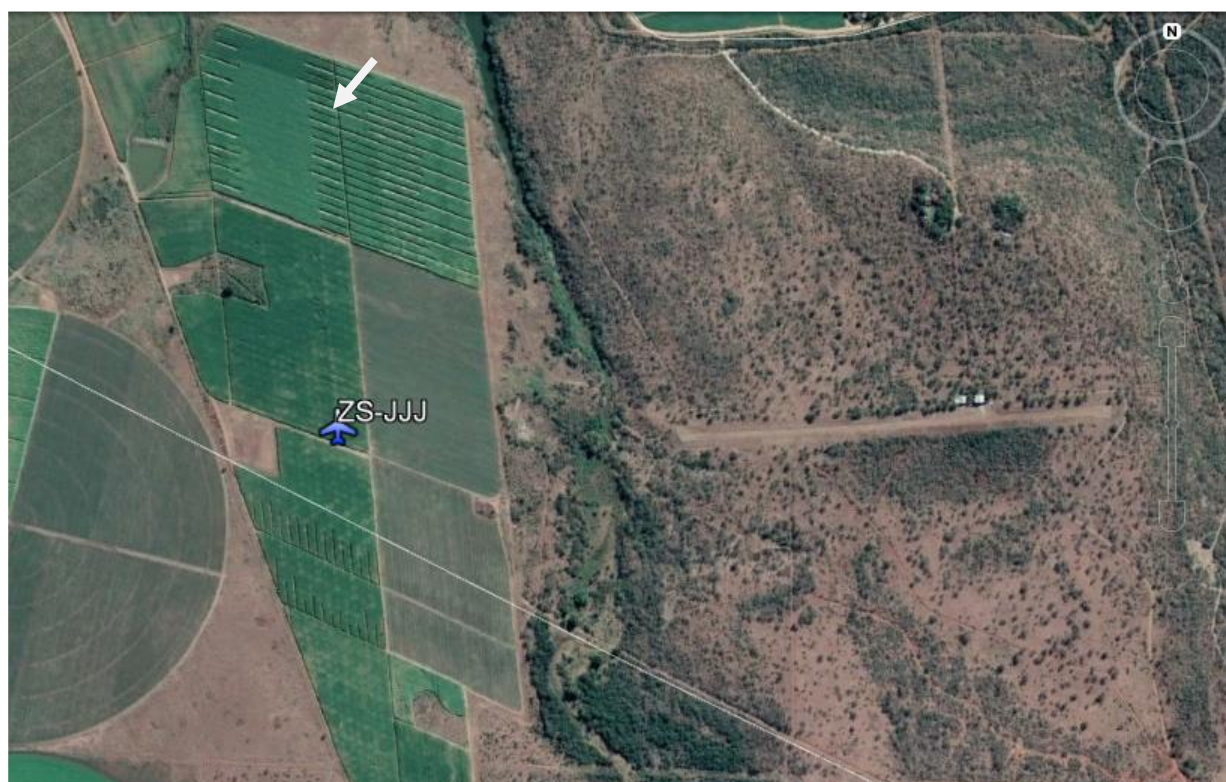
1.1.3 The accident occurred on a gravel road 500m from the take-off flight path at Global Positioning System (GPS) co-ordinates determined to be 27°34'69" S 031°41'2.91" E at an elevation of 913 feet (ft) above mean sea level (AMSL).

**Figure 2:** The approximate flight path and the accident location. (Source: Google Earth)
