PRELIMINARY ACCIDENT REPORT

Accident
- Preliminary Report -
AIID Ref No: CA18/2/3/10033

Reference Number : CA18/2/3/10033
Name of Operator : Mach 1 Aviation
Manufacturer : Piper Aircraft Corporation
Model : PA-34 200T Seneca II
Nationality : South African
Registration Marks : ZS-KFG
Place : Springs Aerodrome (FASI)
Date : 26 August 2021
Time : 0900Z

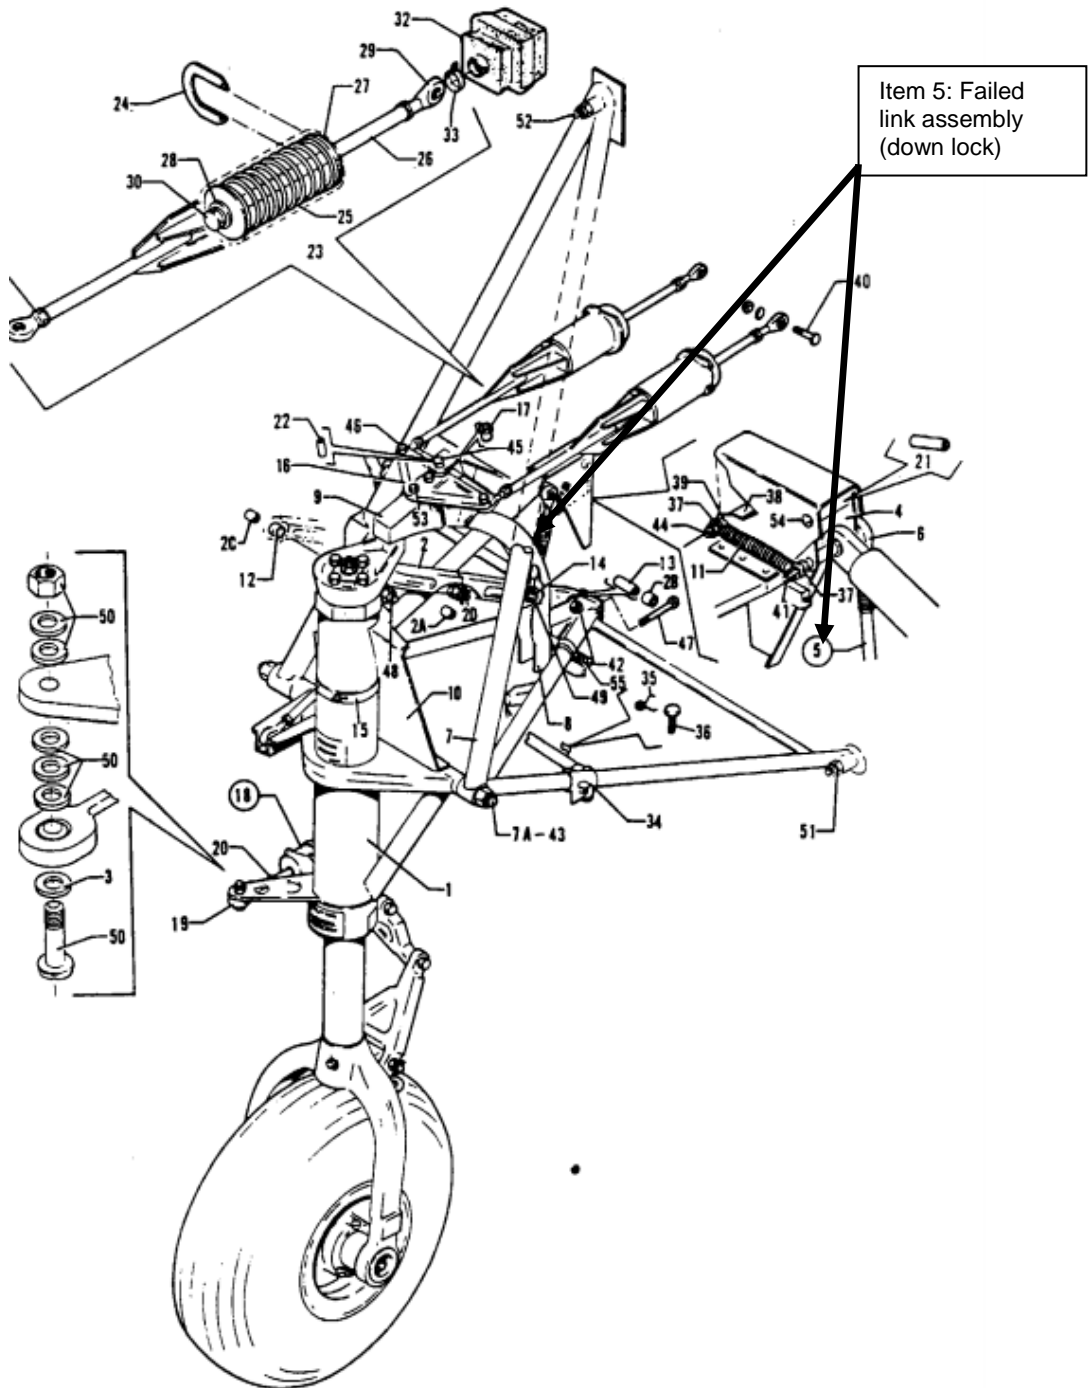
Diagram 1: Nose gear assembly schematics. (Source: Illustrated Part Catalogue)

1.16.1 Post-accident, it was discovered that the nosewheel link assembly (down lock) had broken off and separated from the rod end bearing. The cause of the damage to the link assembly is yet to be determined in the final report.

- 2.2.10 The aircraft sustained substantial damage during the accident; however, no persons were injured.
- 2.2.11 Preliminary findings revealed that the nose gear link assembly down lock mechanism had failed, resulting in the collapse of the nose gear during landing.
