PRELIMINARY ACCIDENT REPORT

Accident and Incident Investigations Division

Accident
- Preliminary Report -
AIID Ref No: CA18/2/3/10004

Reference Number : CA18/2/3/10004
Name of Owner/Operator : Gypsy Empire Properties (Pty) Ltd
Manufacturer : Robinson Helicopter
Model : R44 Raven II
Nationality : South African
Registration Marks : ZS-RSK
Place : Vaal Marina Dam, Gauteng province at GPS co-ordinates:
S 26° 54' 28.1", E 028° 12' 37.0"
Date : 14 May 2021
Time : 1610Z

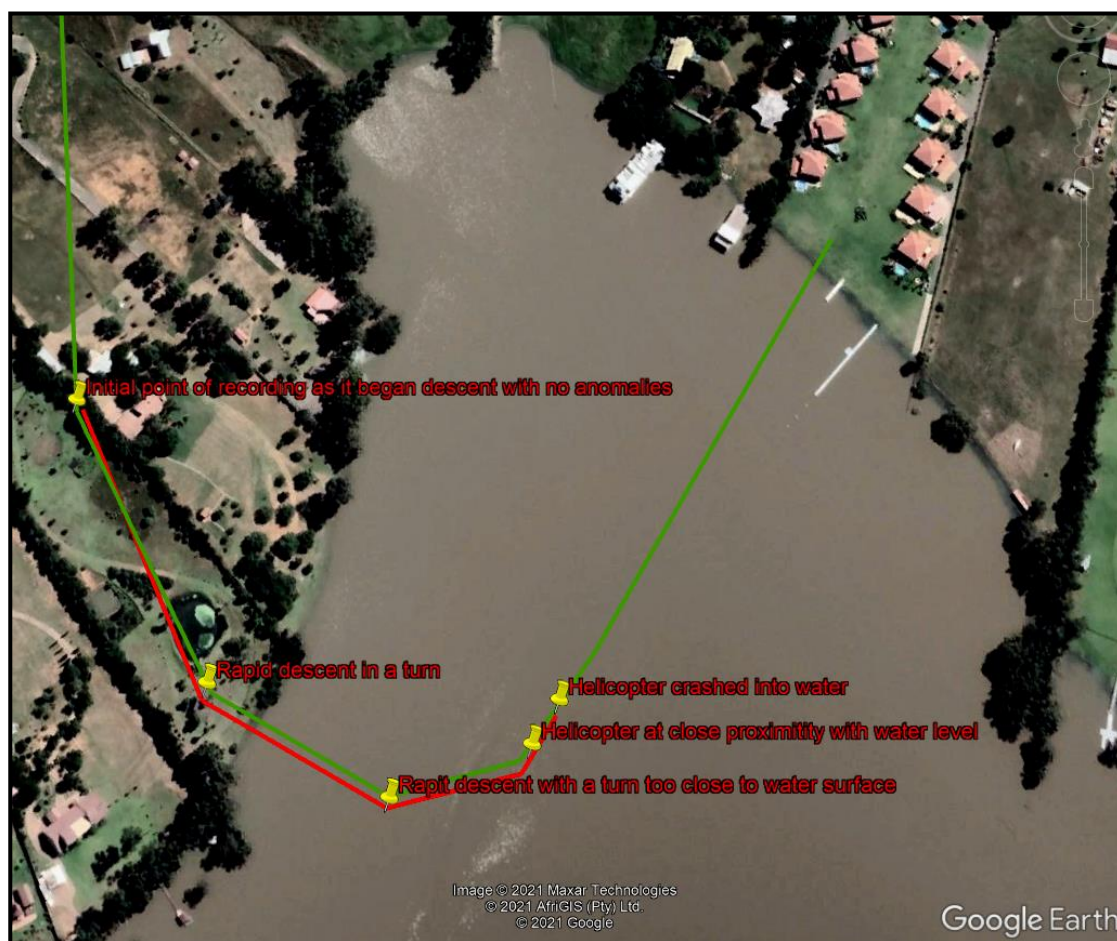
- 1.1.4 The helicopter approached from the north-westerly direction and was flying at a low height above water before making a turn (over the water) to line up for a straight-in approach for landing on an open grassy strip between the dam and the houses.

Figure 2: The helicopter route as per the video footage. (Source: Google Earth)

1.1.6 The helicopter is then observed descending rapidly and very low towards the water surface while turning towards the landing site. It then struck the water surface, followed by a bright spark and a loud bang.
