PRELIMINARY ACCIDENT REPORT

Accident
- Preliminary Report -
AIID Ref No: CA18/2/3/9946

Reference Number : CA18/2/3/9946
Name of Owner/Operator : National Airways Corporation (Pty) Ltd
Manufacturer : Bell Corporation
Model : Bell 430
Nationality : South African
Registration Marks : ZT-RRT
Place : Colenso
Date : 21 January 2021
Time : 1135Z

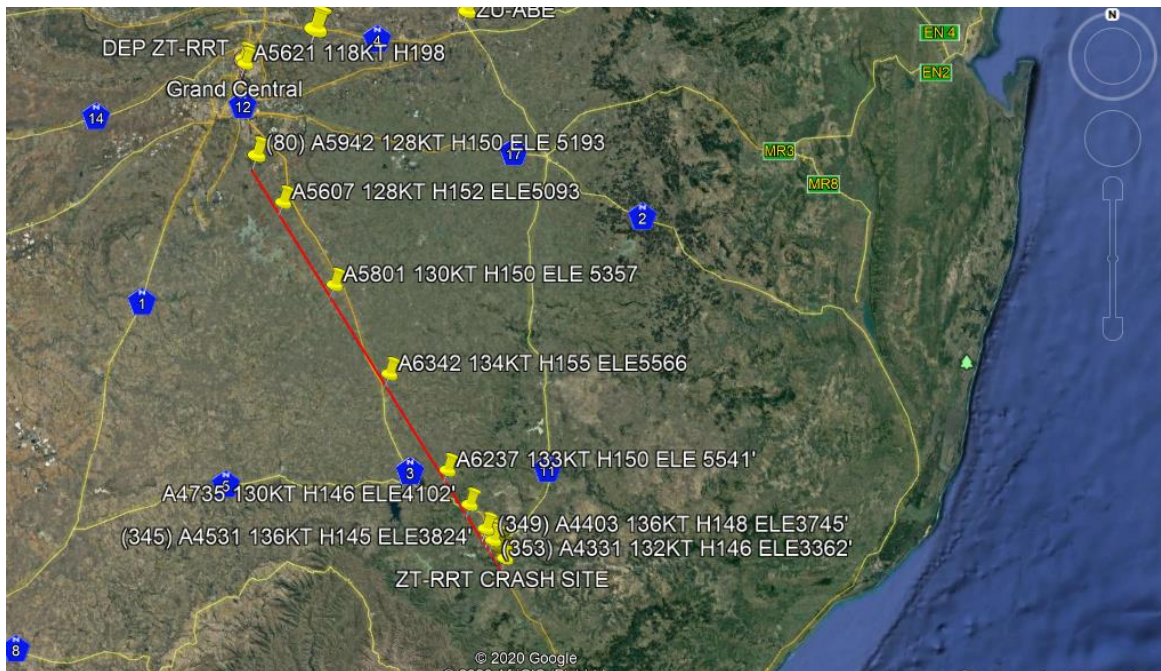
Figure 2: The flight path taken by the ZT-RRT before it crash. (Source. Google Earth)

1.1.6 According to several eye witnesses who were travelling on the N3 Highway as well as a farmer (who was positioned to the west, in relation to the flight path), the helicopter suddenly started to spin around whilst losing height rapidly. The witnesses then saw what looked like helicopter parts breaking off before it crashed and burst into flames 2.45nm from position 361 (see Figure 6). This position is in the south-east of the helicopter's intended route. Debris from the helicopter was scattered along this path. The accident site stretched for approximately half a kilometre from the furthest/first located object of the wreckage. The helicopter was destroyed by post-impact fire and the pilot and four passengers were fatally injured.

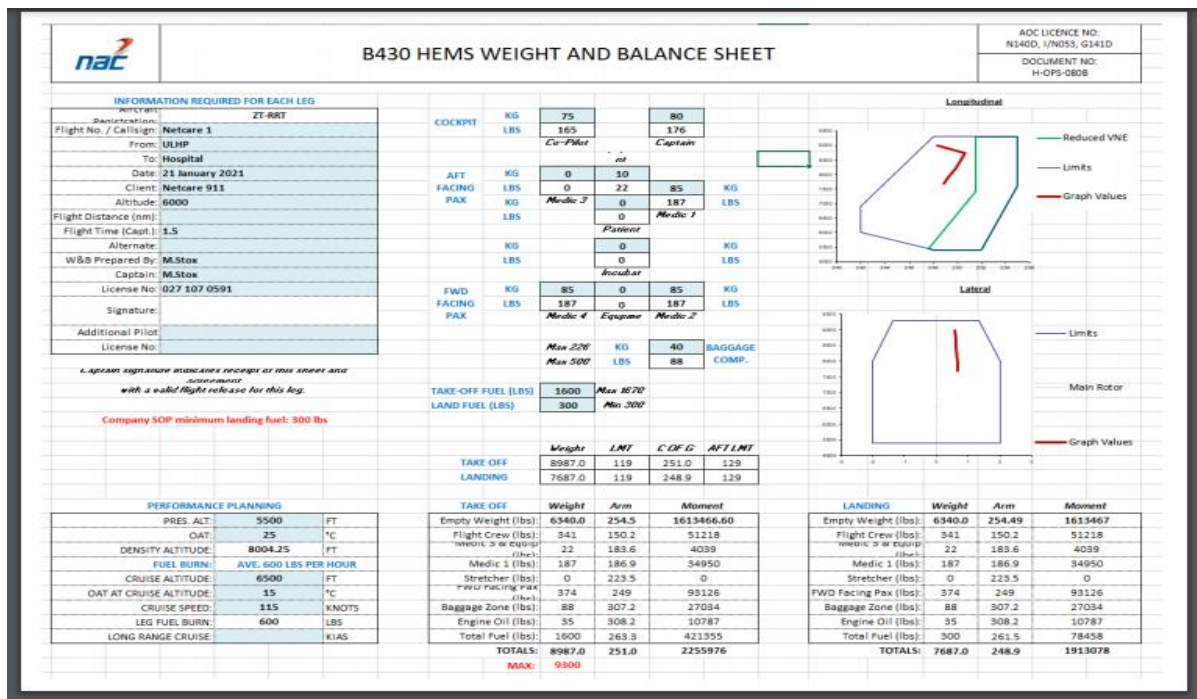
1.6.3 According to the weight and balance, the helicopter seating arrangement was as follows: the pilot and the helicopter paramedic were seated at the front seats whilst the two doctors and the theatre nurse were seated at the back seats. The 12 full oxygen bottles were strapped down in the luggage compartment. The helicopter had 1600 pounds (lb) of fuel; with a fuel consumption of 600lb per hour. This meant that this flight had fuel endurance of 2 hours and 36 minutes. The maximum take-off weight of the helicopter is 8999lb. The ZT-RRT helicopter take-off weight was 8987lb, which meant that it was 12lb below all-up weight.

Figure 4: The ZT-RRT weight and balance. (Source: Operator)
