PRELIMINARY ACCIDENT REPORT

Accident and Incident Investigations Division

Accident
- Preliminary Report -
AIID Ref No: CA18/2/3/10070

Figure 1: Evektor SportStar, ZU-EIJ. (Source: Ben Snyman)

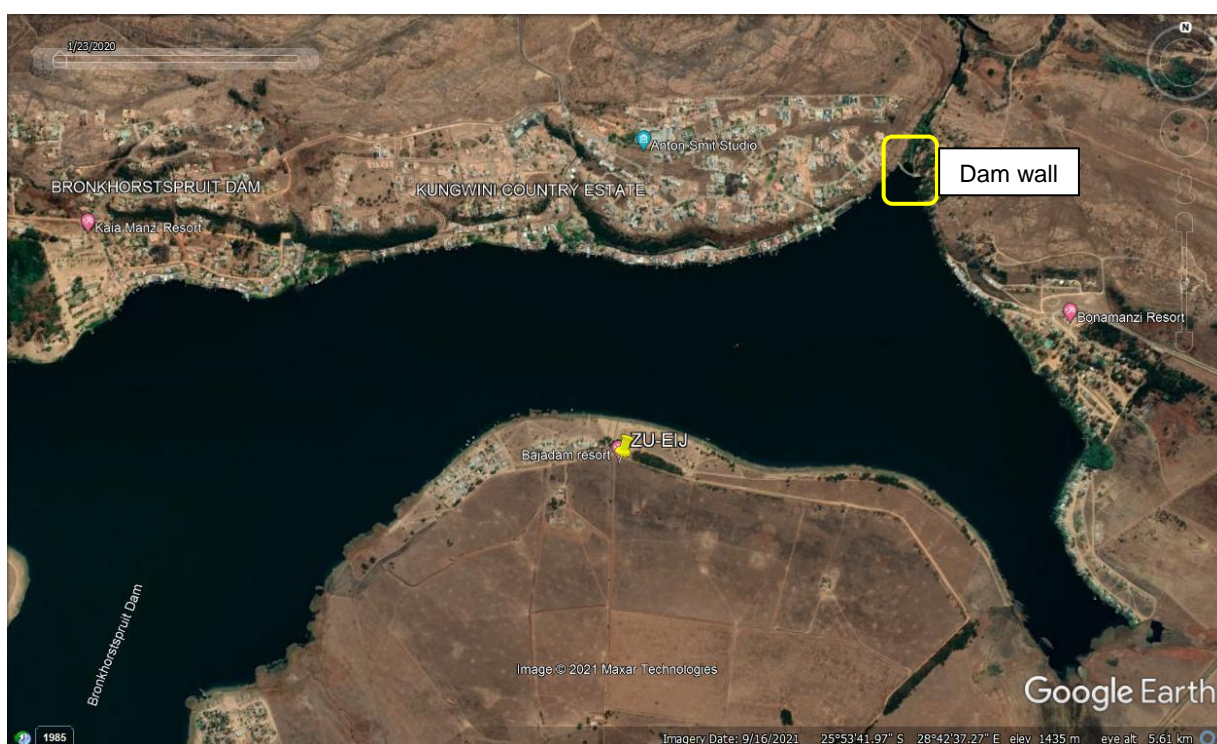
- 1.1.5 According to eyewitnesses staying next to the dam, they saw the aircraft flying over the dam from the north to the south, and towards the eastern side of the dam. At the time, a strong wind was blowing in the area. The eyewitnesses saw something (blue in colour) breaking off the aircraft fuselage while it was flying over the dam, whereafter, the pilot most probably lost control of the aircraft. The aircraft was seen twirling in the sky while descending before it impacted terrain (open field) on the southern side of the dam. The outer section of the left wing that failed was located approximately 100 metres (m) from the main wreckage, closer to the water line.
- 1.1.6 The accident occurred during daylight at Bajadam Resort at Global Positioning System (GPS) co-ordinates determined to be: 25°53'52.44" South, 028°42'38.00" East, at an elevation of 4 740 feet (ft).

Figure 2: Overlay of the position of the accident site, yellow pin ZU-EIJ. (Source: Google Earth)
