PRELIMINARY ACCIDENT REPORT

Accident
- Preliminary Report -
AIID Ref No: CA18/2/3/9963

On Thursday 4 March 2021, a pilot on-board a Fokker E.III with registration ZU-FOK took off on a private flight from the Coves Airfield. The pilot reported that during the flight, he experienced a rough running engine. A few seconds later, the engine stopped. The pilot decided to execute a forced landing on a ploughed field. The aircraft was substantially damaged during the accident and the pilot sustained minor injuries.

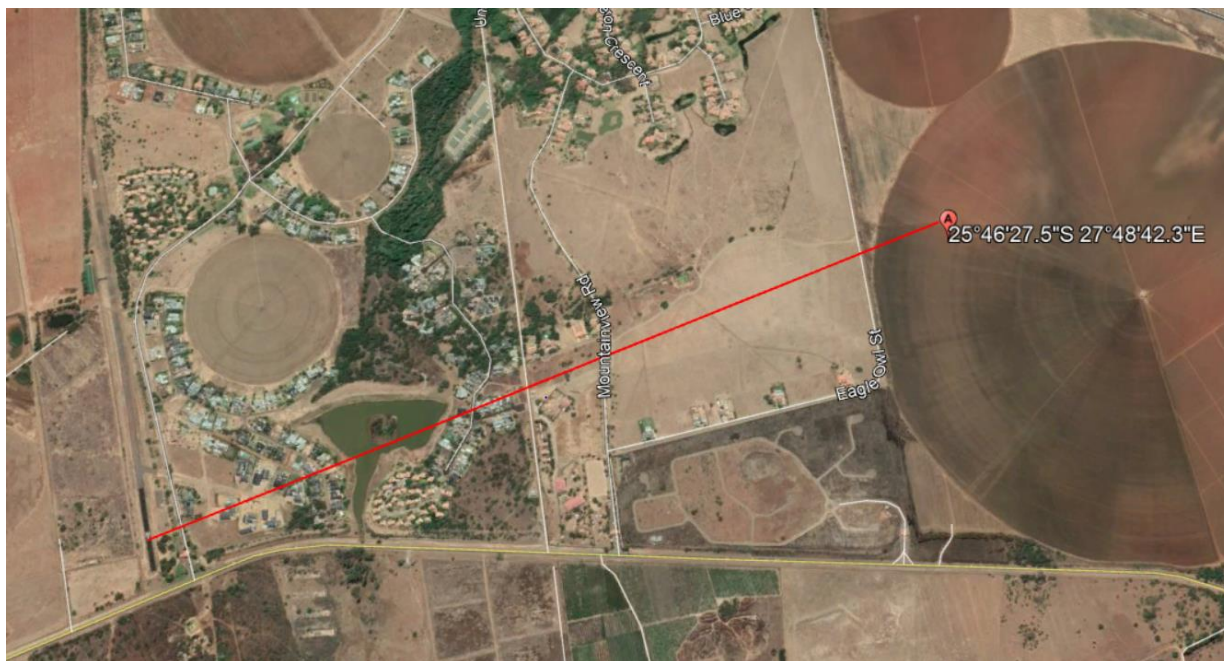
Figure 2: The approximate flight path and the accident location. (Source: Google Earth)

1.1.4 The accident occurred in a ploughed field approximately 1 nautical mile (nm) from the take-off airfield at Global Positioning System (GPS) co-ordinates determined to be 25°46'27.5" S 027°48'42.3" E at an elevation of 4000 feet (ft).
