**PRELIMINARY ACCIDENT REPORT**

**Accident and Incident Investigations Division**

Accident  
- Preliminary Report -  
AIID Ref No: CA18/2/3/10007

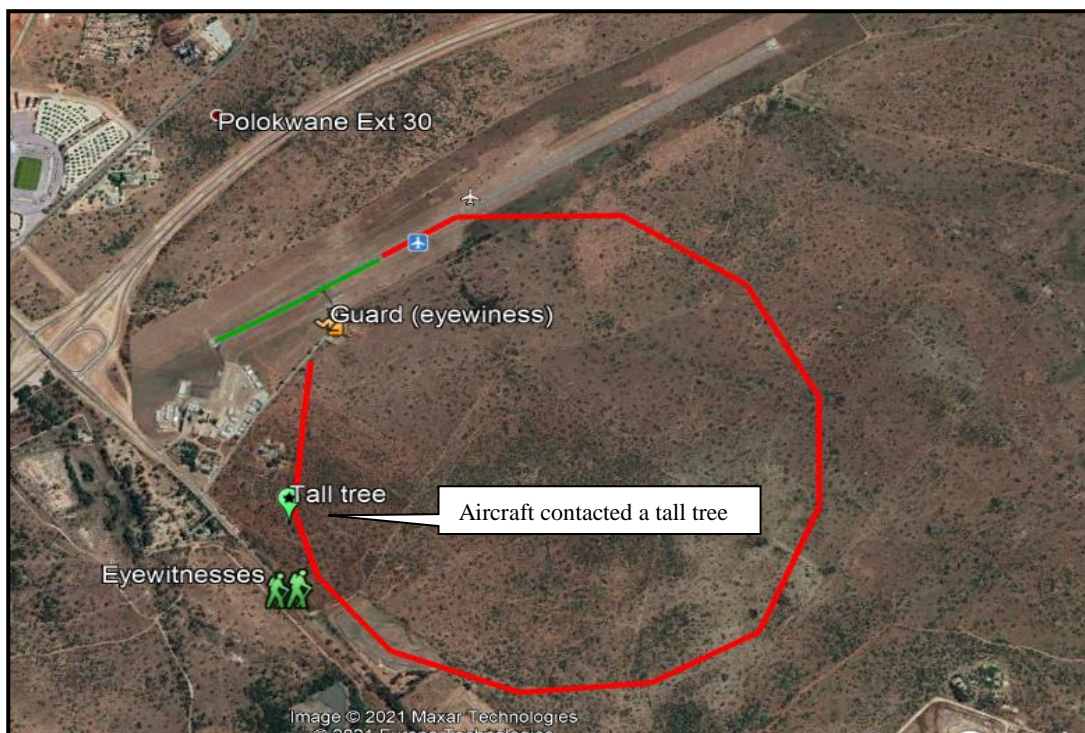
1.1.2 Three circuits were completed uneventfully. On the fourth circuit following take-off while the aircraft was in a right turn on downwind, the pilot reported an engine failure. According to the FAPP ATC, the pilot advised that he intended to execute a forced landing at FAPI.

**Figure 2:** The flight path of the aircraft leading to the accident. (Source: Google Earth)
