PRELIMINARY ACCIDENT REPORT

Accident
- Preliminary Report -
AIID Ref No: CA18/2/3/10022

Reference Number : CA18/2/3/10022
Name of Owner/Operator : Johannesburg Flying Academy
Manufacturer : Sling Aircraft
Model : Sling 2
Nationality : South African
Registration Marks : ZU-FZZ
Place : Panorama Airfield, Gauteng Province
Date : 9 July 2021
Time : 0720Z

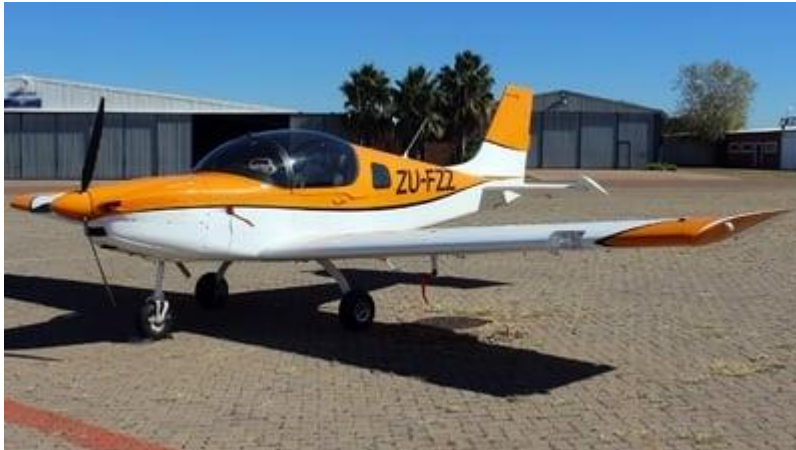
Figure 1: File photo of the ZU-FZZ accident aircraft. (Source: Jet photos)

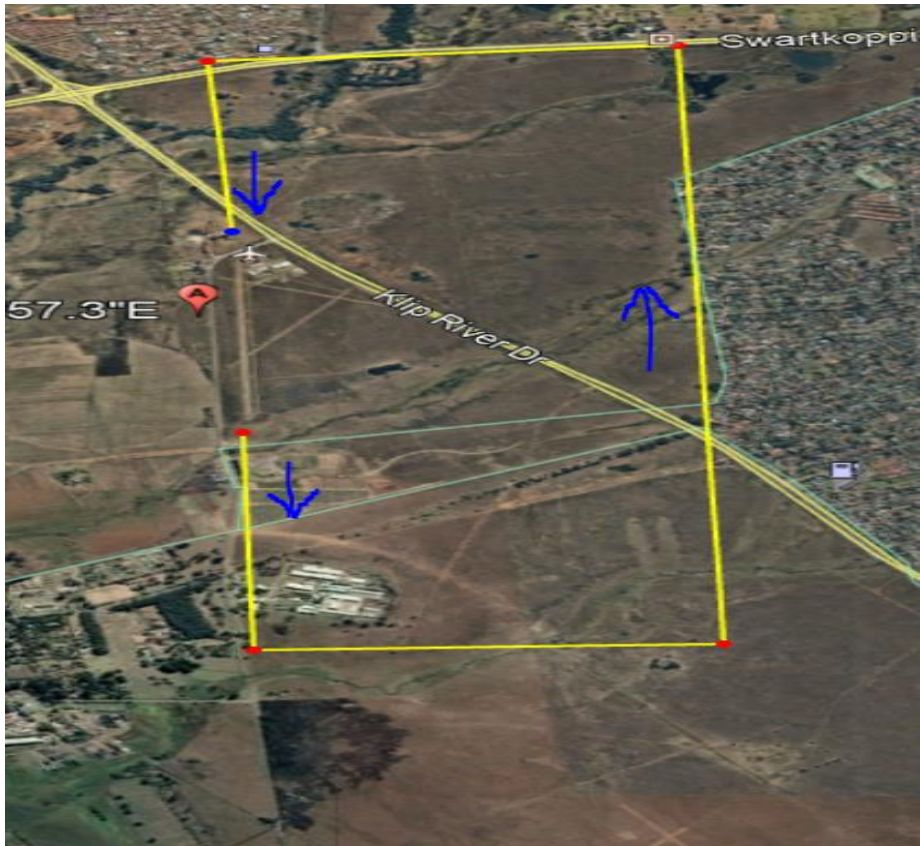
- 1.1.2 The student pilot carried out three circuit-and-landing exercises successfully with the instructor. Thereafter, the instructor allowed the student pilot to conduct solo circuit-and-landing exercises. The student pilot carried out five circuit-and-landing exercises on RWY 20 without incident (see Figure 2). However, on the sixth circuit, the student pilot changed circuit-to-fly from RWY 20 to RWY 02 (see Figure 3) because the wind direction had changed to a wind from the north. The aircraft landed on RWY 02 and veered off to the left. The pilot then lifted off (again) to evade trees on the left of the runway, however, the aircraft clipped the top of the trees.

Figure 2: Runway 20 circuit. (Source: Google Earth)
