PRELIMINARY ACCIDENT REPORT

Accident
- Preliminary Report -
AIID Ref No: CA18/2/3/10111

Reference Number : CA18/2/3/10111
Name of Owner : DG 808B Partnership
Name of Operator : Private (Part 94)
Manufacturer : DG Flugzeugbau G.m.b.H.
Model : DG 808B
Nationality : South African
Registration Marks : ZU-KDP
Place : Langeberg Mountain, Suurbraak area, Western Cape
Date : 1 February 2022
Time : 1350Z

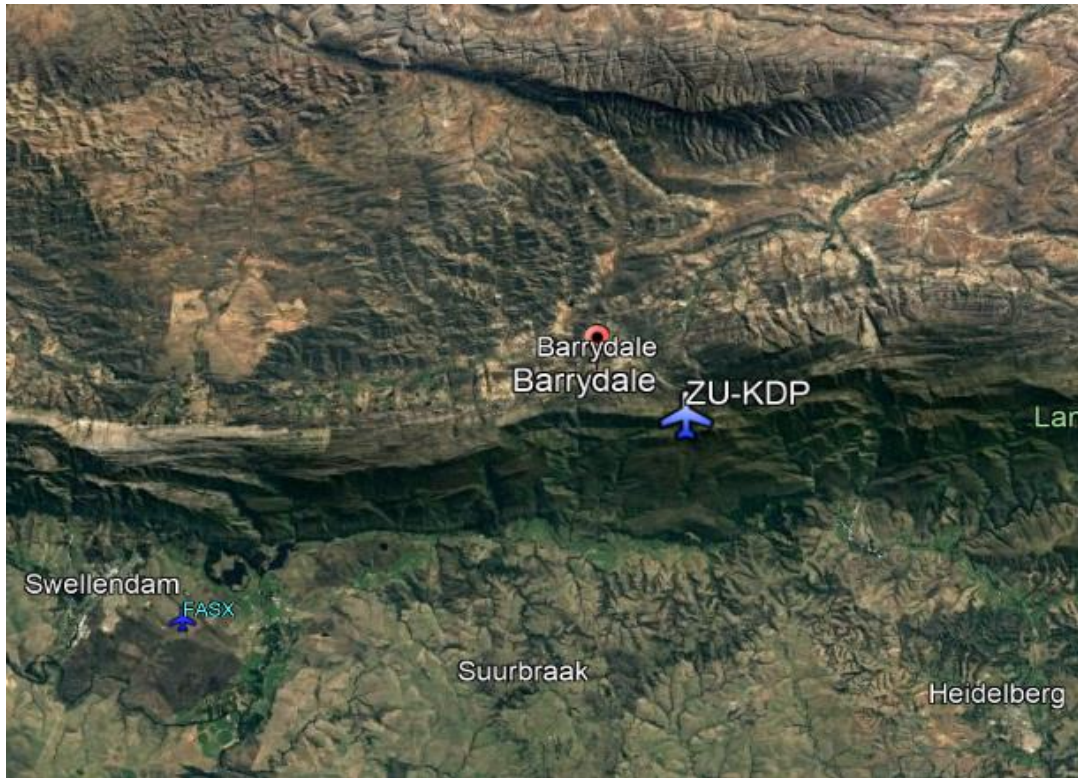
- 1.1.6 The accident occurred on the windward side of Langeberg Mountain near Barrydale, Western Cape, during day light at GPS coordinates determined to be 33°57'00.9" South 020°46'54.0" East, at an elevation of 4 389ft.

Figure 2: Overlay of the accident site. (Source: Google Earth)

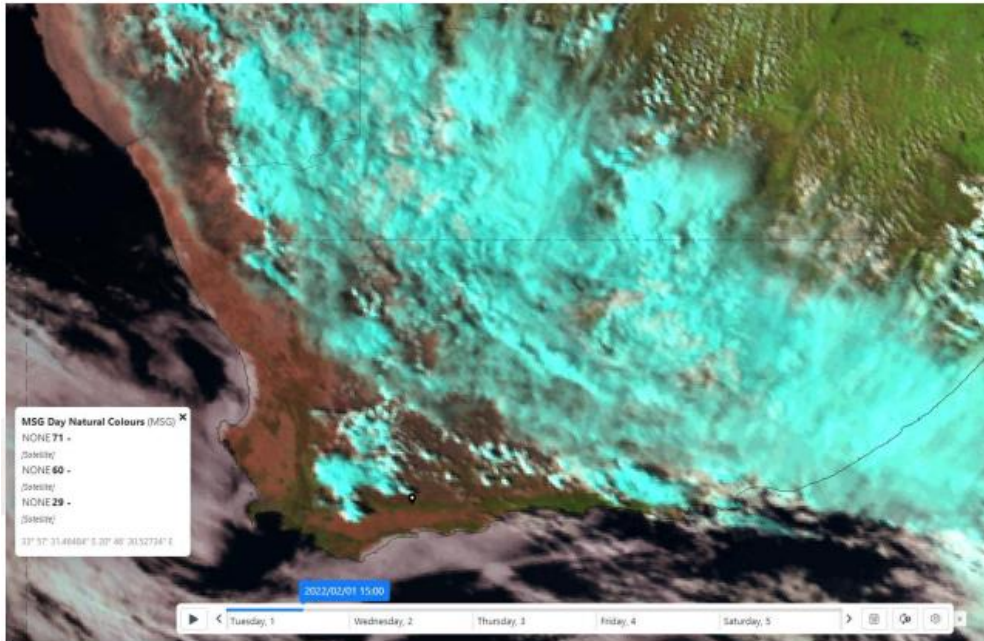
Figure 4: Day Natural Colours satellite imagery at 1500Z for 1 February 2022. (Source: SAWS)

The Day Natural Colours satellite imagery of the MeteoSat Second Generation (MSG) taken at 15:00Z on 01 February 2022 indicate that there were no significant clouds (clear skies) over the area of accident, however; there were scattered (3 to 4 oktas) cumulus, scattered towering cumulus and few cumulonimbus clouds in the vicinity of the area of accident. Figure 4

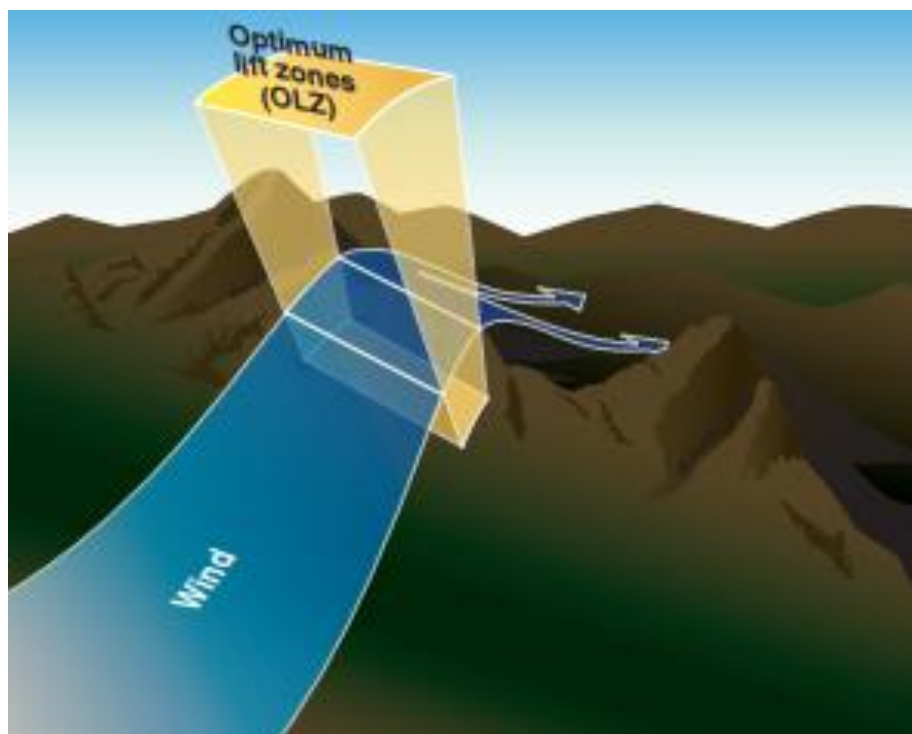
Efficient slope soaring (also called ridge soaring or ridge running) is fairly easy; simply fly in the updraft along the upwind side of the ridge. Although the appearance may seem simple, it is very complicated and can be very hazardous for the untrained glider pilot. Ridge soaring can also be very demanding on the glider and the pilot. Even though it is easy to fly, there are many situations in which a glider pilot can be exposed to hazards if proper training has not been received. A thorough preflight and route planning needs to be accomplished. This planning also includes ridge selection based on the current winds. The horizontal distance from the ridge varies with height above the ridge, since the best lift zone, or optimum lift zones (OLZ) tilts upwind with height above the ridge. These zones, or OLZ, vary but usually are slightly off the top of the

ridge, with a slight angle into the prevailing wind. The bottom of the OLZ may be slightly down from the top line under normal conditions. These OLZ vary with the size and terrain makeup of the ridge.

Figure 14: Optimum lift zone of a ridge.

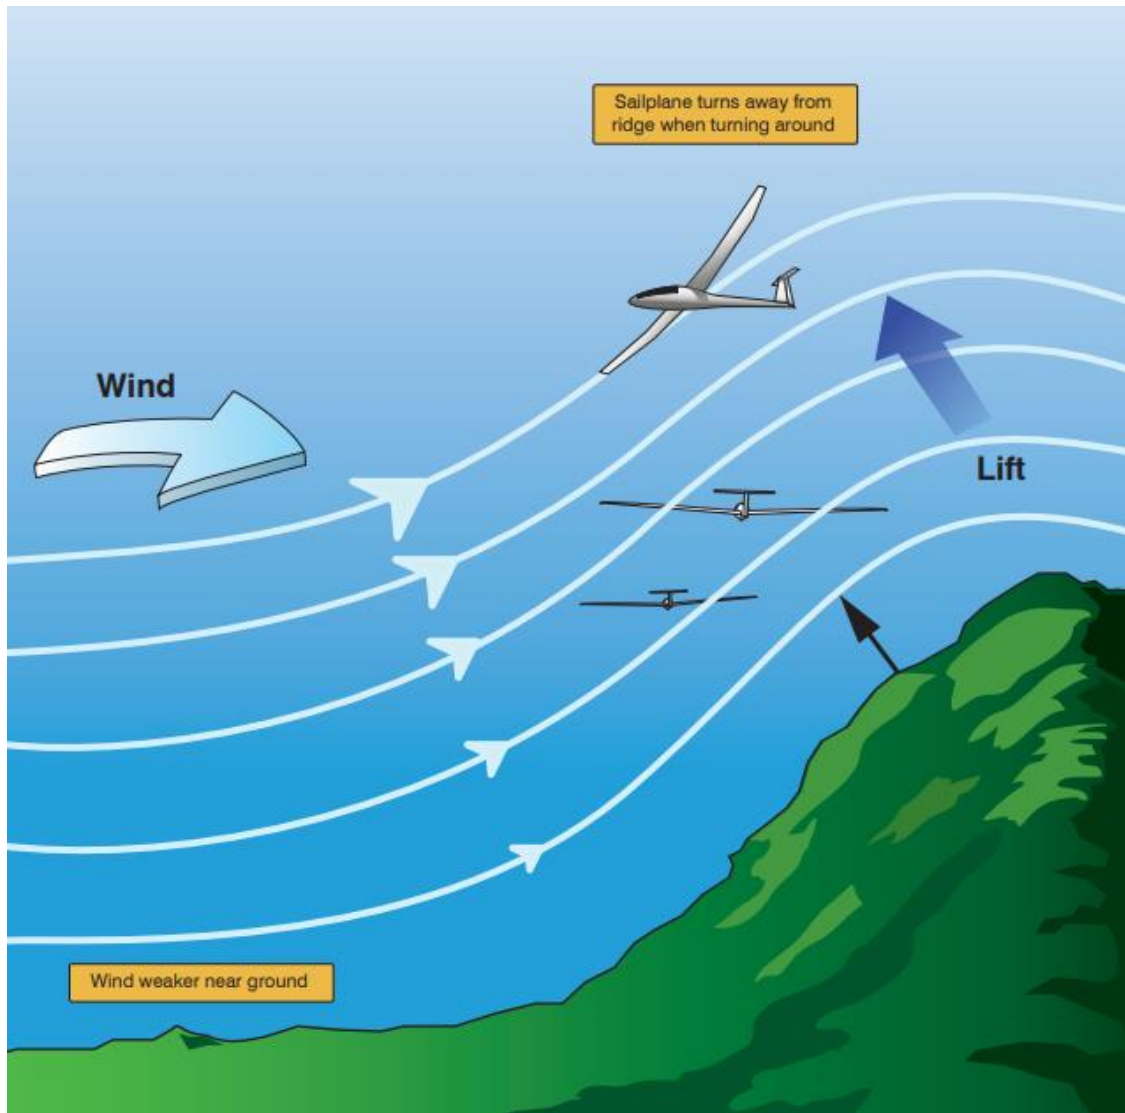
Surface winds of 15–20 knots that are perpendicular to the ridge are ideal. Wind flow within 45° of the perpendicular line also provides adequate lift. Winds less than 10 knots have also produced adequate ridge soaring dependent on the terrain, but with 10 knots of wind or less, pilots should avoid flying low over any ridge due to the possibility of encountering sink. Local ridge pilots know about of these conditions and the need for good preflight planning and training is required. [Figure 15] • Airflow mirrors a hill or ridge shape. Imagine a flow of water around the ridge instead of air. However, air is thinner and can be compressed as in a “venturi effect” and can be “squeezed” and accelerated, especially along the ridge. • Ridges that have an irregular profile are hazardous. The more complicated the ridge is, the more erratic the airflow may become.

Figure 15: Ridge wind flow.
