**PRELIMINARY ACCIDENT REPORT**

Accident  
- Preliminary Report -  
AIID Ref No: CA18/2/3/10178

On 25 June 2022, a pilot and a passenger on-board a Sling 2 aircraft with registration ZU-WCG were engaged on a private night navigation flight. The aircraft took off from Gqeberha International Airport (FAPE), Eastern Cape province, to Buyskloof general flying area, towards the north-east of the aerodrome, with the intention to land back at FAPE.

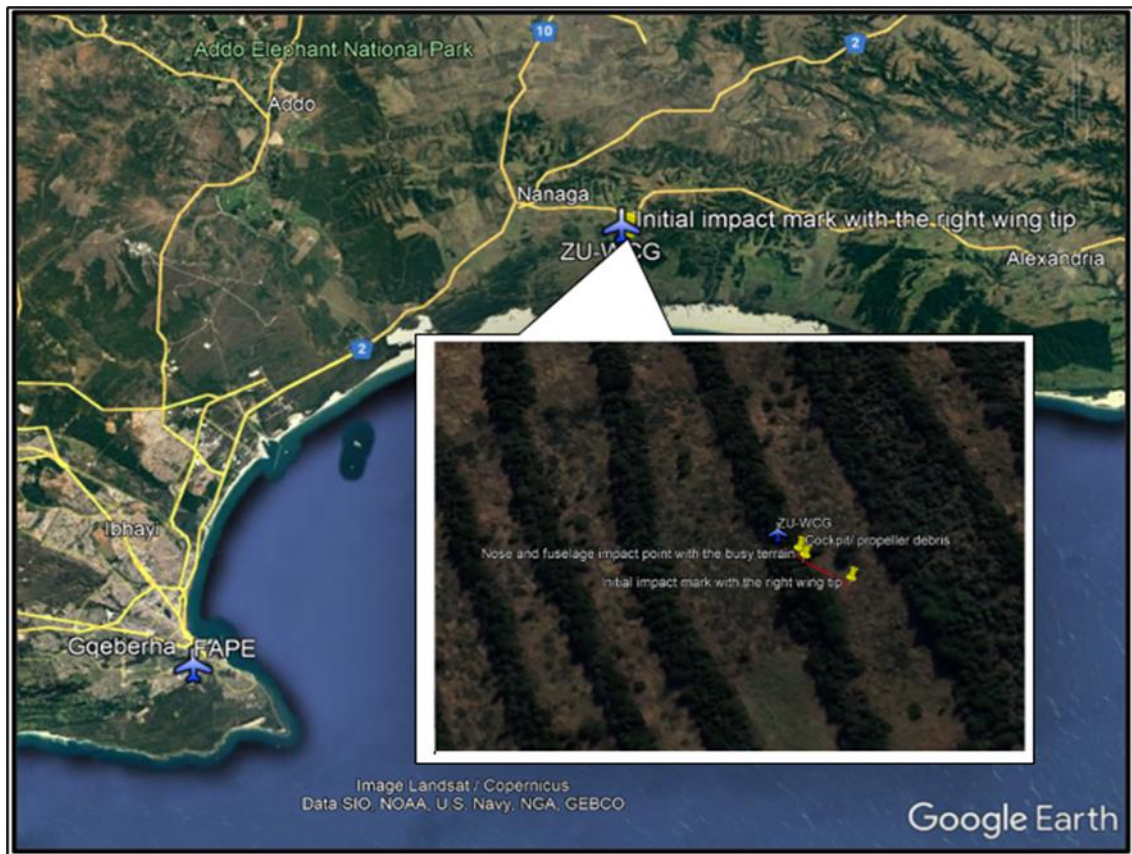
- 1.1.4 The aircraft accident occurred during night meteorological conditions at Essenwood Dairy Farm, situated approximately 16nm north-east of FAPE at GPS co-ordinates determined to be S 33°38'26.79" E 026°0'44.85" at a field elevation of 750ft.

**Figure 2:** View of the accident site. (Source: Google Earth)
