INSPECTION - ELEVATOR BELLCRANK PIVOT

- A. EFFECTIVITY PAL 750XL aircraft up to and including S/N 215.

- B. REASON It is possible that the Elevator Bellcrank Pivot joint could be assembled with a bolt that is a gauge size too short leaving threads inside the working section of the joint. This can be determined by measuring the length of the bolt. If it is found on inspection that the shorter bolt has been used to assemble this hinge, the bolt will need to be replaced with the next gauge size up.

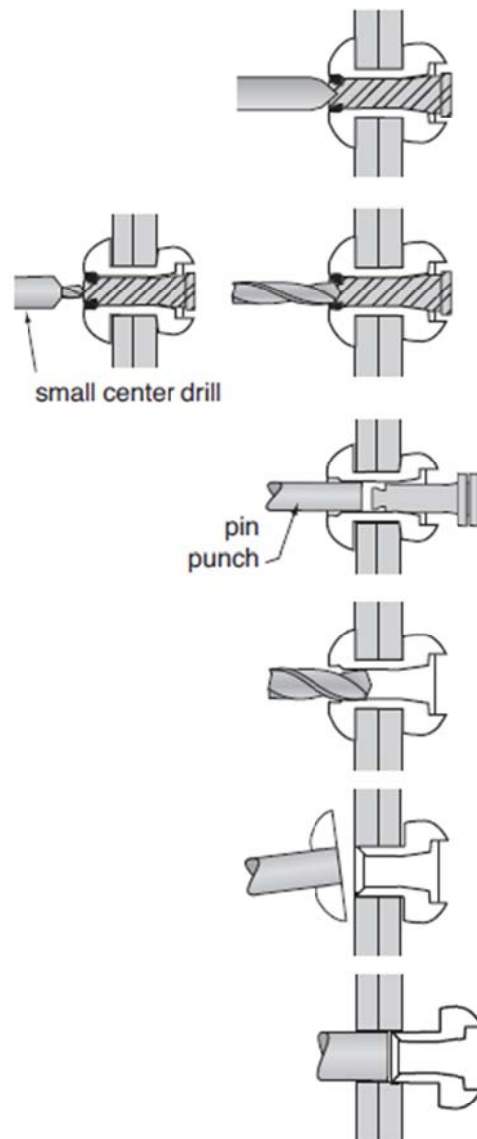
1. Center punch stem.
2. It is recommended that a small center drill be used to provide a guide for a larger drill on top of the rivet stem, and the upper portion of the stem be drilled away to destroy the lock.
3. Drive out the rivet stem using a steel pin punch.
4. Drill nearly through the head of the rivet using a drill the same size as the rivet shank.
5. Break off rivet head using a pin punch as a pry.
6. Drive out the remaining rivet shank with a pin punch.

Caution: DO NOT drill completely through the rivet sleeve to remove a rivet as this may enlarge the hole.

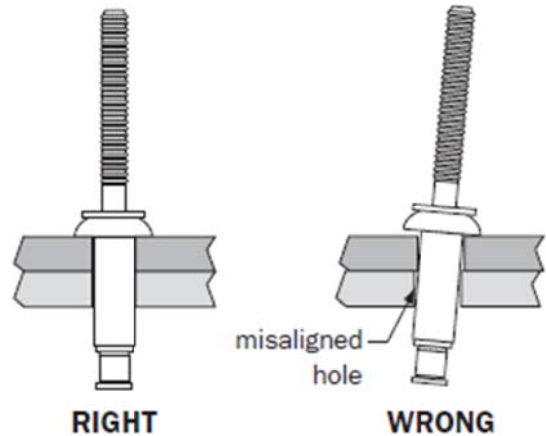
PLACING THE RIVET IN THE HOLE

The holes in the sheets to be fastened must be of correct size and aligned properly. Do not force the rivet into the hole! Tack rivets and/or spring-loaded fasteners are recommended to minimize material creep and sheet gap.

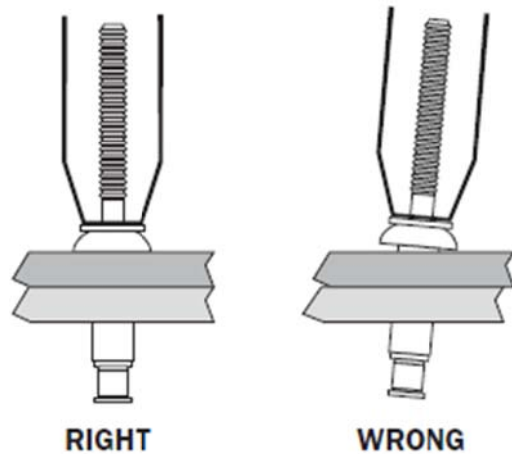
PLACING THE PULLING HEAD ON THE RIVET STEM

Hold the riveter and pulling head in line with the axis of the rivet. Press firmly against head of rivet to minimize head gapping and sheet gap.
