Continued Airworthiness Notification to the International Community

Date: October 31, 2019

Subject: This message is to advise you of the FAA's ongoing activities related to cracking and fracturing of the right aileron flight control cable end fittings (terminal attachment fittings) connected to the turnbuckle barrel on various Textron Aviation Inc. (type certificate formerly held by Beechcraft Corporation) (Textron) airplanes.

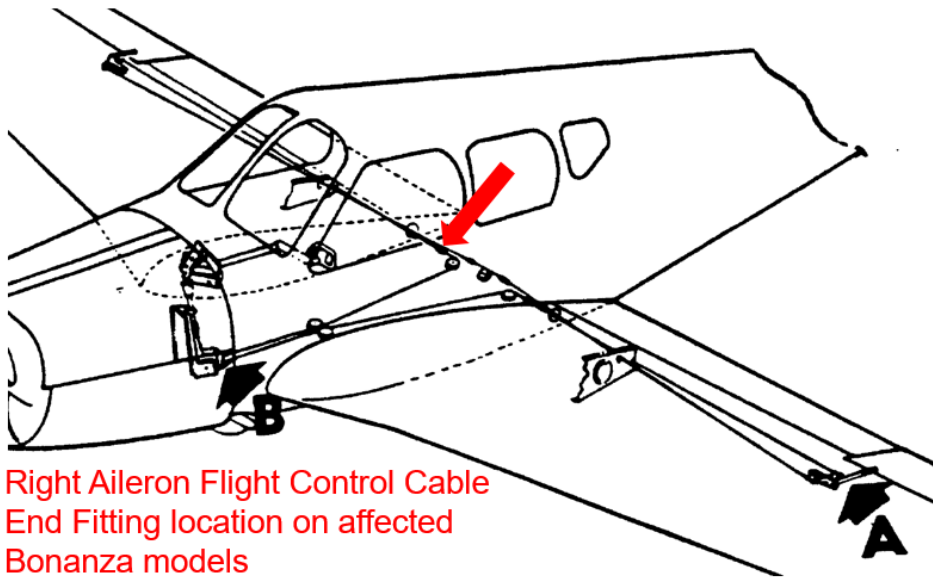
Right Aileron Flight Control Cable
End Fitting location on affected
Bonanza models

Typical Beechcraft Bonanza Aileron Controls
