Feedback

Canadian Aviation Service Difficulty Reports

The following content was published between January 1st, 2019 and August 13th, 2019

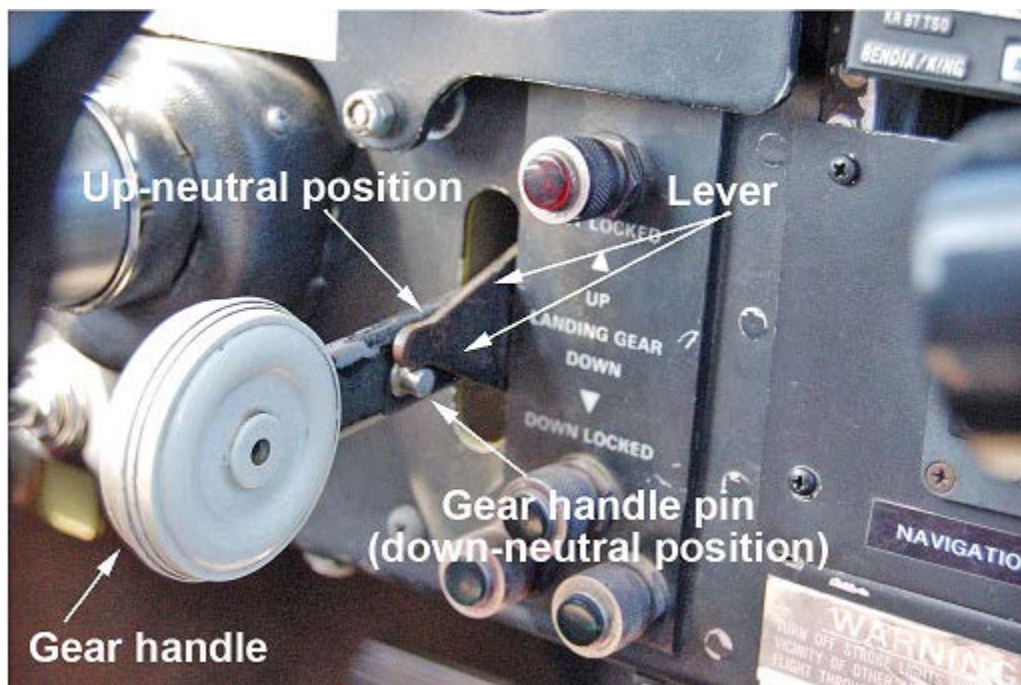
Piper PA31-350 Landing Selector

The submitter's finding in this SDR, that the manual does not specifically require the technician to rotate the shaft to verify that it is not bent, is a valuable observation. Even though it is not specifically called out in the Instructions for Continued Airworthiness (ICAs), TCCA highly recommends that maintainers of these types of aircraft be diligent in inspecting for this condition (bent shaft) specifically, in addition to other negative conditions (e.g. weak return springs in handle, proper alignment and functioning of anti-retraction solenoid and or squat switch etc.)

TCCA also reminds maintainers and operators that if any such conditions are found, to submit an SDR to TCCA.

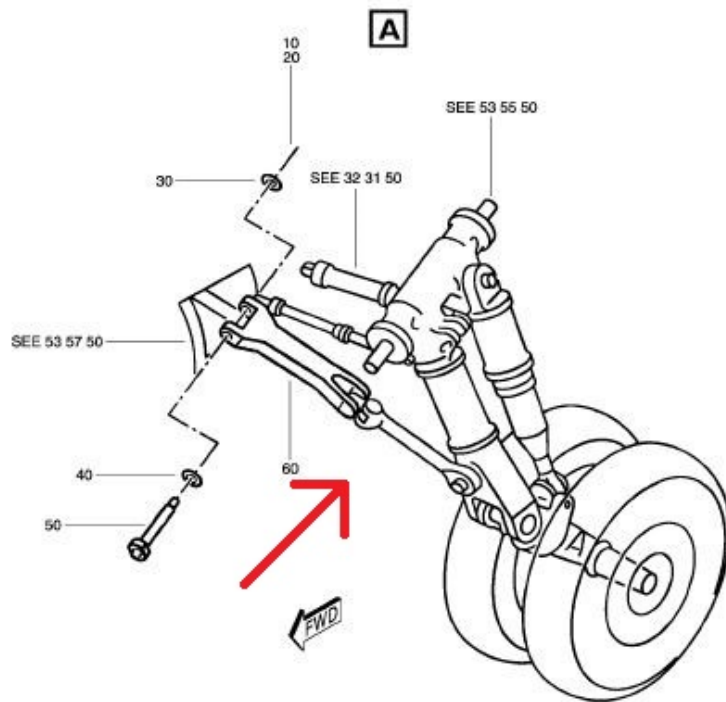
BRACE INSTL-SIDE, 2731-741

During a walk-around of the aircraft, the right-hand main landing gear (R/H MLG) side brace lower attach bearing brace was found to be migrating from the assembly bore. The R/H MLG side brace assembly was replaced and gear swings carried out in accordance with ATR42 AMM JIC 32-11-53 RAI 10000. No further faults.

Parts Catalogue showing side brace location

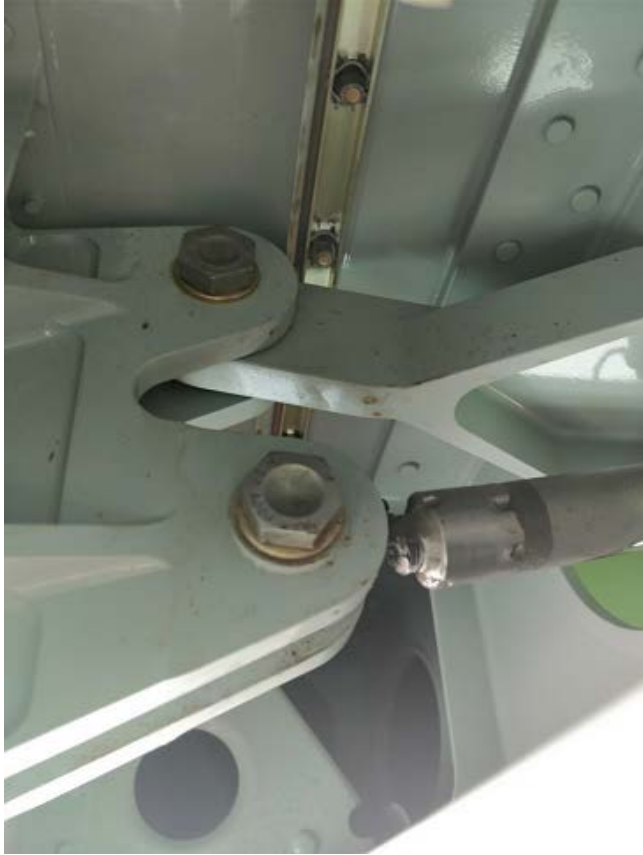
While performing the maintenance task for the operational test of the elevator power control units, the technicians found that the left elevator movement was abnormal when the test was performed with elevator PCU #1. When access was gained to inspect the elevator PCU, it was discovered that the PCU #1 rod end was sheared and the bearing was jammed. Evidence of light corrosion was also found on the rod end and this type of defect was not expected on such a low time aircraft. The aircraft had been operating briefly in a maritime environment with flights to the islands.

Side view from elevator PCU fitting

To remove the PCU, both the rod end and attachment bolt had to be cut and additional damage was found on the elevator PCU fitting. Bombardier was contacted and the fitting damage was repaired following their repair instructions. The other (5) PCUs from the left and right elevators were inspected as per Service Bulletin 670BA-27-074 with no additional findings. The left elevator PCU#1 and all the associated hardware was replaced with new parts.

This is the third Feedback article written on this subject and all Bombardier CRJ model aircraft including the CL850 are known to have this problem. If you are finding this problem on your aircraft, Transport Canada recommends reducing the inspection interval and/or adding additional inspections. Some operators already perform abbreviated and similar flight control function tests on their pre-flight checks to ensure correct function of all PCUs. In one case, a broken PCU rod end defect was discovered by the flight crew during their pre-departure flight control checks. These operators have added additional inspections via function tests in order to ensure proper system function and integrity at a more frequent interval.
