**SUBJ: ATA 53 Fuselage – Pilatus Flugzeugwerke AG P3 models -Fuselage to Horizontal Tail Fittings – Identification, Repetitive Inspections** SAIB: CE-20-08 R1  
Date: August 10, 2020

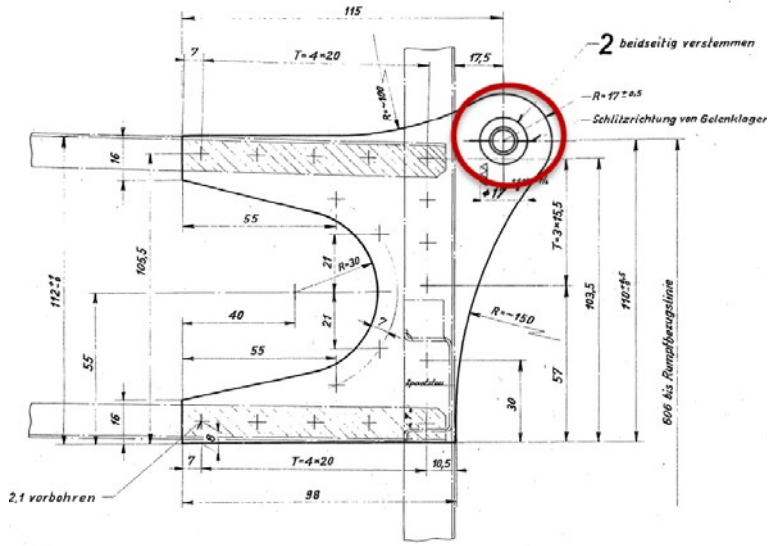
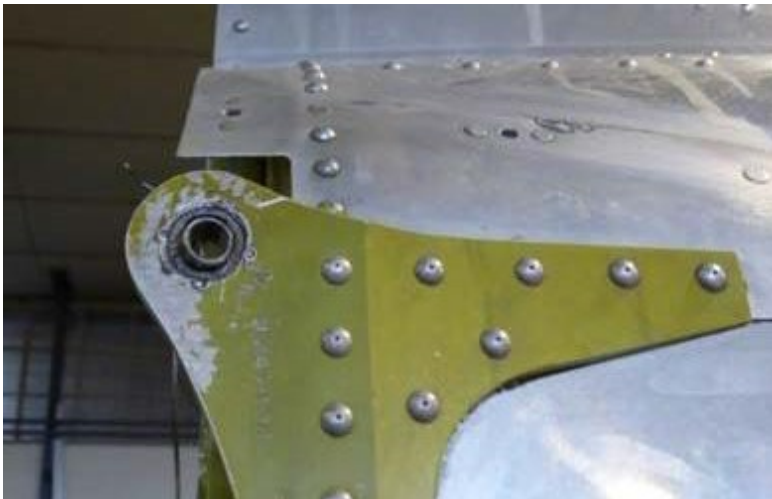
Appendix 1 (continued)

Fuselage to horizontal tail fitting: damage caused by using a centre punch tool during

- (3) If during the inspection required by paragraph (1) of this AD any fuselage to horizontal tail fittings with signs of damage caused by using a center punch tool are found, before next flight, replace the fitting with a serviceable part or repair the fitting in accordance with an approved repair solution.
