Feedback

Canadian Aviation Service Difficulty Reports

The following content was published between July 8, 2020 and December 29, 2020. The full accessible version of each article is available on the Feedback [website](#).

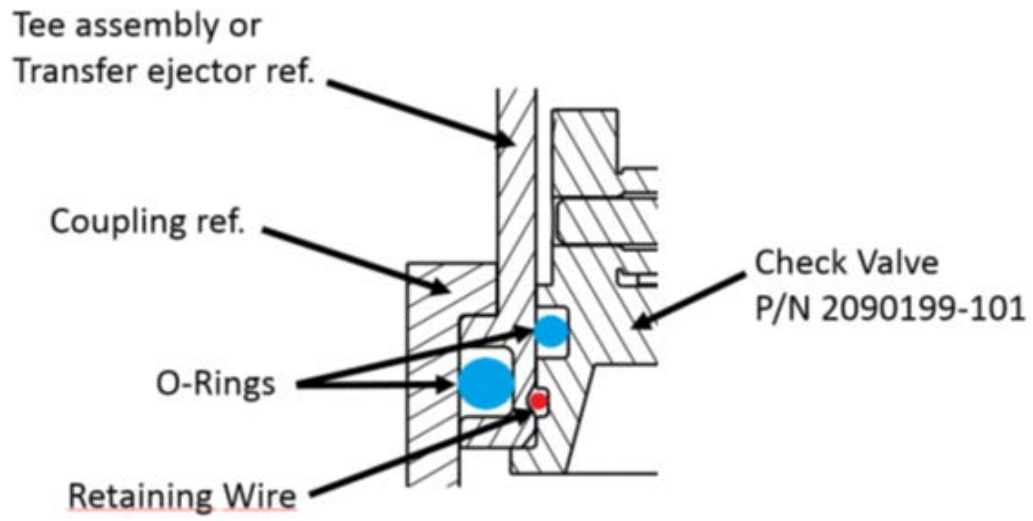
Pic 2 - Cross-section of a typical Fuel Check Valve installation

Transport Canada recommends that all operators of the A220-100 and A220-300 series of aircraft follow Airbus Canada Service Letter CS-SL-28-20-0004 and replace the Fuel Check Valve P/N 2090199-101 retaining wire at all 6 locations (3 in each wing) with the new P/N 2183023-101 retaining wire.
