AIRCRAFT ACCIDENT REPORT AND EXECUTIVE SUMMARY

Reference:		CA18/2/3/10273	
Aircraft Registration	ZS-OKS	Date of Accident	22 February 2023		Time of Accident	0951Z	
Type of Aircraft	Beechcraft Baron BE55		Type of Operation		Private (Part 91)		
Pilot-in-command Licence Type	Airline Transport Pilot Licence (ATPL) Aeroplane		Age	54	Licence Valid	Yes	
Pilot-in-command Flying Experience	Total Flying Hours		4900.0		Hours on Type	53.3	
Last Point of Departure	Pearly Beach Private Airstrip, Western Cape Province						
Next Point of Intended Landing	Oudtshoorn Aerodrome (FAOH), Western Cape Province						
Damage to Aircraft	Substantial						
Location of the accident site with reference to easily defined geographical points (GPS readings if possible)							
R43 road, 3.7km from Runway 15 threshold at Global Positioning System (GPS) determined to be 34°39'01"S 019°30'48"E at an elevation of 65.6 ft							
Meteorological Information	Wind velocity: 230° at 6KT; Temperature: 23°C; Dew Point: 11°C; Visibility: ≥10000m; Cloud: CAVOK; QNH: 1019 hPa

Probable Cause							
Loss of engine power due to incorrect setting of the fuel condition levers which led to fuel starvation and the subsequent unsucce

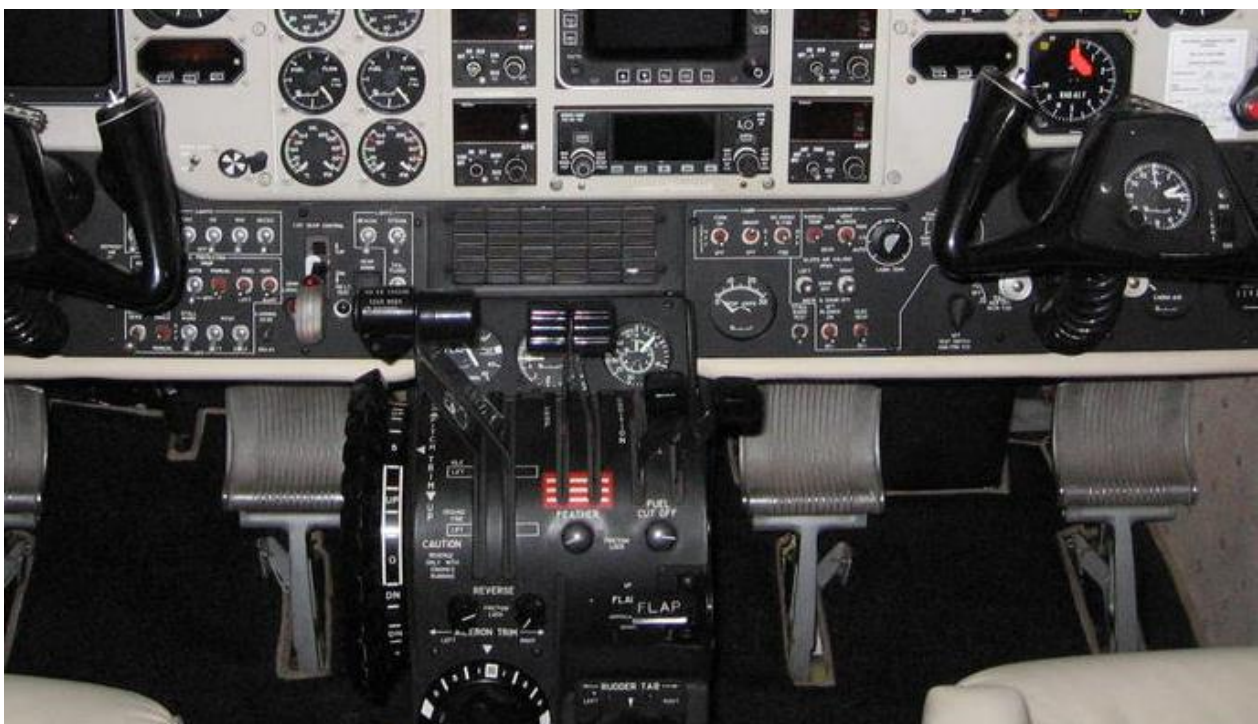
Figure 12: An example of the BE20 cockpit layout. (Source: <https://www.generalairways.co.za/kingAirB200/>)

1.16.6 Below is an example of the cockpit layouts of the King Air BE20 (Figure 11) and the Piper Seminole PA44 (Figure 12) multi-engine aircraft, with the throttle lever on the left, propeller lever in the centre, and mixture lever to the right of the quadrant, which the pilot was also rated on. The accident aircraft's throttle lever is positioned in the middle of the quadrant (Figure 4).
