**AIRCRAFT ACCIDENT REPORT AND EXECUTIVE SUMMARY**

<b>Reference:</b>		<b>CA18/2/3/10568</b>	
<b>Aircraft Registration</b>	<b>ZU-IMP</b>	<b>Date of Accident</b>	22 March 2025		<b>Time of Accident</b>	1300Z	
<b>Type of Aircraft</b>	Impala Mk I		<b>Type of Operation</b>		Private (Part 94)		
<b>Pilot-in-command Licence Type</b>		Commercial Pilot Licence (CPL) Aeroplane	<b>Age</b>	59	Licence Valid	Yes	
<b>Pilot-in-command Flying Experience</b>		<b>Total Flying Hours</b>		1 896.2 (Fixed Wing)	<b>Hours on Type</b>	26	
<b>Last Point of Departure</b>		Saldanha/Vredenburg Airport (FASD), Western Cape Province					
<b>Next Point of Intended Landing</b>		Saldanha/Vredenburg Airport (FASD), Western Cape Province					
Damage to Aircraft		Destroyed					
<b>Location of the accident site with reference to easily defined geographical points (GPS readings if possible)</b>							
Approximately 400m from Runway 20/02 at Saldanha/Vredenburg Airport (FASD), Western Cape Province

**Synopsis**

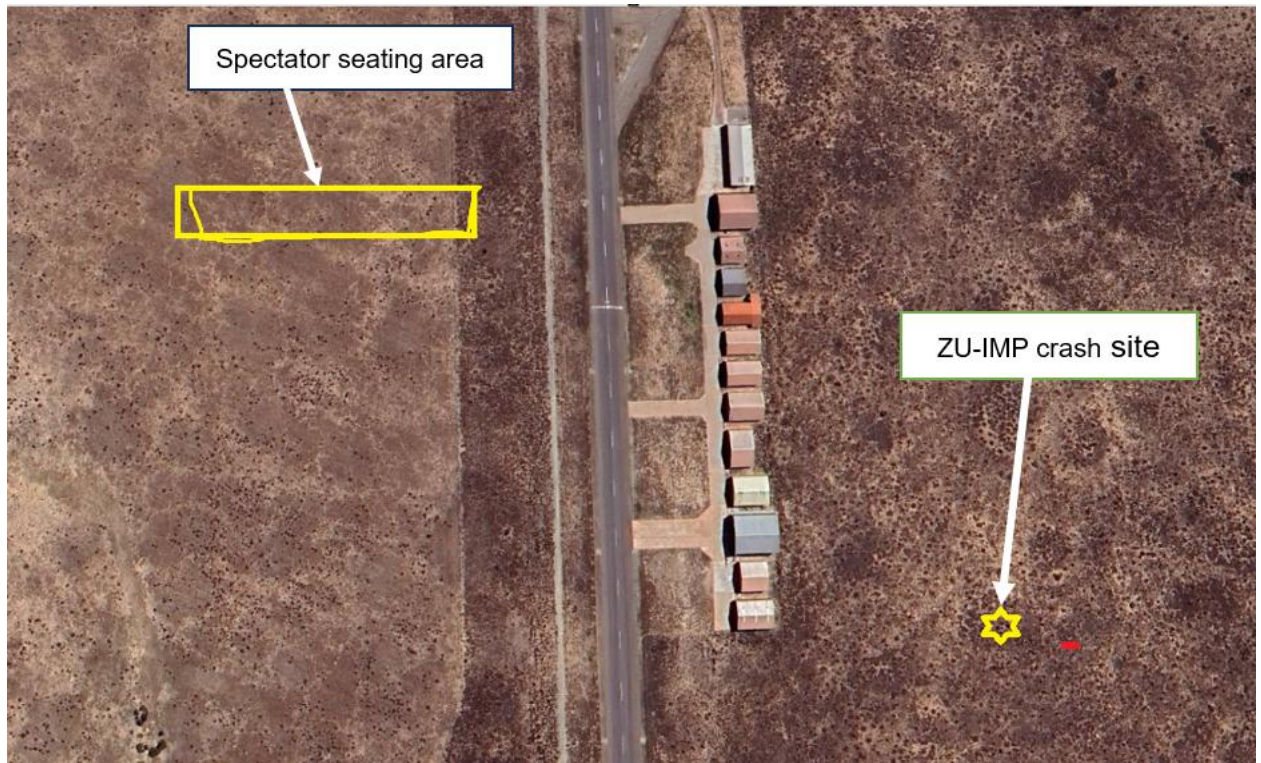
1.1.11. The accident occurred during daylight approximately 400 metres (m) from the left of FASD Runway 02 at Global Positioning System (GPS) co-ordinates determined to be 32°57'47" South 017°58'20" East, at an elevation of 33ft.

**Figure 9:** The layout, seating arrangement and the approximate accident site at the airshow.  
(Source: Event organiser)
