LIMITED OCCURRENCE INVESTIGATION REPORT – FINAL

Reference Number		CA18/2/3/10650								
Classification		Accident	Date		29 March 2026	Time		0630Z		
Type of Operation		Private (Part 94)								
Location										
Place of Departure		Uitspan Klein Karoo Guest Farm Airstrip near Ladismith, Western Cape Province			Place of Intended Landing		Uitspan Klein Karoo Guest Farm Airstrip near Ladismith, Western Cape Province			
Place of Occurrence		On the left side of the gravel runway at Uitspan Klein Karoo Guest Farm, Western Cape Province								
GPS Co-ordinates		Latitude	33°32'28.97" S	Longitude	021°9'11.80" E	Elevation	1 190 ft			
Aircraft Information										
Registration		ZU-ANU								
Make; Model; S/N		Skystar; Kitfox IV (Serial Number: 1712)								
Damage to Aircraft		Substantial			Total Aircraft Hours		625.4			
Pilot-in-command										
Licence Type		National Pilot Licence (NPL)		Gender		Male		Age	68	
Licence Valid		Yes		Total Hours		1 813.1		Total Hours on Type		625.4

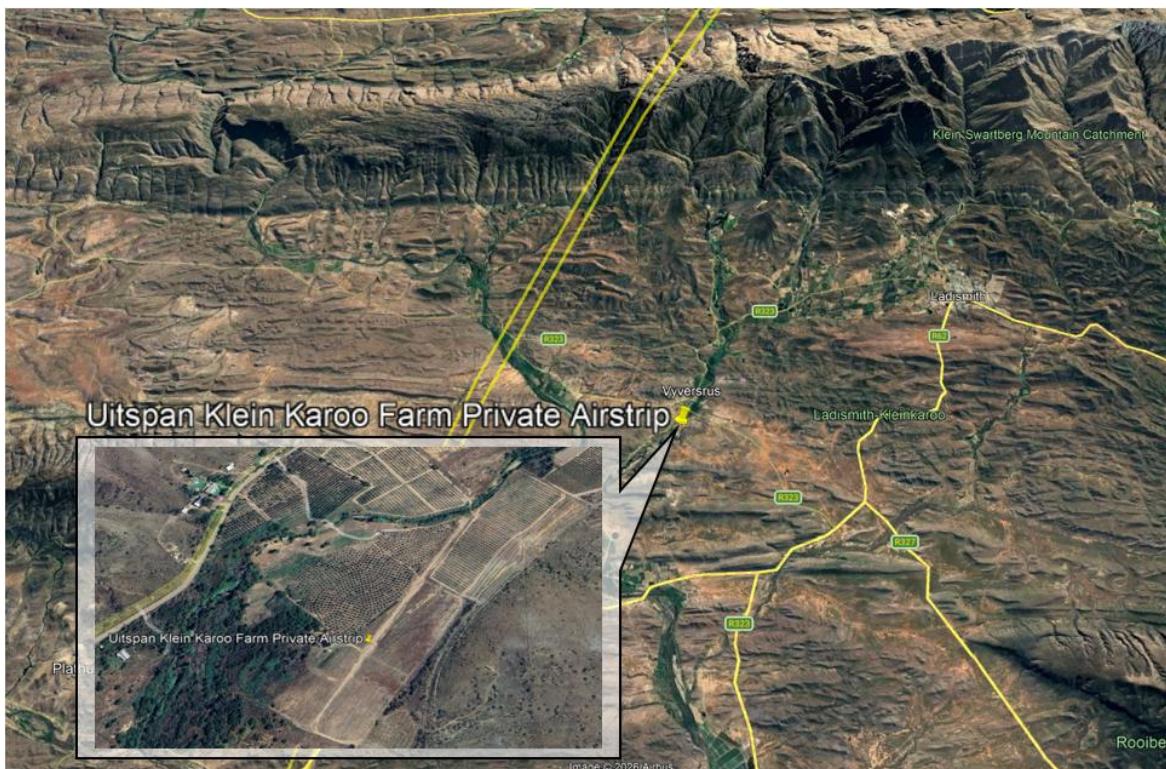
Figure 1: The position of the aircraft and the runway. (Source: Google Earth)

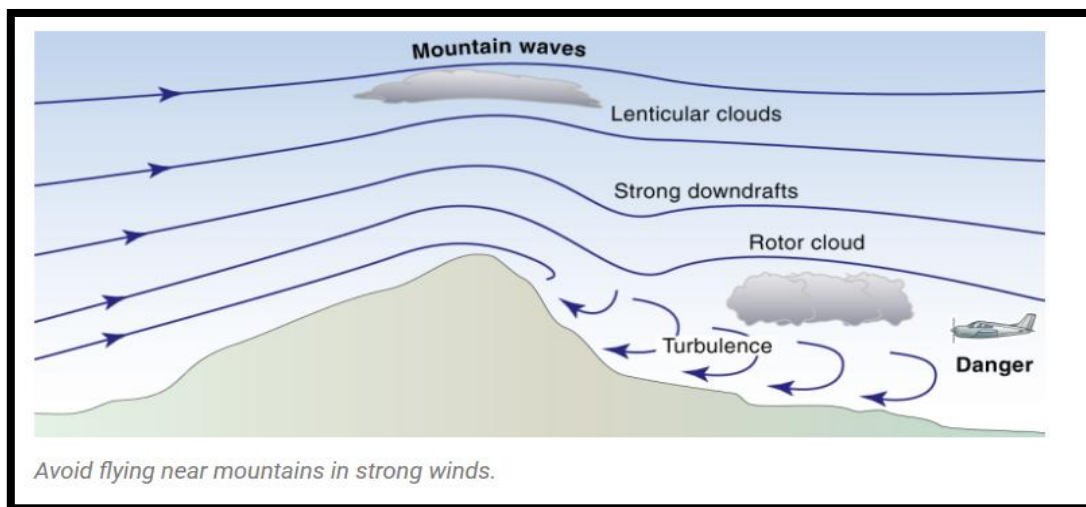
Figure 6: Turbulence in mountainous regions.

This same condition is even more noticeable when flying in mountainous regions. While the wind flows smoothly up the windward side of the mountain and the upward currents help to carry an aircraft over the peak of the mountain, the wind on the leeward side does not act similarly. As the air flows down the leeward side of the mountain, it follows the contour of the terrain and is increasingly turbulent. This tends to push an aircraft into the side of a mountain. The stronger the winds, the greater the downward pressure and turbulence become. Due to the effect terrain has on the wind in valleys or canyons, downdraft can be severe. Before conducting a flight in or near mountainous terrain, it is helpful for a pilot unfamiliar with a mountainous area to get a checkout with a mountain-qualified flight instructor.
