LIMITED OCCURRENCE INVESTIGATION REPORT – FINAL

Reference Number	CA18/3/2/1516						
Classification	Serious Incident	Date	24 November 2025		Time	1250Z	
Type of Operation	Air Transport Operations, Carriage of less than 20 passengers (Part 135)						
Location							
Place of Departure	Arathusa Safari Lodge Aerodrome (FAAR), Mpumalanga Province		Place of Intended Landing	O.R. Tambo International Airport (FAOR), Gauteng Province			
Place of Occurrence	On Runway 16 at Arathusa Safari Lodge Aerodrome, Mpumalanga Province						
GPS Co-ordinates	Latitude	24°44'11.68" S	Longitude	031°30'51.50" E	Elevation	1 256 feet	
Aircraft Information							
Registration	ZS-KMH and ZS-KMJ						
Make; Model; S/N	Cessna Aircraft Corporation, 208B Caravan (Serial Numbers: 208B-5742 [ZS-KMH] and 208B-5749 [ZS-KMJ])						
Damage to Aircraft	Substantial		Total Aircraft Hours	2 123.22			
Pilot-in-command							
Licence Type	Commercial Pilot Licence		Gender	Female		Age	26
Licence Valid	Yes	Total Hours	953.6		Total Hours on Type	651.6

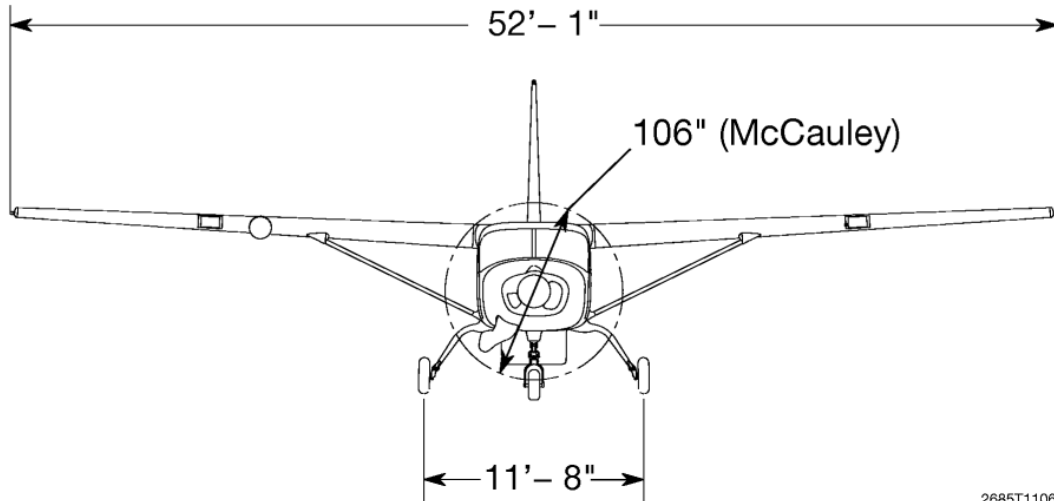
Diagram 1: The wingspan of the Cessna 208B is 15.9m (52 feet and 1 inch), and the wheelbase is 3.55m (11 feet and 8 inches) (Source: Information Manual Cessna 208B, Section 1)
