LIMITED OCCURRENCE INVESTIGATION REPORT – FINAL

Reference Number	CA18/3/2/1530							
Classification	Serious Incident		Date	10 February 2026		Time	0600Z	
Type of Operation	Training (Part 141)							
Location								
Place of Departure	Secunda Airfield (FASC), Mpumalanga Province		Place of Intended Landing	Wonderboom Airport (FAWB), Gauteng Province				
Place of Occurrence	On Runway 35 at Rand Airport (FAGM), Gauteng Province							
GPS Co-ordinates	Latitude	26° 14' 33.31" S	Longitude	28° 9' 4.54" E	Elevation	5 477ft		
Aircraft Information								
Registration	ZS-IIZ							
Make; Model; S/N	Cessna; 177RG (Serial Number: 177RG-0134)							
Damage to Aircraft	Minor			Total Aircraft Hours	3 543.7			
Pilot-in-command								
Licence Type	Private Pilot Licence (PPL)		Gender	Male		Age	22	
Licence Valid	Yes	Total Hours	133.3		Total Hours on Type	48.4		
Total Hours 30 Days	9.6		Total Flying on Type Past 90 Days	48.4				
People On-board	1 + 1		Injuries	0		Fatalities	0

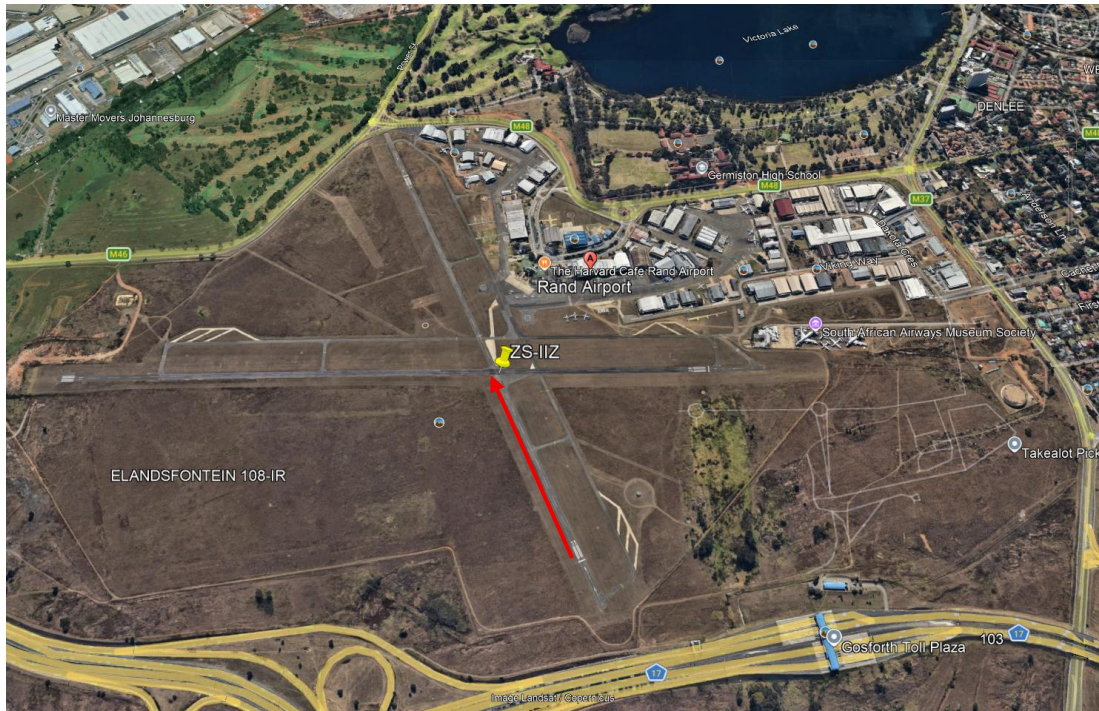
Figure 1: The airport layout and the approximate area where the serious incident occurred (yellow pin). The red arrow indicates the direction of landing. (Source: Google Earth)
