## LIMITED OCCURRENCE INVESTIGATION REPORT – FINAL

<b>Reference Number</b>	CA18/3/2/1533						
<b>Classification</b>	Serious Incident	<b>Date</b>	13 February 2026		<b>Time</b>	1025Z	
<b>Type of Operation</b>	Training (Part 141)						
<b>Location</b>							
Place of Departure	Wonderboom Airport (FAWB), Gauteng Province		Place of Intended Landing	Wonderboom Airport (FAWB), Gauteng Province			
Place of Occurrence	Runway 24 at Wonderboom Airport (FAWB)						
GPS Co-ordinates	Latitude	25° 25' 39.29" S	Longitude	028° 13' 14.62" E	Elevation	4 081 ft	
<b>Aircraft Information</b>							
Registration	ZS-EOZ						
Make; Model; S/N	Piper; PA-28-140 Cherokee (Serial Number: 28-22041)						
Damage to Aircraft	Substantial		Total Aircraft Hours	11 937.4			
<b>Pilot-in-command</b>							
Licence Type	Commercial Pilot Licence (CPL)		Gender	Male		Age	27
Licence Valid	Yes	Total Hours	1 230.2		Total Hours on Type	1 053.3	
Total Hours 30 Days	21.1		Total Flying on Type Past 90 Days	63.2

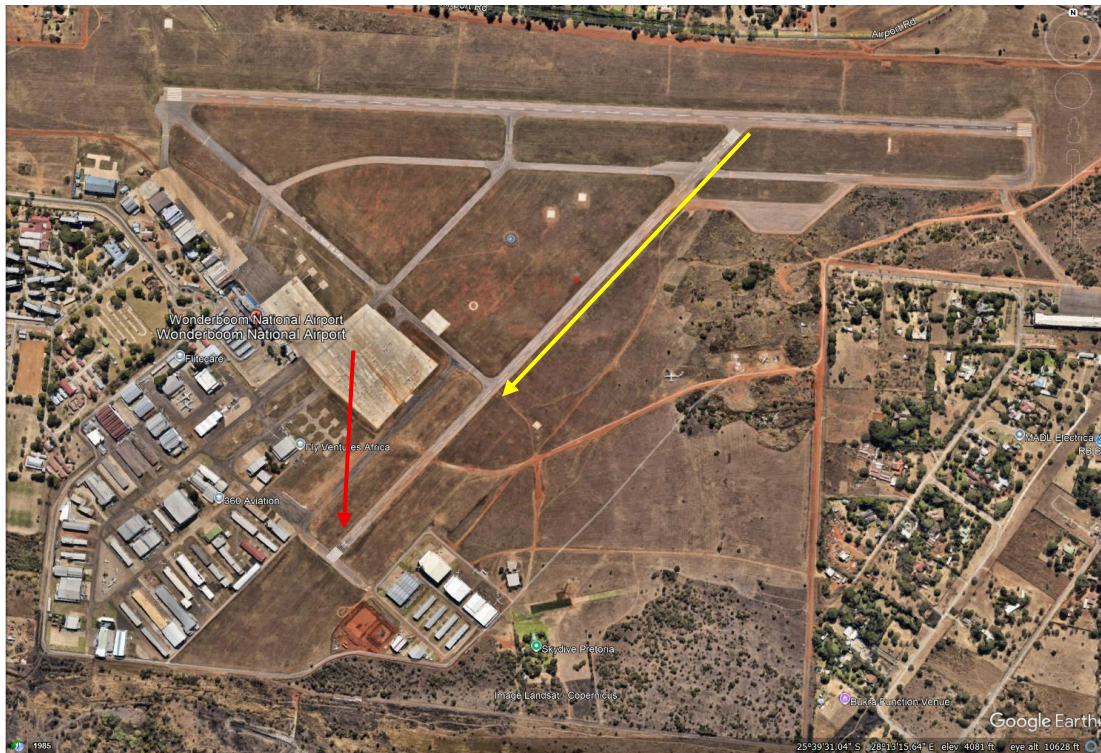
**Figure 1:** An aerial view of FAWB, the direction of landing on Runway 24 (yellow arrow) and the approximate area where the aircraft stopped (red arrow). (Source: Google Earth)
