LIMITED OCCURRENCE INVESTIGATION REPORT – FINAL

Reference Number	CA18/3/2/1535						
Classification	Serious Incident		Date	17 February 2026		Time	0740Z
Type of Operation	Private (Part 94)						
Location							
Place of Departure	Johan Pienaar Airport (FAKU), Northern Cape Province		Place of Intended Landing		Rhenosterfontein Farm Airstrip, North West Province		
Place of Occurrence	On the gravel runway at Rhenosterfontein Farm Airstrip, North West Province						
GPS Co-ordinates	Latitude	27° 11' 26.0" S	Longitude	24° 18' 11.0" E	Elevation	4 603ft	
Aircraft Information							
Registration	ZU-EGC						
Make; Model; S/N	Jabiru J430 (Serial number: 280)						
Damage to Aircraft	Substantial			Total Aircraft Hours	1 078.2		
Pilot-in-command							
Licence Type	Private Pilot Licence (PPL)		Gender	Male		Age	44
Licence Valid	Yes	Total Hours	187.4		Total Hours on Type	187.4	
Total Hours 30 Days	3.7		Total Flying on Type Past 90 Days		20.9		
People On-board	1 + 0	Injuries	0	Fatalities	0	Other (on ground)	0

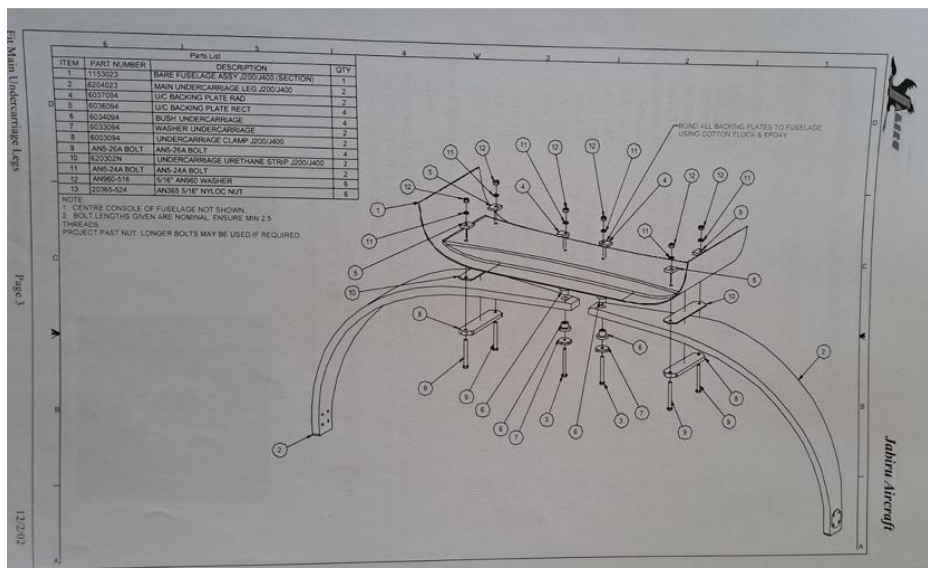
The Jabiru J430 aircraft is powered by a 120 horsepower (hp) Jabiru 3300 six-cylinder engine. The main landing gear (MLG) comprises two separate composite beams which are bolted to the fuselage at the top and centre, and to the wheel stub at the bottom. The nose gear is a welded steel, trailing arm assembly with a rubber spring system. The nose wheel is steerable with the rudder pedals. The nose wheel and main wheel speed fairings (wheel spats) are optional equipment. For all models discussed in this manual, the main undercarriage has the same general arrangement: a laminated composite spring forms the leg which is bolted to the fuselage at one end and the main wheels at the other.

Figure 3: Illustration of the main landing gear legs. (Source: Jabiru Illustrated Parts Catalogue [IPC])
