LIMITED OCCURRENCE INVESTIGATION REPORT – FINAL

Reference Number	CA18/3/2/1536						
Classification	Serious Incident		Date	21 February 2026		Time	1000Z
Type of Operation	Private (Part 94)						
Location							
Place of Departure	Alzu Rondefontein Airfield, Mpumalanga Province		Place of Intended Landing	Zevenfontein Farm Airstrip, Mpumalanga Province			
Place of Occurrence	Zevenfontein Farm Airstrip, Mpumalanga Province						
GPS Co-ordinates	Latitude	25°48'00.4" S	Longitude	29°43'23.6" E	Elevation	5 426.5 ft	
Aircraft Information							
Registration	ZU-IKU						
Make; Model; S/N	Van's; RV10 (Serial Number: 41730)						
Damage to Aircraft	Substantial		Total Aircraft Hours	768			
Pilot-in-command							
Licence Type	Private Pilot Licence		Gender	Male		Age	59
Licence Valid	Yes	Total Hours	611.1		Total Hours on Type	500	
Total Hours 30 Days	10		Total Flying on Type Past 90 Days	23.2			
People On-board	1 + 0	Injuries	0	Fatalities	0	Other (on ground)	0
What Happened

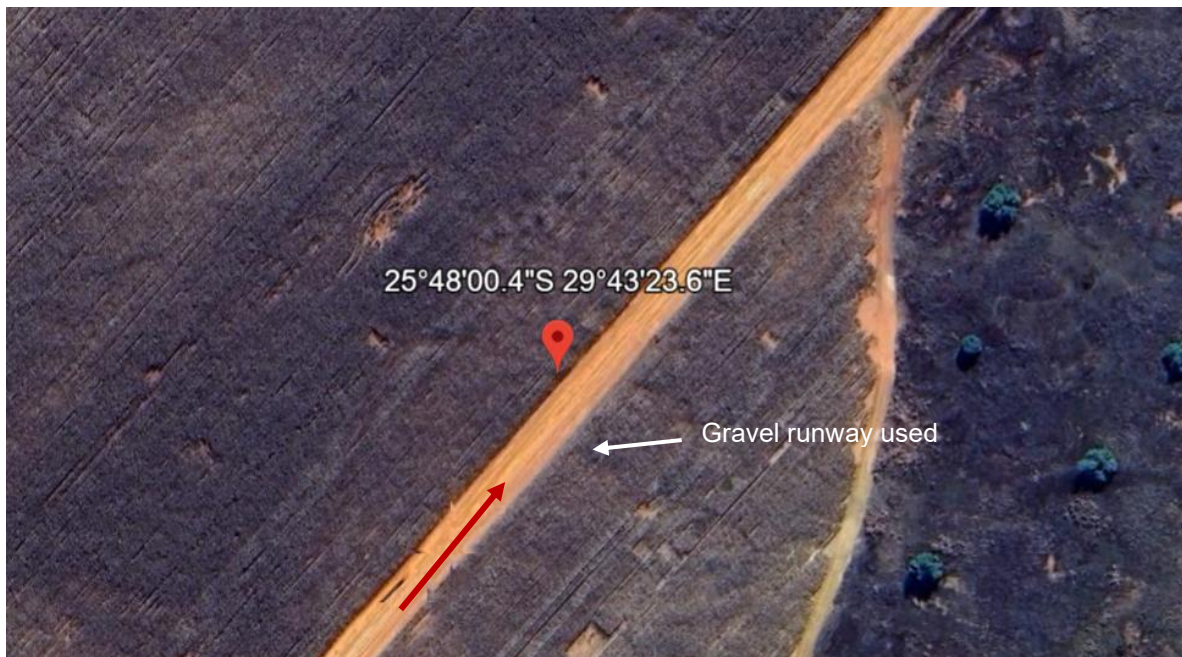
Figure 1: An aerial view of the gravel runway, the landing direction (red arrow) and the approximate area where the aircraft had stopped. (Source: Google Earth)
