**LIMITED OCCURRENCE INVESTIGATION REPORT – FINAL**

| <b>Reference Number</b> | CA18/3/2/1543 | | | | | | |
| <b>Classification</b> | Serious Incident | | <b>Date</b> | 11 April 2026 | | <b>Time</b> | 0835Z |
| <b>Registration</b> | ZU-JOL | | | | | | |

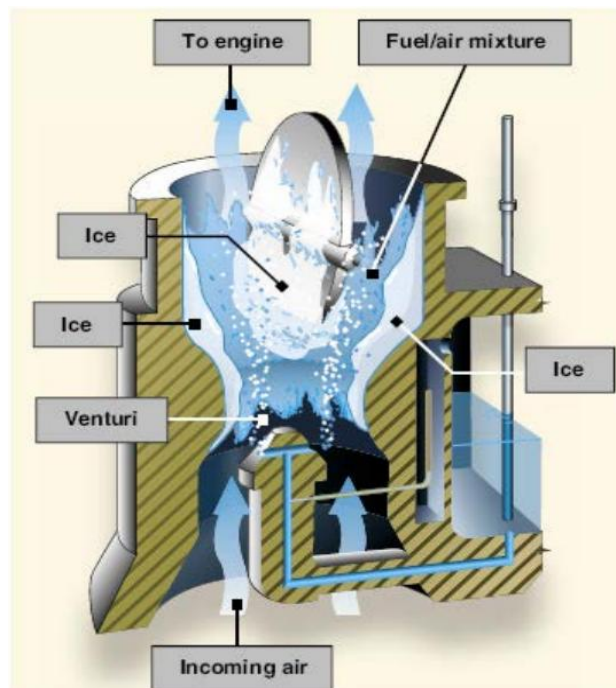
**Figure 5:** The formation of carburettor ice may reduce or block fuel/air flow to the engine. (Source: [highsierrapilots.club/carburetor-icing/](http://highsierrapilots.club/carburetor-icing/))

The first indication of carburettor icing in an aircraft with a fixed-pitch propeller is a decrease in engine revolutions per minute (rpm), which may be followed by engine roughness. In an aircraft with a constant-speed propeller, carburettor icing is usually indicated by a decrease in manifold pressure, but no reduction in rpm. Propeller pitch is automatically adjusted to compensate for loss of power. Thus, a constant rpm is maintained. Although carburettor ice can occur during any phase of flight, it is particularly dangerous when using reduced power during a descent. Under certain conditions, carburettor ice could build unnoticed until power is added. To combat the effects of carburettor ice, engines with float-type carburetors employ a carburettor heat system.

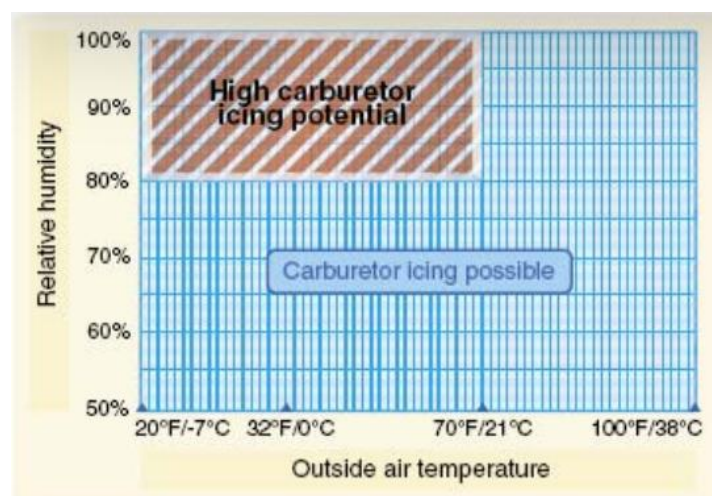
According to the carburettor icing probability chart below, the recorded conditions showed a dew point depression of 10°C with an ambient temperature of 23°C and a dew point of 13°C. An estimated relative humidity of about 55% was recorded. A likelihood of carburettor icing was considered a serious probability at descent power settings. Additionally, the aircraft was in descent phase of flight in preparation for landing at FAKR. Typically, this involved lower engine power settings which further increased the potential for ice formation.

**Figure 6:** Relative humidity and outside temperature chart for carburettor icing formation probability (Source: [http://avstop.com/AC/weight\\_shift\\_control/4-10.html](http://avstop.com/AC/weight_shift_control/4-10.html))
