Section/division **Accident and Incident Investigations Division**

## LIMITED OCCURRENCE INVESTIGATION REPORT – FINAL

| <b>Reference Number</b> | CA18/3/2/1554 | | | | | | |
| Registration | ZS-DPN | | | | | | |

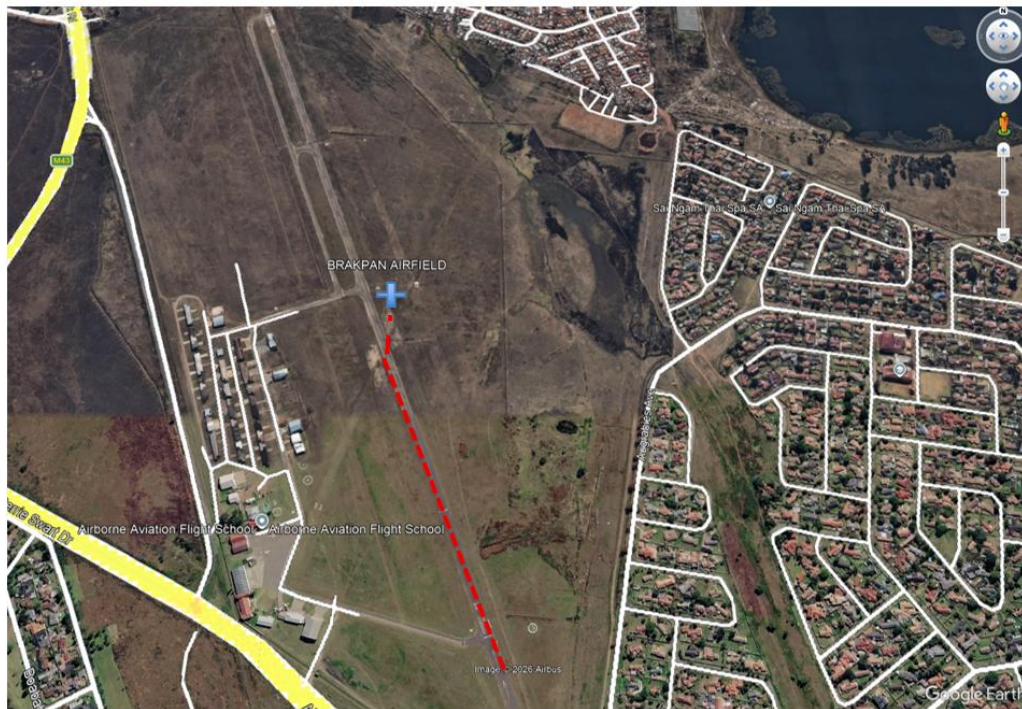
was not successful. The aircraft drifted off the runway and came to rest in the bushes. The wing tip, propeller blade and the nose gear were damaged. The pilot sustained minor injuries.

**Figure 1:** Aerial view of the serious incident site. (Source: Google Earth)

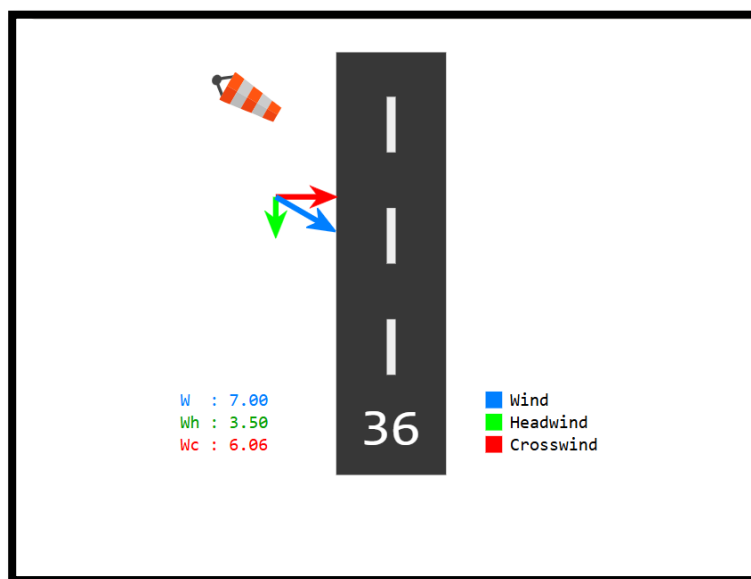
The crosswind was minimal and played no role in this serious incident. The maximum crosswind component was 17 knots.

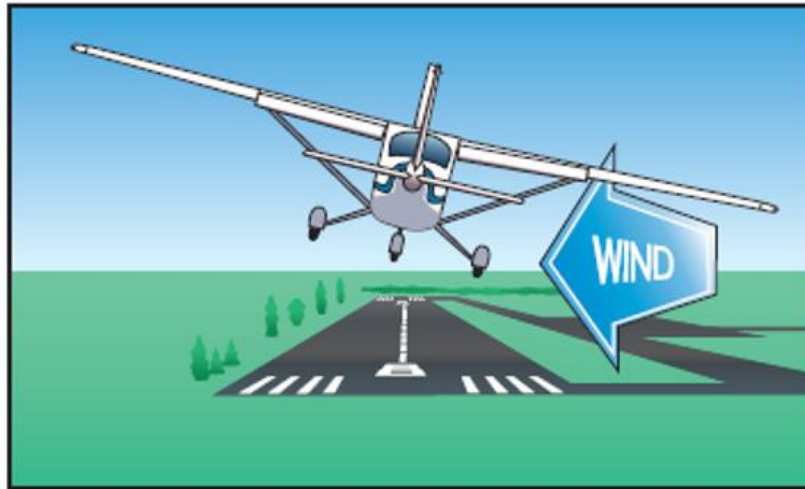
**Figure 4:** Sideslip technique illustration. (Source: FAA-H-8083-3A)

| <p><b>Probable Cause(s)</b></p> <p>The aircraft which was configured in a sideslip veered off the runway after touchdown due to the student pilot's inability to maintain directional control.</p> |
