**PRELIMINARY ACCIDENT REPORT**

**Accident and Incident Investigations Division**

Accident  
- Preliminary Report -  
AIID Ref No: CA18/2/3/10673

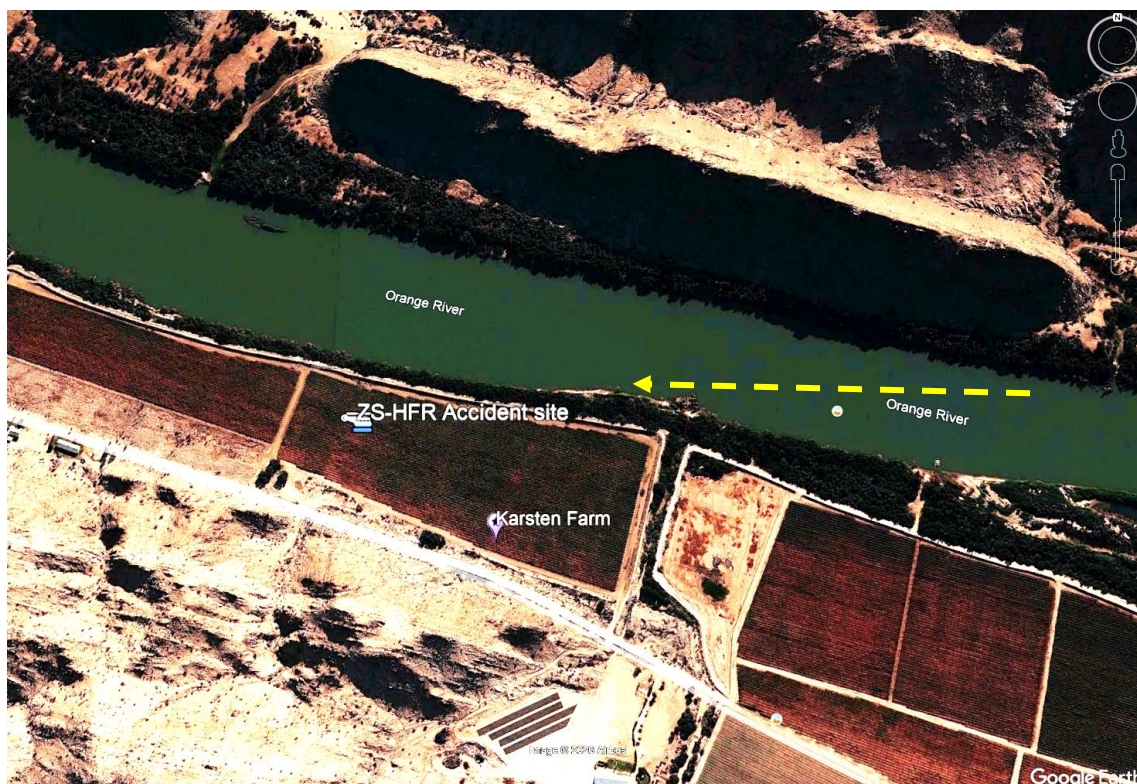
- 1.1.5. The pilot was seriously injured during the accident sequence; he was airlifted to a hospital. The helicopter was destroyed.
- 1.1.6. The accident occurred at Karsten Boerdery, west of Upington, at Global Positioning System (GPS) co-ordinates determined to be 28°27'22.0"S 020°03'03.3"E, at an elevation of 1 441ft.

**Figure 2:** The accident site. The yellow arrow indicates the direction of flight. (Source Google Earth)
