**PRELIMINARY ACCIDENT REPORT**

**Accident and Incident Investigations Division**

Accident  
- Preliminary Report -  
AIID Ref No: CA18/2/3/10655

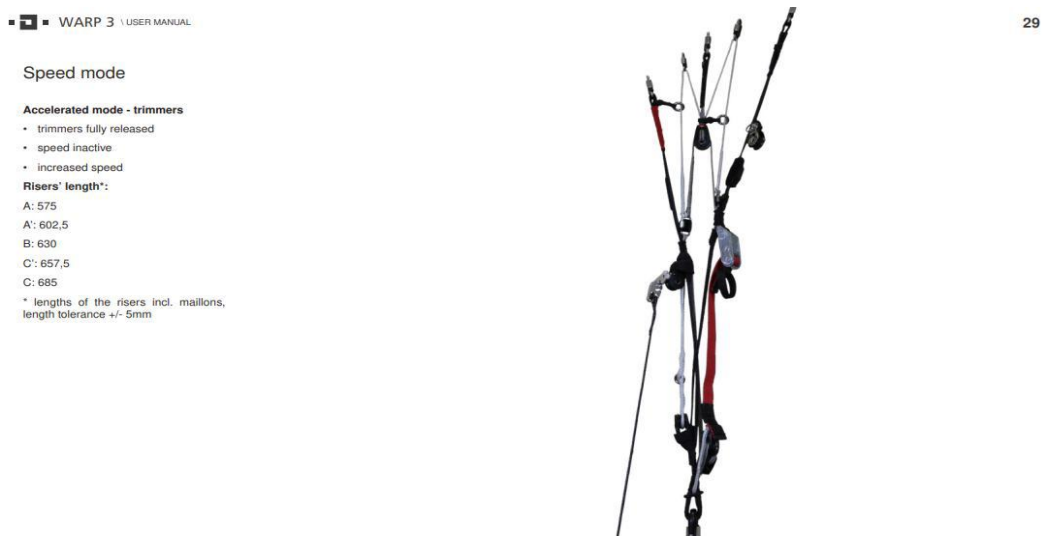
**Figure 22:** Illustration of the wing speed trim controls.

*This narrative aligns with Dudek's published safety guidance, warning that launching with very slow trim settings can cause the wing to stay behind the pilot, increase the angle of attack, and potentially result in an asymmetric or deep stall if the launch is continued.*
