**PRELIMINARY SERIOUS INCIDENT REPORT**

Serious Incident  
- Preliminary Report -  
AIID Ref No: CA18/3/2/1550

On 11 May 2026, an Airbus A320 aircraft with registration ZS-SZE, operated as a scheduled passenger flight SA327, departed from O.R. Tambo International Aerodrome (FAOR) to Cape Town International Aerodrome (FACT) with six crew members and 137 passengers on-board.

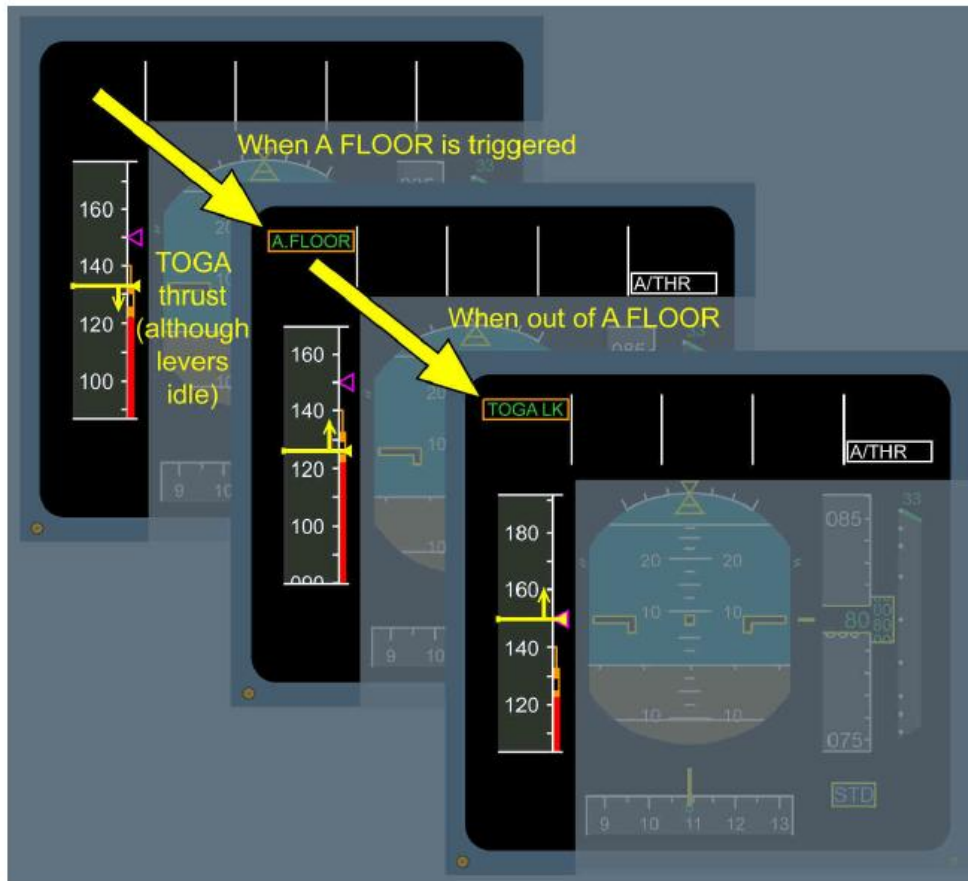
- *The aircraft in descent with the thrust levers manually set to IDLE.*
- *The aircraft deceleration during manual flight with the Flight Director (FD) off, as indicated on the Flight Mode Annunciator FMA.*

When the speed decreases, so that the angle-of-attack reaches the Alpha Floor threshold, A/THR activates and orders TOGA thrust, even though the thrust levers are at idle. When the aircraft accelerates again, the angle-of-attack drops below the Alpha Floor threshold. TOGA thrust is maintained or locked. This enables the flight crew to reduce thrust, as necessary. TOGA locked (LK) appears on the FMA to indicate that TOGA thrust is locked. The desired thrust can only be recovered by setting A/THR to off, with the instinctive disconnect pushbutton. Alpha Floor is available when the flight controls are in Normal Law, from lift-off to 100ft Resolution Advisory (RA) at landing. It is inhibited in some cases of engine failure.
