PRELIMINARY ACCIDENT REPORT

Accident and Incident Investigations Division

Accident
- Preliminary Report -
AIID Ref No: CA18/2/3/10640

Reference Number : CA18/2/3/10640
Occurrence Category : Accident (Category 1)
Type of Operation : Agricultural Operations (Part 137)
Name of Operator : Natal Aerial Spray
Aircraft Registration : ZS-XAP
Aircraft Make and Model : Air Tractor (AT-502A)
Nationality : South African
Place : Qwaggavlake Farm, north-west of Wesselsbron
Date and Time : 25 February 2026 at 1252Z
Injuries : Fatal
Damage : Destroyed

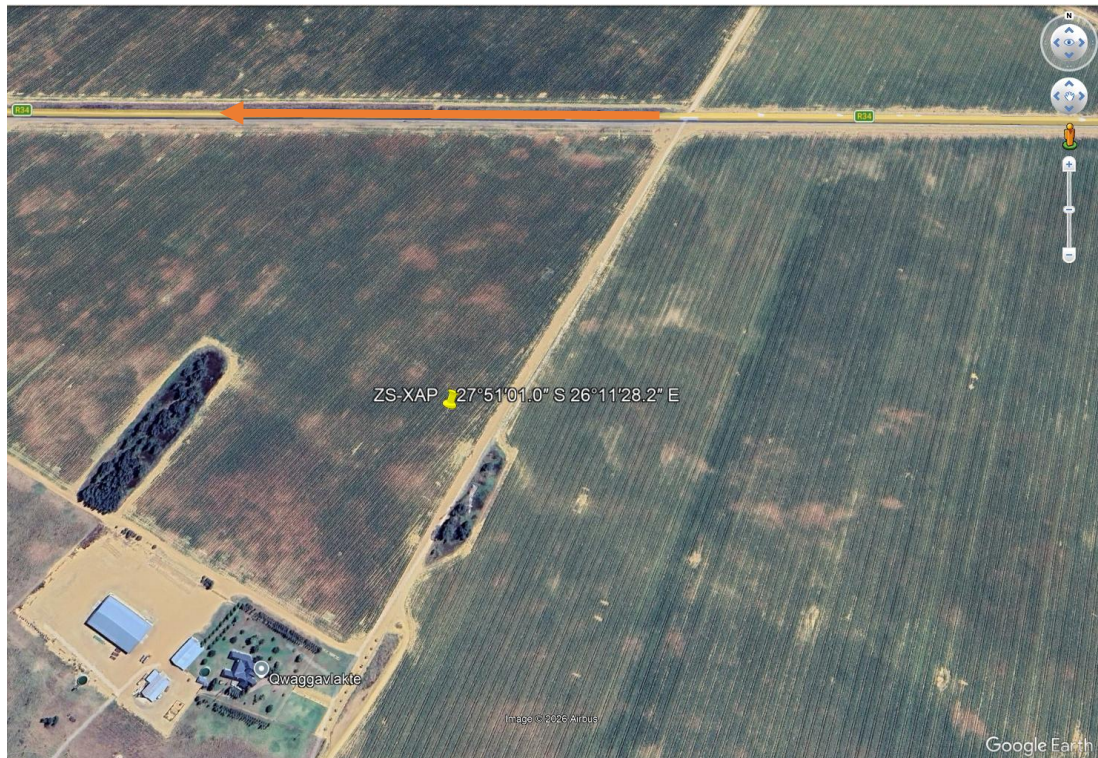
1.1.6. The accident occurred at Qwaggavlake Farm, north-west of Wesselsbron at Global Positioning System (GPS) co-ordinates determined to be 27°51'01.0" South 26°11'28.2" East, at an elevation of 4166 feet (ft).

Figure 2: An aerial view of the accident site (yellow pin) and the direction of travel of the eyewitness' motor vehicle and truck. (Source: Google Earth)
