AIRCRAFT ACCIDENT REPORT AND EXECUTIVE SUMMARY

Reference:	CA18/2/3/10097			
Aircraft Registration	ZS-NRJ	Date of Accident	3 January 2022			Time of Accident	0610Z	
Type of Aircraft	Jetstream 41			Type of Operation		Commercial (Part 121)		
Pilot-in-command Licence Type	Airline Transport Pilot Licence (ATPL)		Age	42		Licence Valid	Yes	
Pilot-in-command Flying Experience	Total Flying Hours			6 851.0		Hours on Type	2 136.9	
First Officer	Commercial Pilot Licence (CPL)		Age	34		Licence Valid	Yes	
Pilot-in-command Flying Experience	Total Flying Hours			2 401.6		Hours on Type	510	
Last Point of Departure	O.R. Tambo International Airport (FAOR), Gauteng Province							
Next Point of Intended Landing	Venetia Mine Airfield (FAVM), Limpopo Province							
Damage to Aircraft	Substantial							
Location of the accident site concerning easily defined geographical points (GPS readings if possible)								
On Runway 08 at FAVM and at Global Positioning System (GPS) co-ordinates determined to be 22°26'54.69" South 029°20'13.68" East, at an elevation of 2 333 feet (ft)

Reference Number : CA18/2/3/10097
Occurrence Category : Category 1
Type of Operation : Commercial (Part 121)
Aircraft Registration

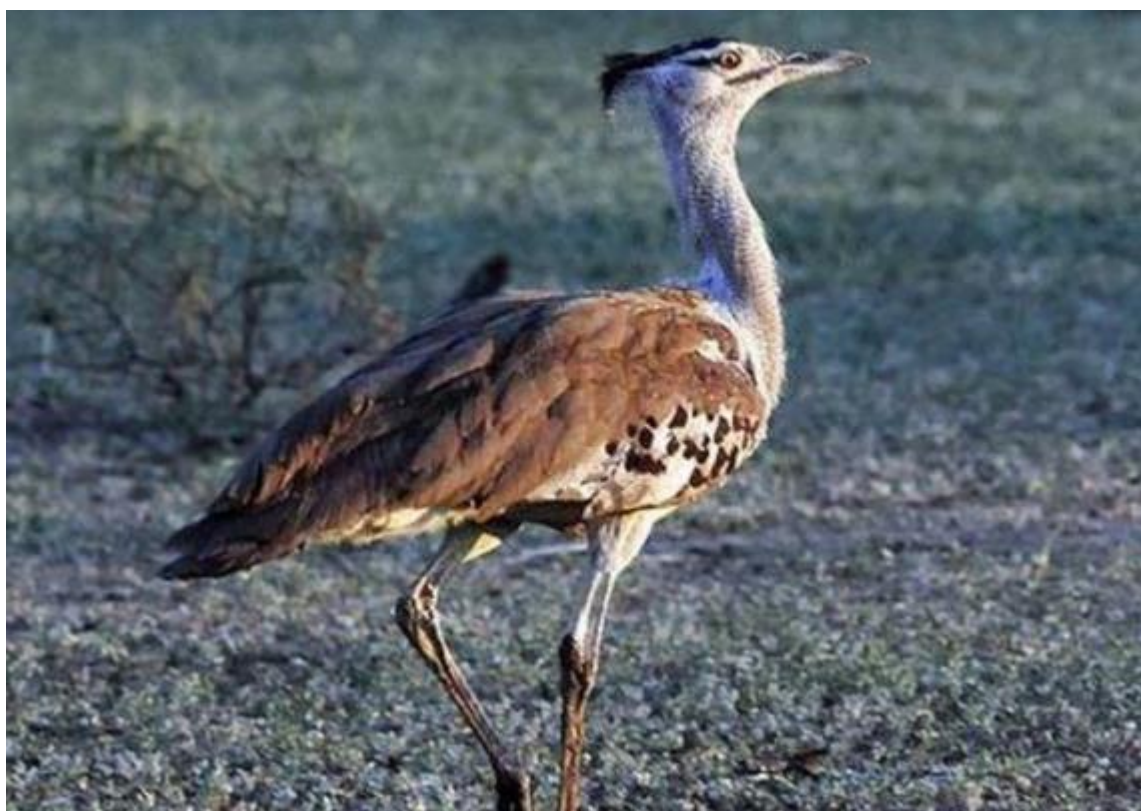
Figure 17: The Kori Bustard.

1.16.1.1. *The Kori Bustard is Africa's heaviest flying bird; it can weigh up to 19kg. It is a land bird with a long neck and long foot ended by three fingers with light brown or grey plumage. The sides of the crown on the head extend into a black crest. There is a white stripe over each eye. The chin, throat, and neck are creamy white mixed with black bands.*

The underparts of the bird are buff coloured with dark brown vermiculation. The tail has wide bands of greyish brown and white. The primaries, or flight feathers, are also similarly marked. The shoulder area has a checkered black-and-white pattern.
